FINAL REPORT ON ACCIDENT TO M/s DECCAN AVIAION PVT, LTD., PC-12/45 AIRCRAFT VT-DAR AT GUWAHATI ON 28-11-2014

M/s Deccan Aviation Pvt. Ltd, PC-12/45 aircraft VT-DAR operating flight from Delhi to Guwahati was involved in an accident during landing at Guwahati airport on 28-11-2014. There were 02 crew members and 01 passenger on board the aircraft.

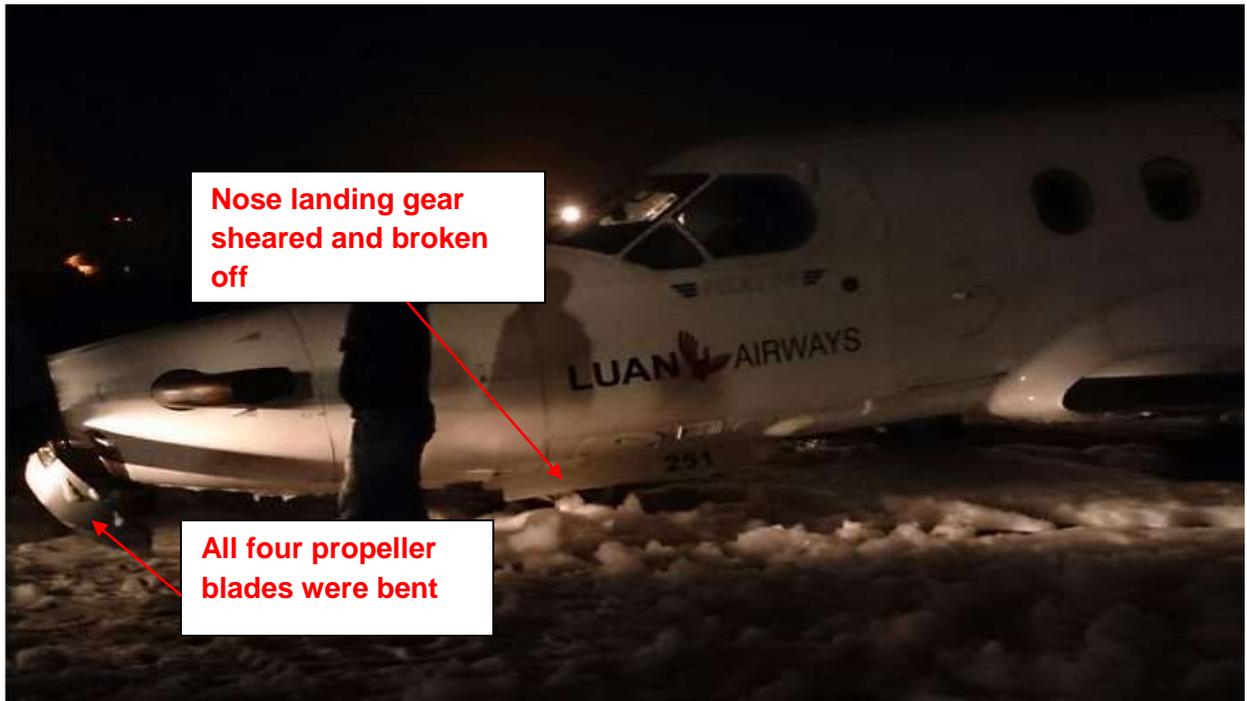
Final resting position of the aircraft on the runway with nose landing gear broken off

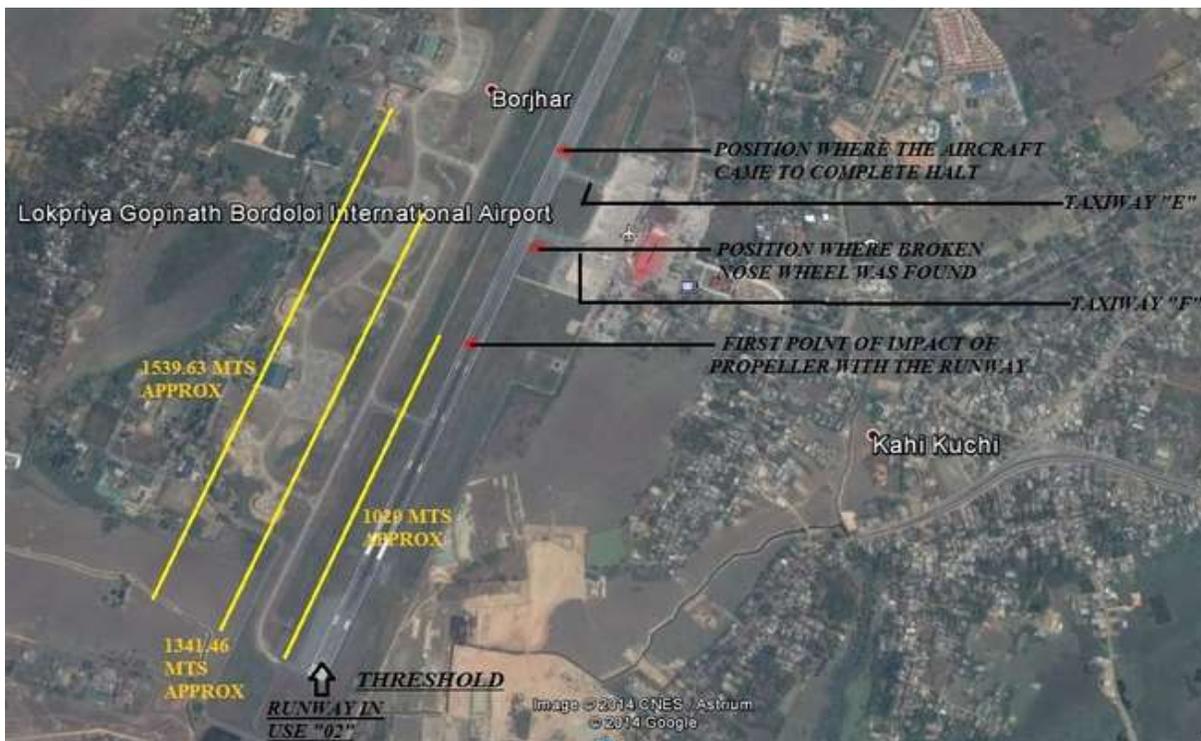
Figure: Location of aircraft and parts on the runway after landing.

During landing the aircraft bounced twice on its main landing gear and on the third time the aircraft impacted on its nose landing gear. The impact was such that the nose gear sheared off from its attachment point and the bend backward.

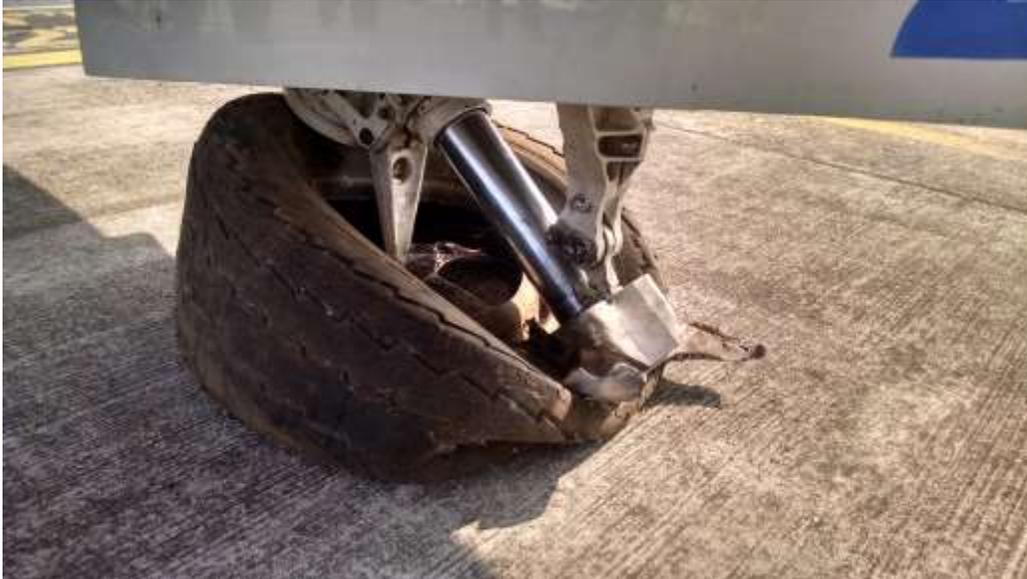
NOSE LANDING GEAR BENT BACKWARD

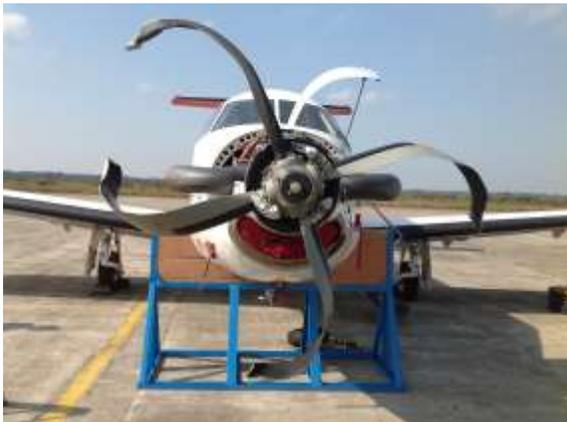
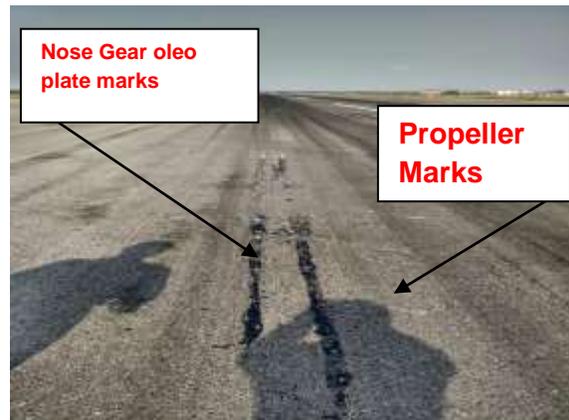
The nose wheel also got detached from the wheel assembly, and the propellers came in contact with the runway surface as it is evident with the propeller marks on the runway surface. After the nose wheel detached from the hub the oleo of the nose gear came in contact with the runway surface as it is evident from the deep gouge marks on the runway surface and also on the nose landing gear.

BENT PROPELLER BLADES

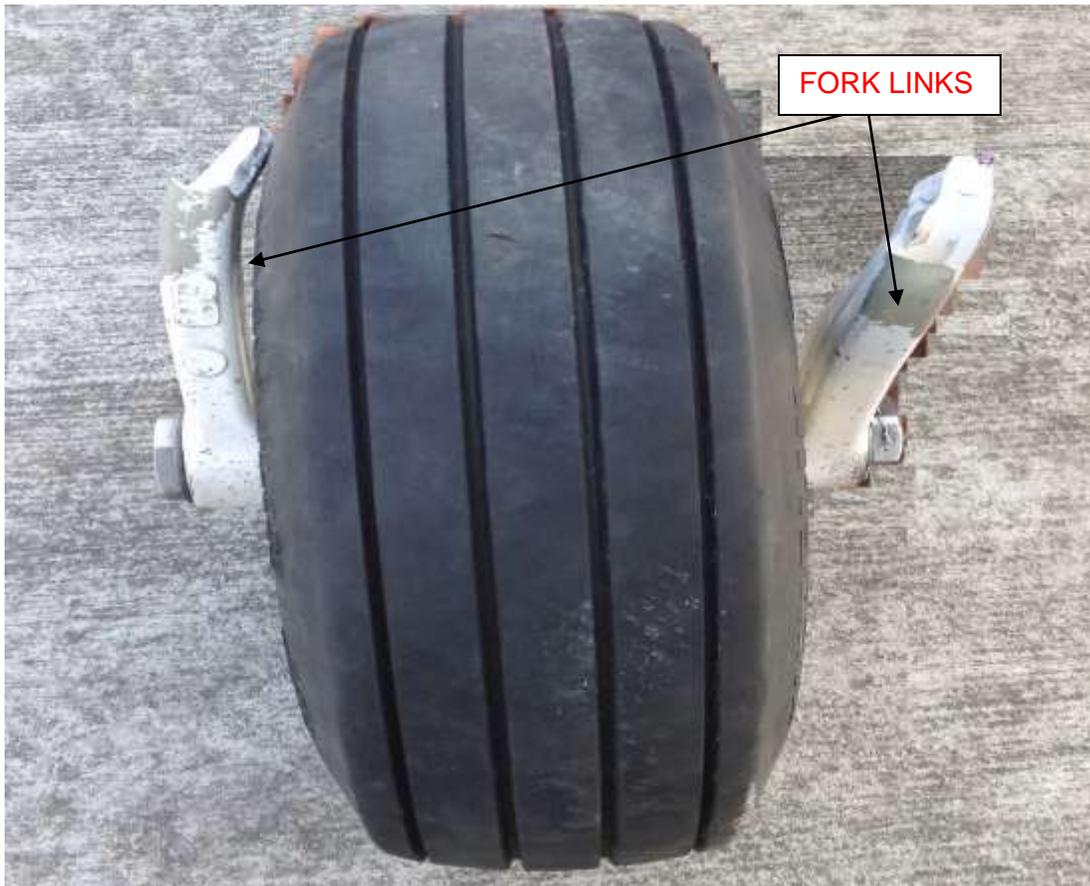
The intensity of the impact on the nose gear on the runway was so strong that both the fork link of the nose wheel broke due to impact on the runway. The nose wheel went away and the propeller hit the runway surface at about 1020 metres from threshold.

BOTH THE FORK LINKS BROKE DUE IMPACT

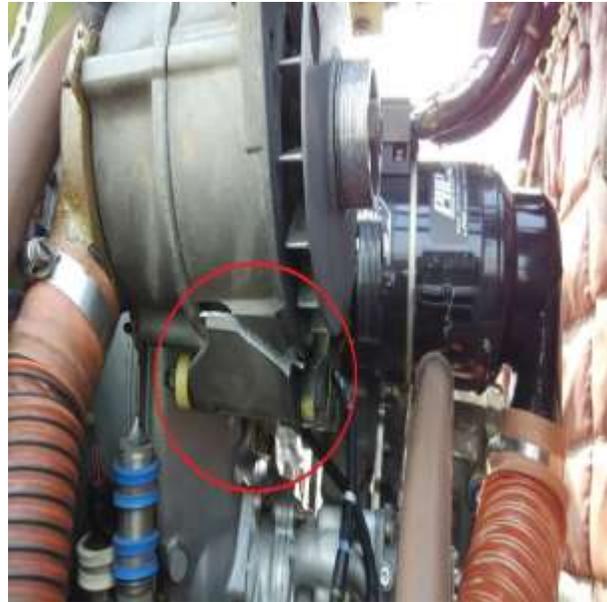
Generator casing rupture due impact

During subsequent inspection it was observed that the AC generator mounted on the engine its cast iron casing had cracked at two locations and also the aircraft frame number 12 had cracked due impact. The hydraulic fluid lines had ruptured and the hydraulic fluid had leaked and spread on the runway surface.

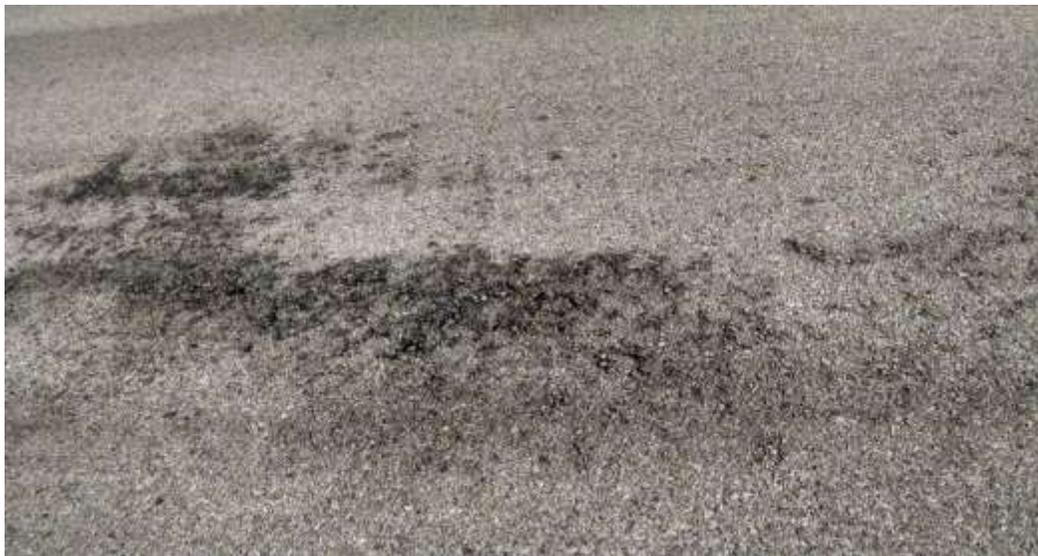
Hydraulic leakage on the runway surface

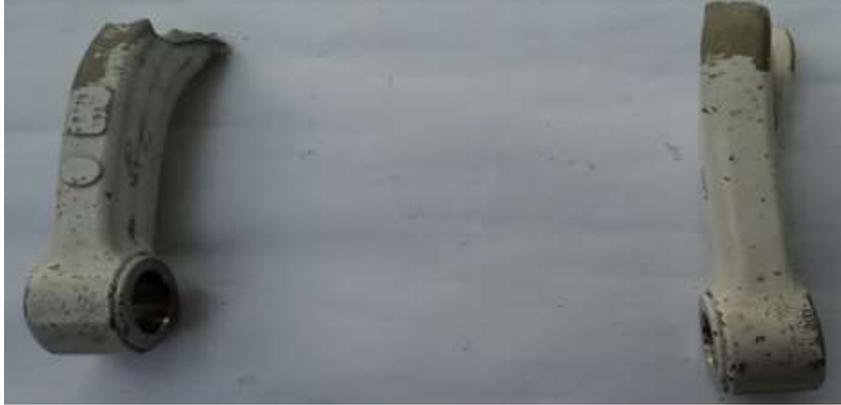
Left and Right fork:- Left & right fork were examined on the microscope. The left fork was found twisted and the fracture surface was observed to be slant & fibrous. On the other end, bore (Inner diameter) and face condition were found satisfactory. Right fork was also found twisted with fracture surface having slant and fibrous appearance.

Figure shows nose wheel fork (right and left) parts

The presence of slant and fibrous fracture surface along with twisting features on the left and right fork indicate that the components have failed under overload conditions. Presence of dull and fibrous appearance on the fracture surface of remaining failed parts i.e. link torque upper and lower part, spring pack assembly & drag link assembly and bearing rod end of spring strut also indicates failure due to overload.

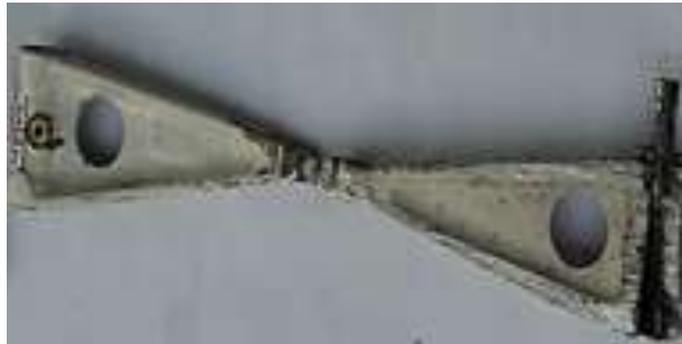
Link torque upper and lower part Fracture surfaces of both the parts are found dull and fibrous.

Figure shows lower and upper part of torque link

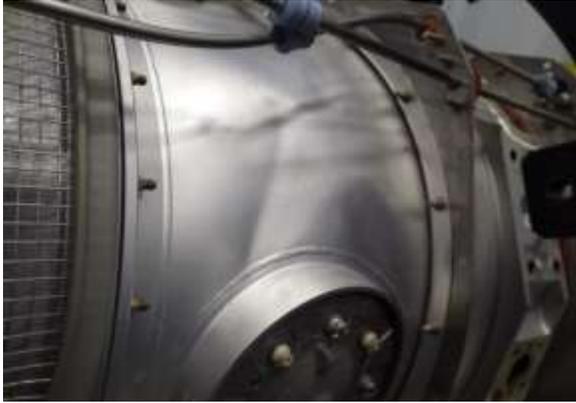
Buckling found at the GG case.

Damage observed to the GG case and AGB housing were because of the sudden stoppage. Light rubbing at the PT blades tip, CT blades tip and compressor were also because of the sudden stoppage.

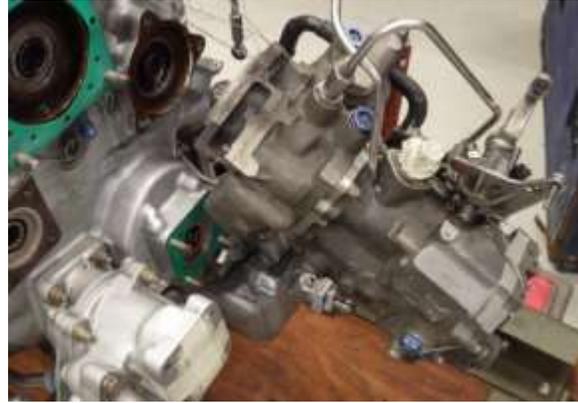
The AGB fuel pump pad was found with broken studs. Engine teared down.

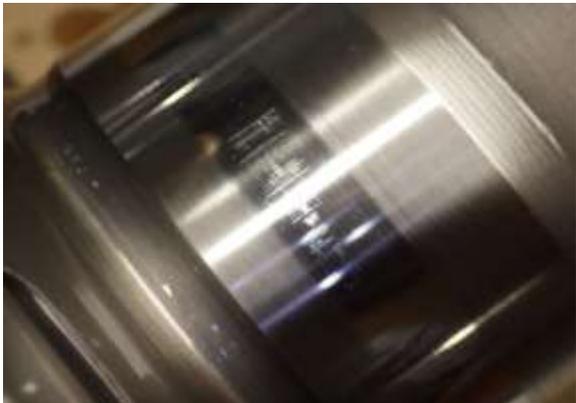
Scores were observed on the 2nd stage carrier at #5 bearing journal.

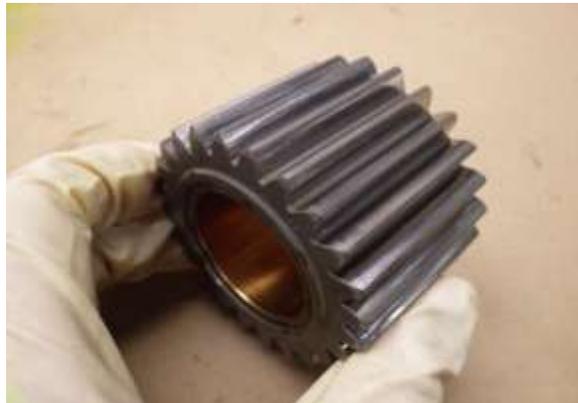
Light wear was observed at the 2nd stage planet gears teeth

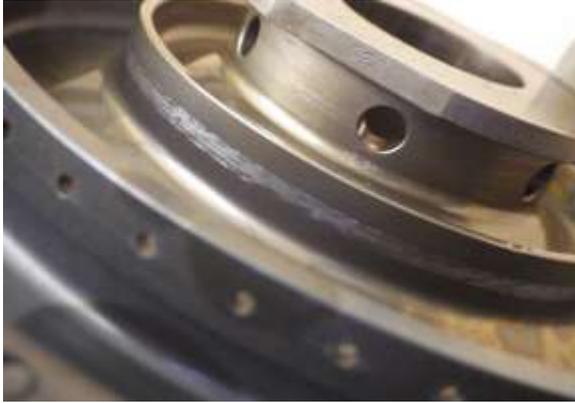
Rubbing at the 1st and 2nd stage PT blades and discs.

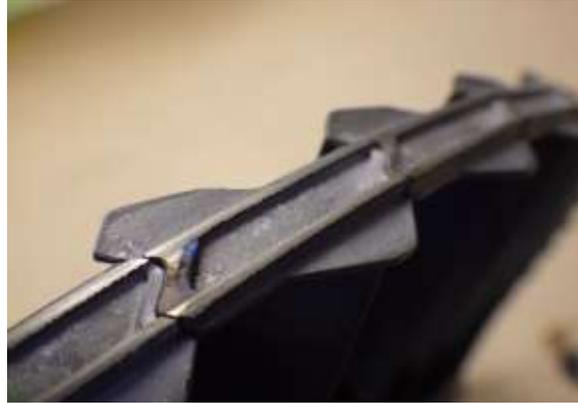
Rubbing at the 1st and 2nd stage PT blades and vanes

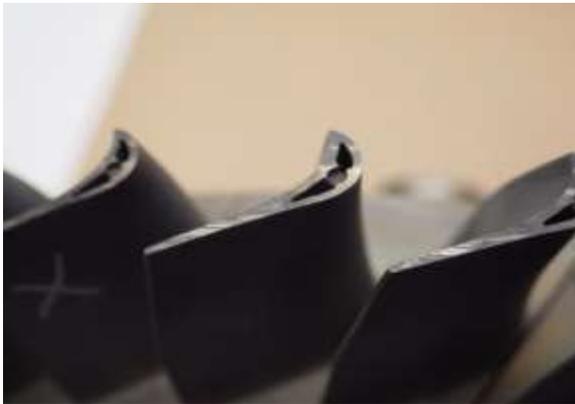
Rubbing observed at the CT blades tip. The inner and outer liner exhibited normal wear.

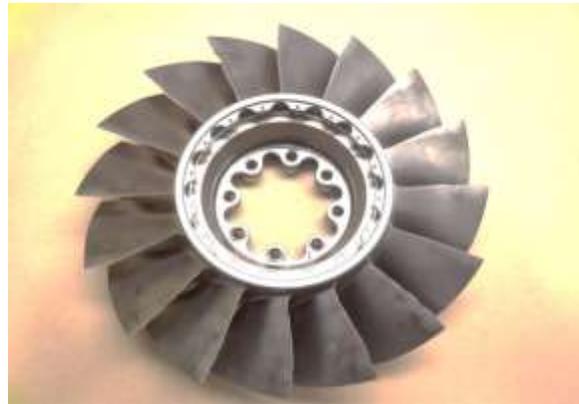
1st stage compressor rotor found with light FOD.

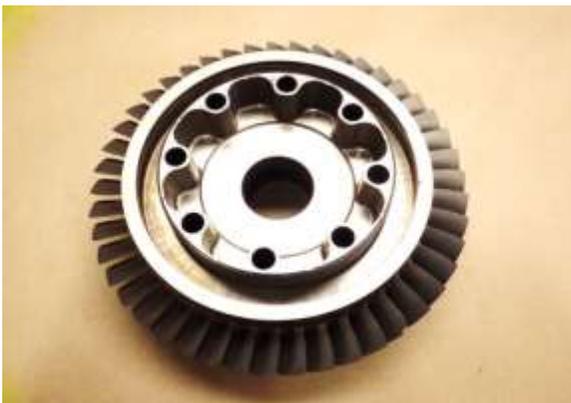
4th stage compressor rotor was found in normal condition (previous cut-back observed) The compressor stator were found with normal wear.

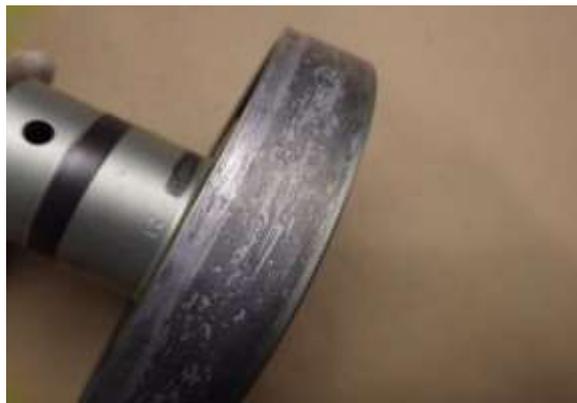
Light rubbing at the rear compressor stub shaft

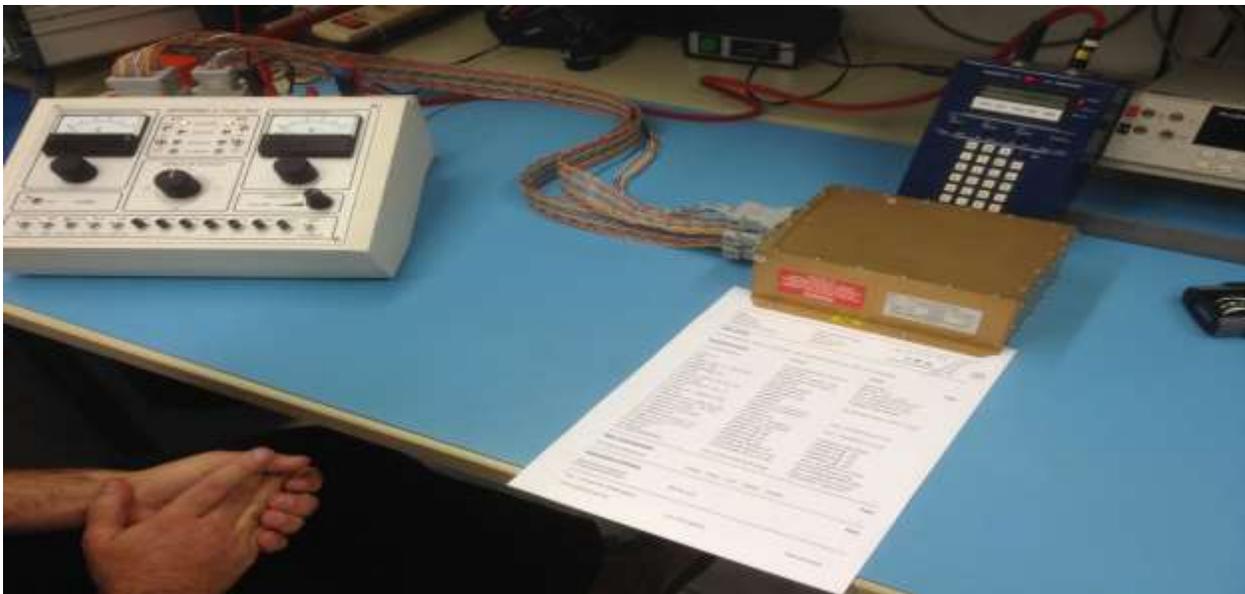
Acceptance Test Procedure of stick pusher computer was carried out. A total of 25 test steps were successfully completed. No errors were detected during test.

Since the Stick Pusher Warning Generator (SPWG) showed correct functions and no error at all, it can be assumed that it performed correctly in the aircraft as well.
