FINAL INVESTIGATION REPORT ON FATAL ACCIDENT
TO M/S M.P FLYING CLUB
CESSNA 152 AIRCRAFT VT-EUE
AT INDORE ON 19/11/2014

**FINAL INVESTIGATION REPORT ON FATAL ACCIDENT TO
M/S M.P FLYING CLUB CESSNA 152 AIRCRAFT VT-EUE
AT INDORE ON 19/11/2014**

1.	Aircraft	Type	Cessna - 152
		Nationality	Indian
		Registration	VT-EUE
2.	Owner & Operator		Madhya Pradesh Flying Club, Indore
3.	Pilot		CPL
	Extent of Injuries		Fatal
4.	Other Pilot		CPL
	Extent of Injuries		Serious
5.	No. of Passengers on board		Nil
6.	Date & Time of Accident		19.11.2014; 0527 UTC
7.	Place of Accident		Devi Ahilyabai Holkar Airport, Indore
8.	Last point of Departure		Devi Ahilyabai Holkar Airport, Indore
9.	Intended landing place		Devi Ahilyabai Holkar Airport, Indore
10.	Type of Operation		Training Flight
11.	Phase of operation		During Climb
12.	Type of accident		Crash Landing
13.	Co-ordinates of Accident Site,		22°43'22" N, 75°48'23.4" E
	AMSL		1840 Ft.

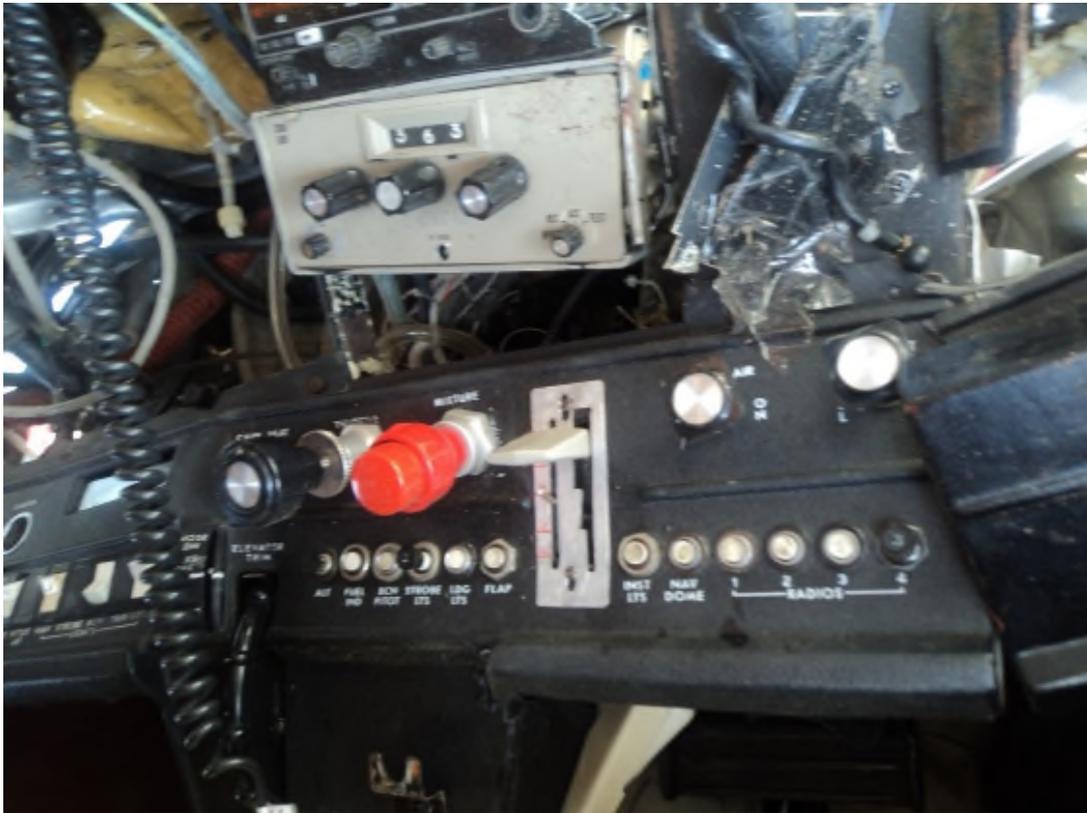
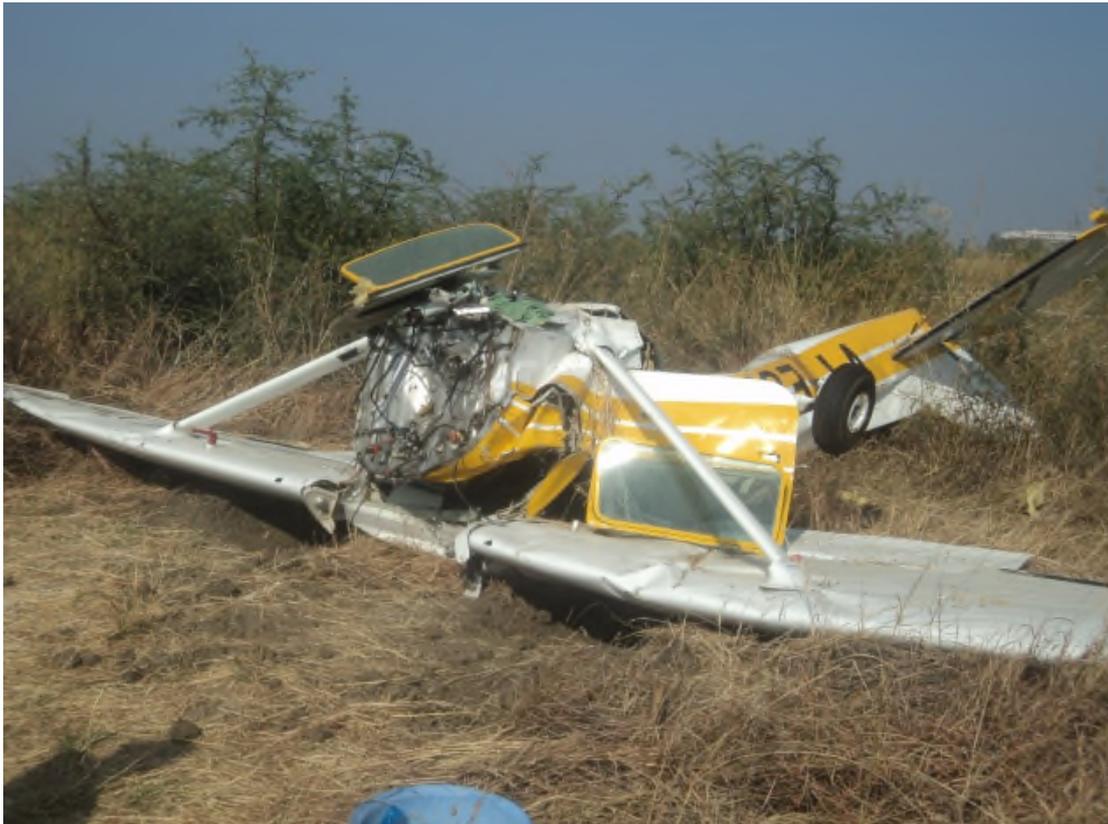
Final rest position of the aircraft

1.12.2 It was observed that the aircraft hit the ground and dragged for about 25 m thereafter hit the mud- bund and toppled upside down. The propeller spinner got disintegrated after the impact. The propeller hub was found buried in ground, along with the propeller blades and the same was also disintegrated from the engine crankshaft. The nose wheel was found 80 meters behind the final resting position of aircraft. The main landing gear was damaged due to impact.

1.12.5. Firewall, engine and engine mount were found squeezed towards the cockpit and the skin was found to bulge out between firewall and the R.H.S. of door hinge. Complete cockpit, fuselage, and wing joints and were found broken due to impact.

Fuselage was also found bent longitudinally. Fuel spillage was found on ground. The cockpit had to be cut open from L.H.S with axe and iron bars to take the PILOT and Other Pilot out of the cockpit.

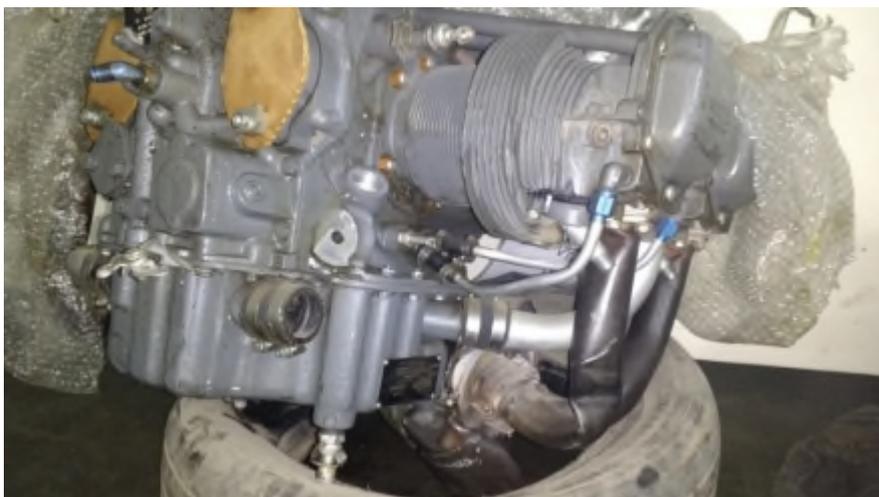
- i) Exhaust Damaged. No external oil leakage observed.

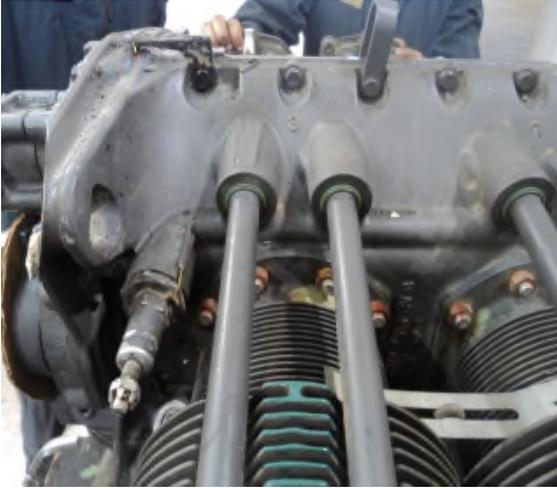
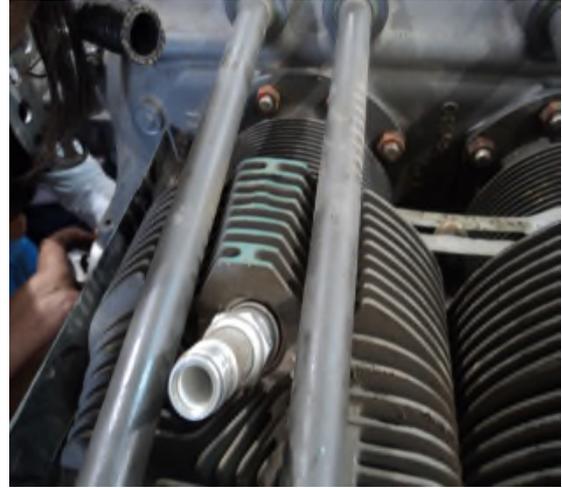
ii) No damage on cylinder fins. All cylinder base nuts found intact. Compression test of the cylinders carried out with Differential Pressure tester and found satisfactory.

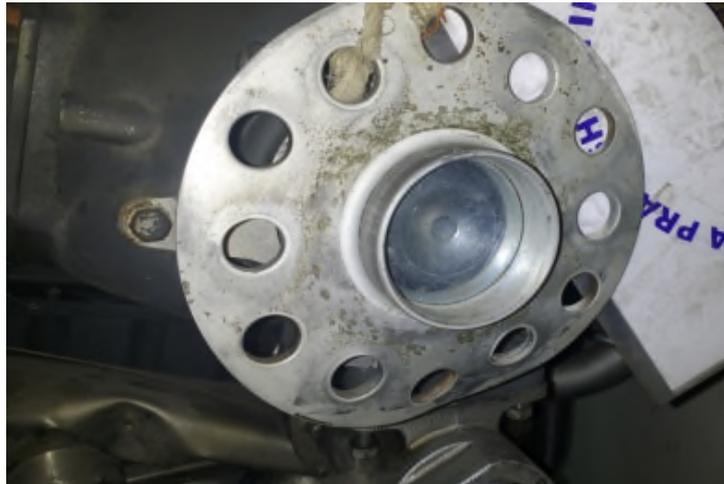
iii) Propeller Flange Bent & Flange bushing sheared off.

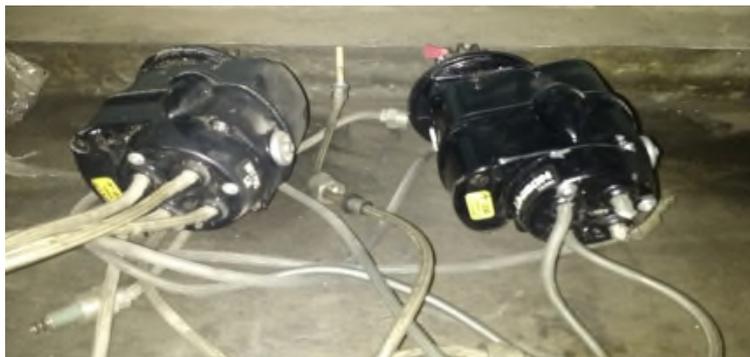
iv) Magnetos ignition harness broken (RH). Magnetos tested and found working satisfactorily.

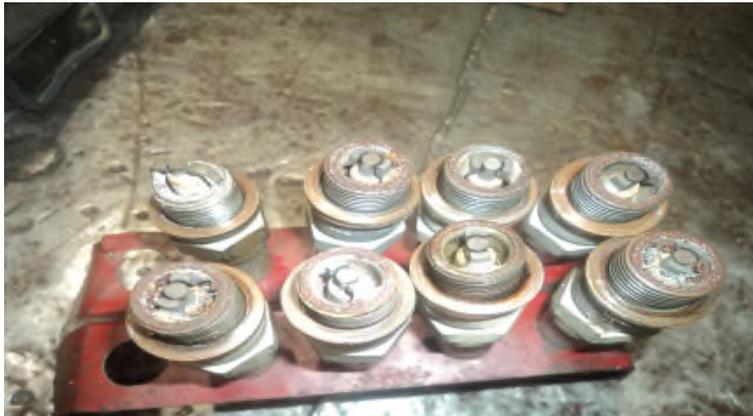
v) All spark plugs found satisfactory. No fouling observed.

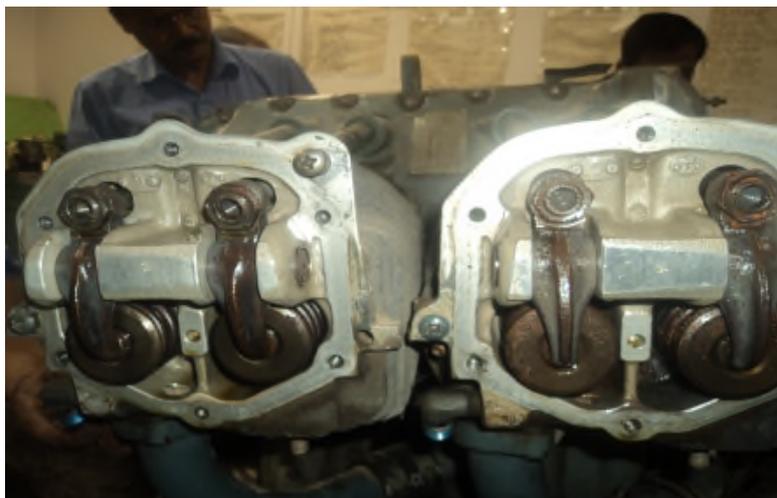
vi) Push rods & rocker arm inspected and found satisfactory. Cold tappet clearance found under limits but at lower side.
