**FINAL REPORT ON ACCIDENT TO PAWAN HANS
HELICOPTER LTD. DAUPHIN 365 N3 VT-SOK AT
CHANDIGARH AIRPORT ON 16/12/2010.**

SUMMARY:

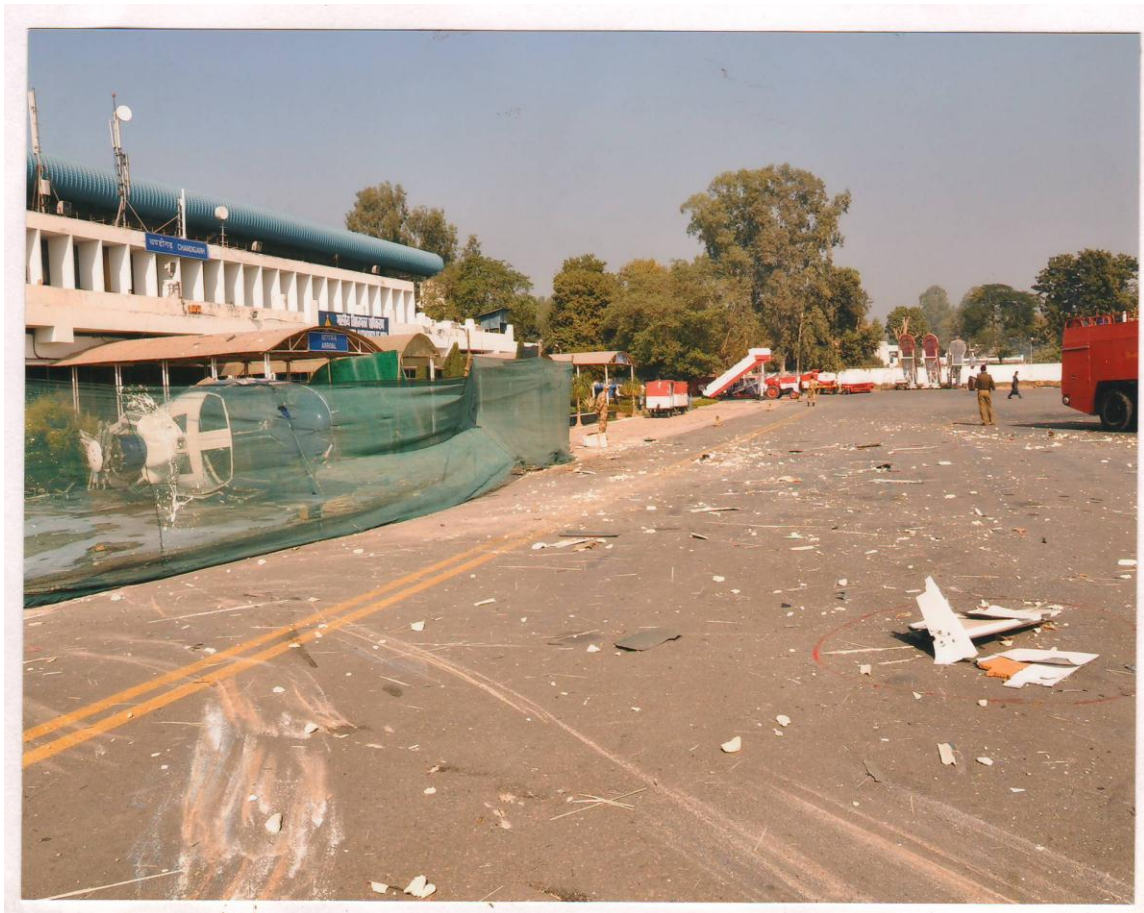
building. There were helicopter rubbing marks and main rotor cut marks on the apron area.

Picture: Helicopter rubbing marks and debris scattered on the apron

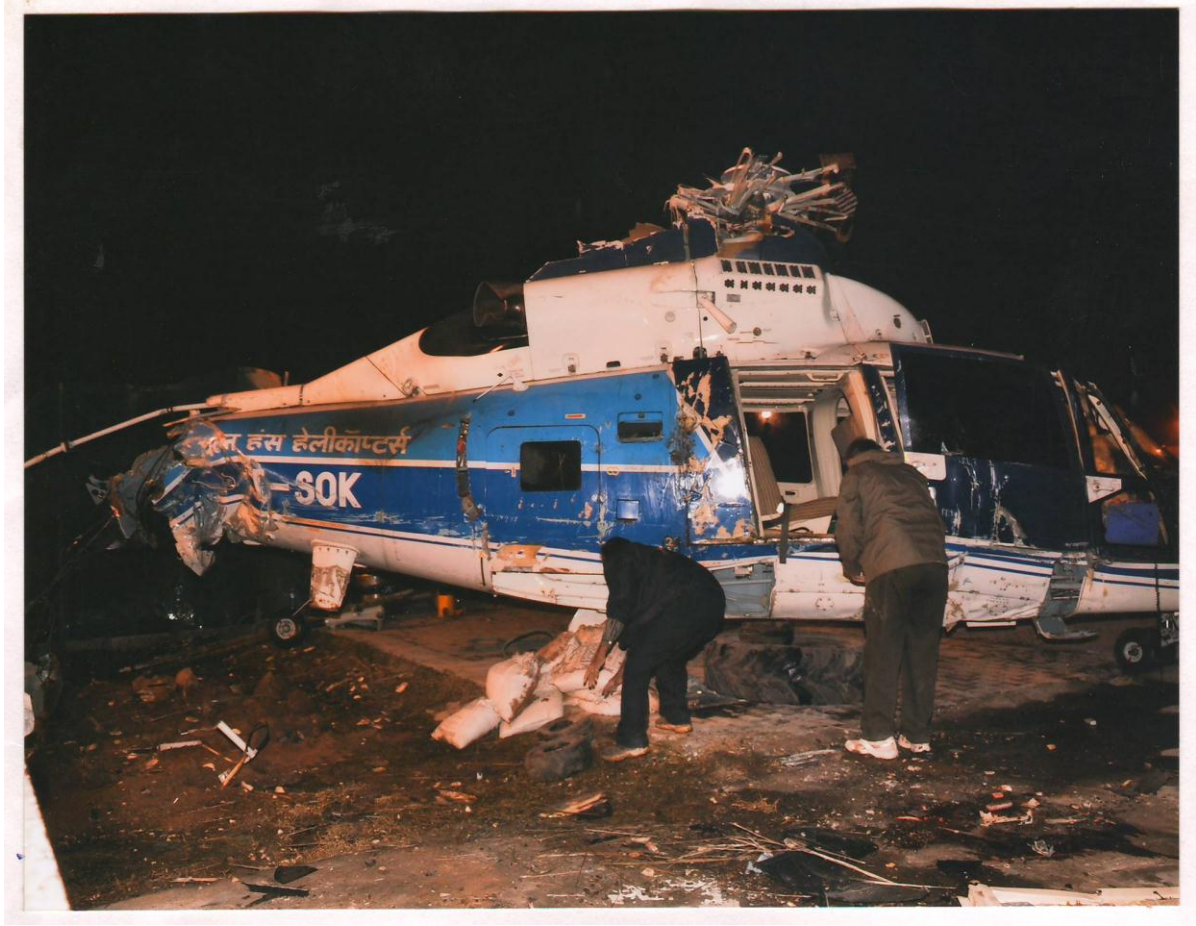
During examination of the Helicopter at site, it was observed that Helicopter was resting on the ground in an upside down position about 20 Mts in front of the arrival building at Chandigarh airport. The RH main landing gear had broken and detached from the helicopter structure. The LH Main Landing Gear attachment was also broken. The tail rotor shaft had broken and the structure sheared off and detached from the helicopter main structure and was lying next to the RH main landing gear. All the four main rotor blades had broken from the root into small pieces and were lying all over the apron area. A portion of the main rotor blade was also found on the terrace of the Chandigarh arrival terminal building. The glass of the main arrival building was also broken due to impact with the pieces of the main rotor blades. The fenstrom had also detached along with the tail rotor shaft and was lying next to the helicopter. Both the horizontal stabilizer had broken and detached from the main structure. The RH door was deformed and broken. Both the cockpit crew were rescued by breaking the top RH side plexi. The left side door and structure was also damaged. The final rest position of the helicopter was on the right side, which was completely

damaged. The nose portion containing all the avionics equipment was also damaged.

Picture: Side view showing damage on Right Side

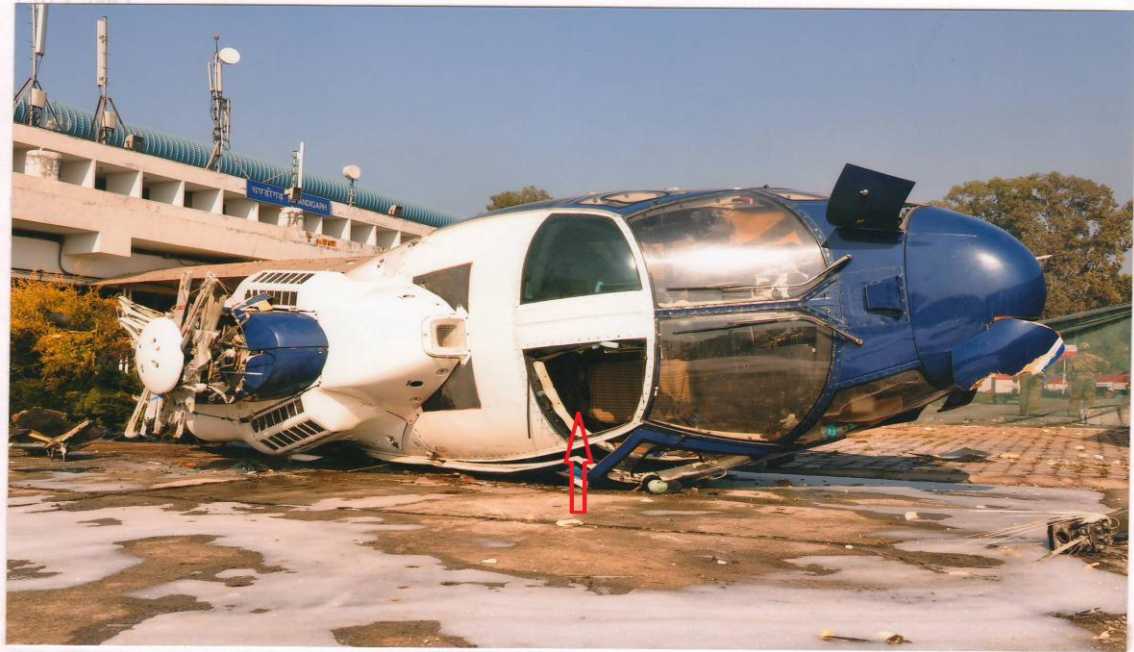
The departure AME and the technician along with the Pawan Hans operation person immediately rushed toward the helicopter and broke the cockpit from the right side overhead plexi to take both the cockpit crew out of the helicopter. The fire vehicles also rushed to the site and sprayed the foam as the fuel was leaking from the fuel tank. Both the cockpit crew were immediately rushed to the

Picture : The Cockpit Crew was rescued after breaking the Plexi

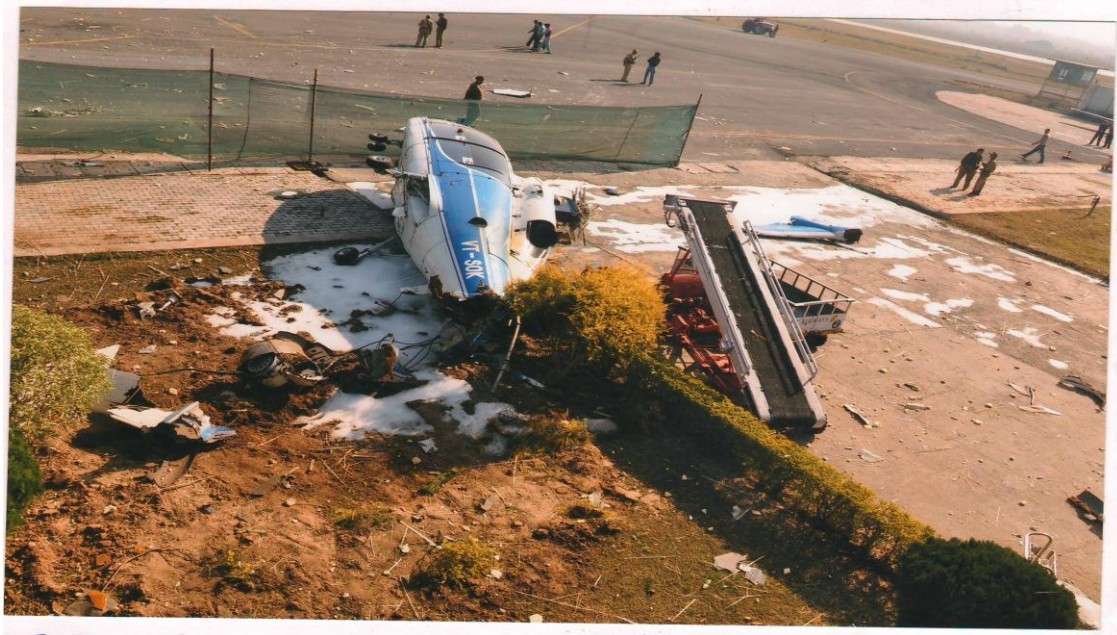
There was no fire after the accident. However, since the helicopter had toppled and skidded the fuel tank got damaged and the fuel started leaking after the accident. The fire vehicles sprayed foam all around the helicopters as a precautionary measure to prevent accidental fire.

Picture: As a precaution fire vehicles sprayed foam since fuel was leaking

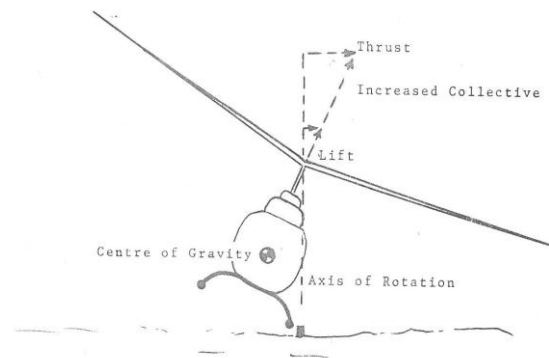
Fig. Dynamic Roll

This phenomenon was experienced by the Dauphin N3 helicopter, VT-SOK at Chandigarh airport on 16/12/11 at 4:30 UTC (approx.). The pilot was performing slope operation and did not use the proper corrective techniques. Since the slope was towards the right the pilot gave a cyclic correction towards the left as a result the right wheel came off the ground. The pilot realizing this immediately came up on collective to do the hover taxi and in the process of picking up, the critical angle was reached and the helicopter started to roll over towards the left side since the cyclic was towards the left and in doing so helicopter went into an oscillation and the fenstrom got damaged and the main rotor thrust vector and its moment was such that the helicopter toppled over in the direction of rotation of the main rotor blades towards the left side.

If the helicopter is engaged in slope operation then lateral cyclic must be applied into the slope, this input is relative to the degree of the slope or quickly applying down collective which is the most effective way to stop dynamic roll over. The captain of VT-SOK did not apply any of these techniques to control the oscillations and this finally resulted into the accident.

1. PHHL to include slope operations in their ground refresher training for the cockpit crew and also part of the syllabus for simulator training.
2. Hqrs may take appropriate action in the matter.
