**FINAL INVESTIGATION REPORT OF
SERIOUS INCIDENT TO M/S JET AIRWAYS
LTD. ATR 72 AIRCRAFT VT-JCZ
AT DELHI ON 14/08/2014**

**AIRCRAFT ACCIDENT INVESTIGATION BUREAU
MINISTRY OF CIVIL AVIATION
NEW DELHI**

FINAL INVESTIGATION REPORT OF SERIOUS INCIDENT TO
M/S JET AIRWAYS LTD. ATR 72-500 AIRCRAFT VT-JCZ
AT NEW DELHI ON 14/08/2014

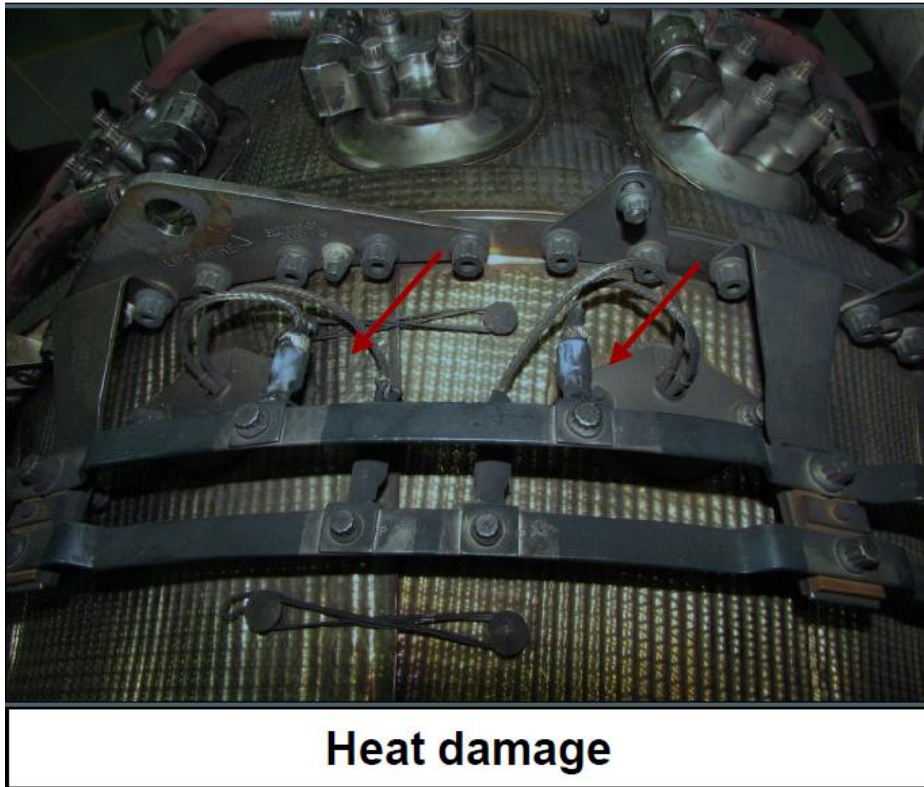
There was no damage observed to the aircraft structure. Damage was limited to the aircraft engine no 01.

1. Evidence of heat damage and fire was observed on the right hand (RH) rearward of the engine after the fuel nozzles.
2. Soot deposit observed aft of the fuel nozzles, from the #1 fuel nozzle position to the #7 fuel nozzle position.
3. #1 to #4 fuel nozzles and manifold observed with soot deposit
4. T6 system observed with heat damage corresponding to fuel nozzle position #1 to #7

5. #1, 2 and 3 fuel nozzle position on the secondary fuel manifold observed conical seals with signs of scoring.
6. #4 fuel nozzle position observed conical seal on secondary manifold with signs of deformation on the conical surface as well as on the legs.
7. #5 fuel nozzle position observed conical seal on secondary manifold with signs of scoring.

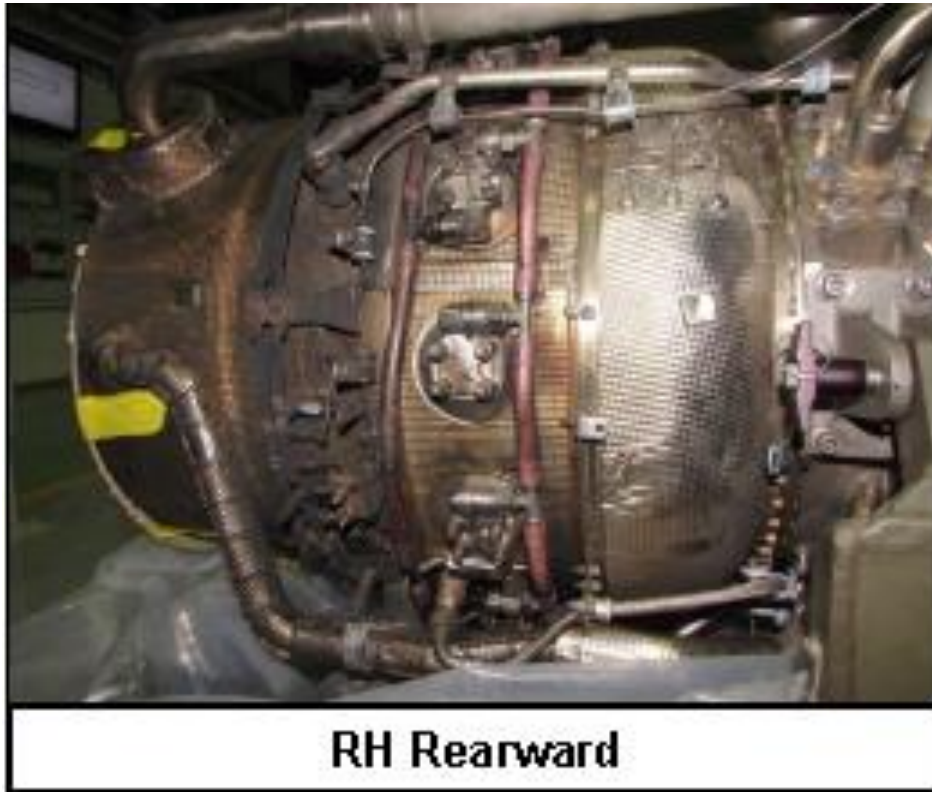
As per the P&W report, the fire occurred on the engine external only. The cause of fire may be attributed to under-torque of fuel nozzles on the right hand side of the engine.

- Evidence of heat damage and fire was observed on the right hand (RH) rearward of the engine after the fuel nozzles.

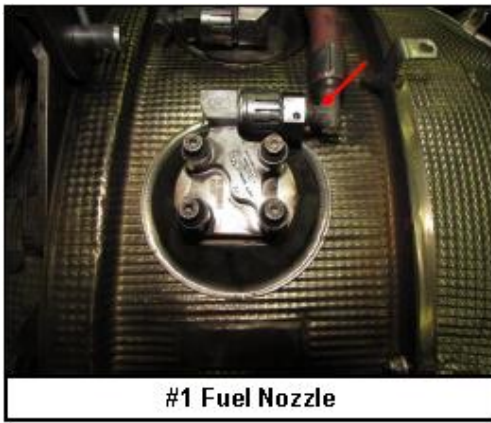
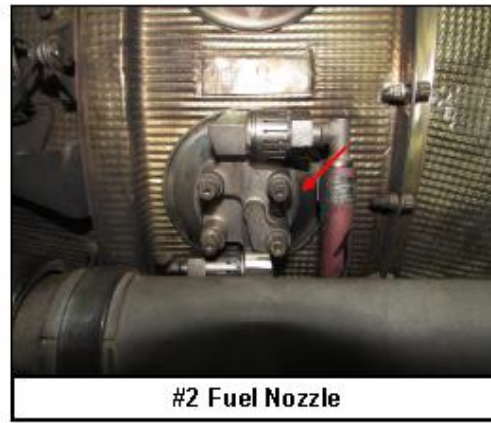
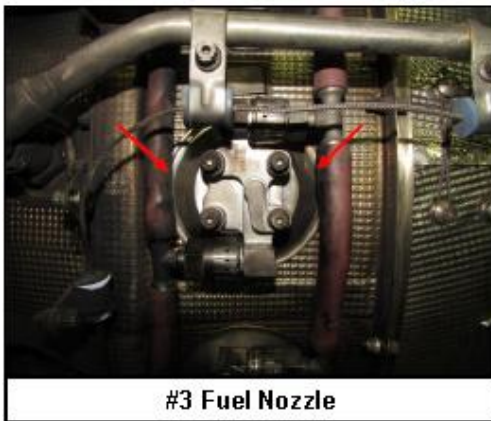
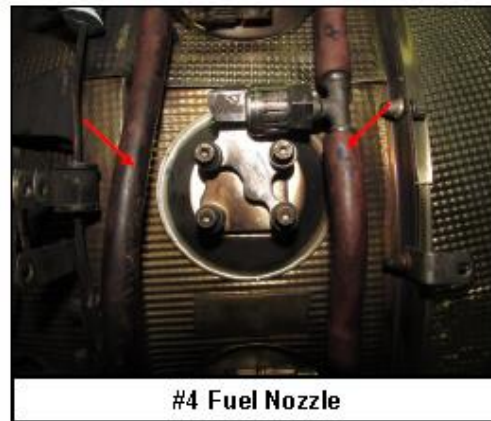
- Soot deposit observed aft of the fuel nozzles, from the #1 fuel nozzle position to the #7 fuel nozzle position. Fuel flow Divider observed to be intact.

- #1 to #4 fuel nozzles and manifold observed with soot deposit.

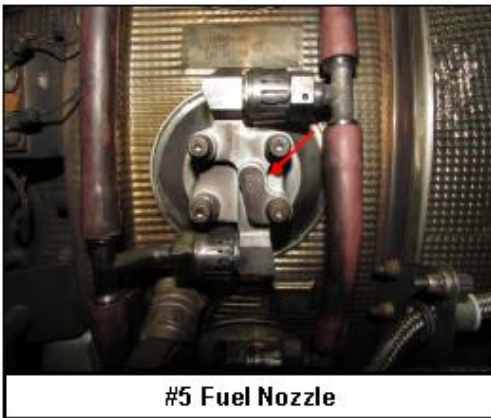
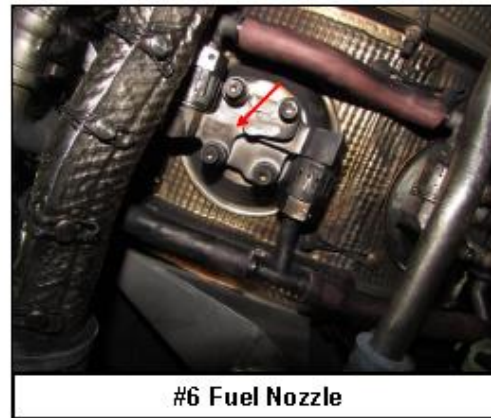
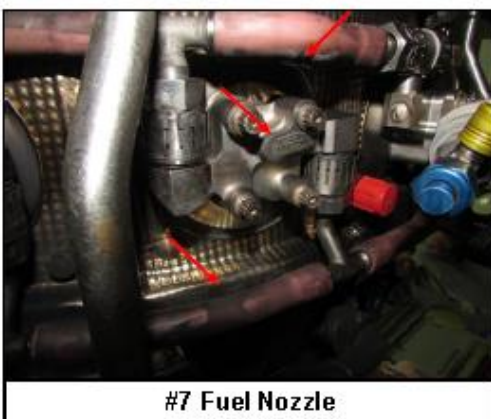
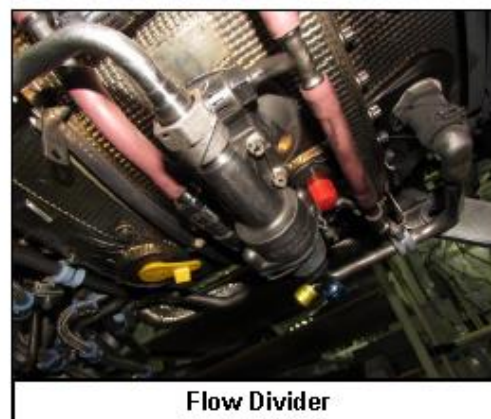
- #5 to #7 fuel nozzles and manifold observed with soot deposit.

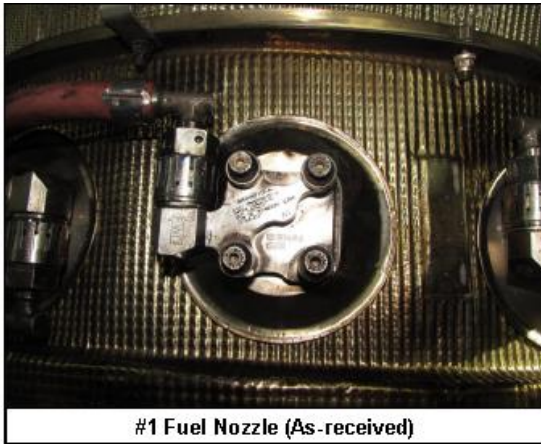
#1 Fuel Nozzle (As-received)

- #1 fuel nozzle observed with nil sign of leak in as-received condition.

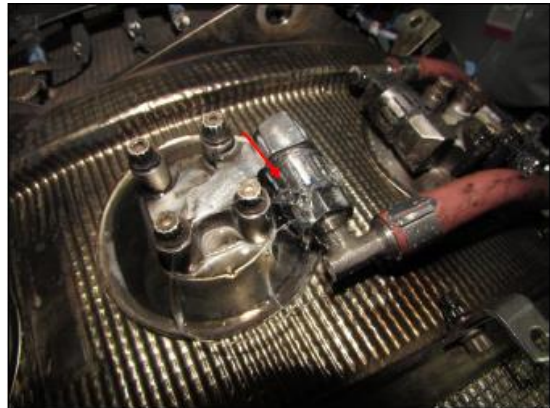
#1 Fuel Nozzle (Marker ink aligned)

- #1 fuel nozzle observed with sign of leakage after marker ink (marked out on- wing) was aligned.

- To duplicate on-wing initial findings, #1 nozzle fuel manifold nut was un-torqued to align marker ink marks as marked out on wing. Nitrogen leak check was then carried out -- observed #1 nozzle with sign of leaking.

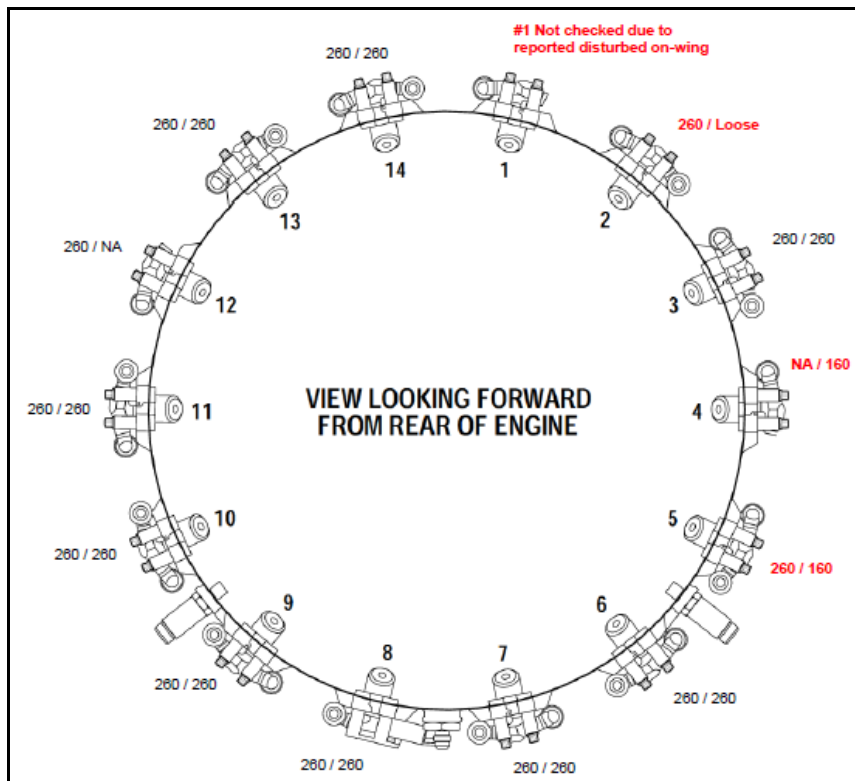
Primary/Secondary
All units are in lb.in

- Torque check carried out on all primary and secondary fuel manifolds observed undertorque on secondary manifold at #4 and #5 position.
- #2 nozzle manifold connection observed to be loose.

- Torque check was performed on all fuel nozzles between # 2, 4 and 5 (to be undertorqued) with #2 nozzle observed to be loose on the secondary fuel manifold.

some of the secondary nozzles. On investigation, it was found that fuel nozzles #2, 4 and 5 were under torqued.

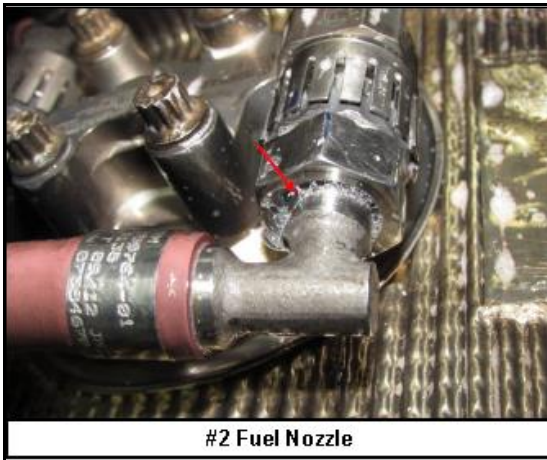
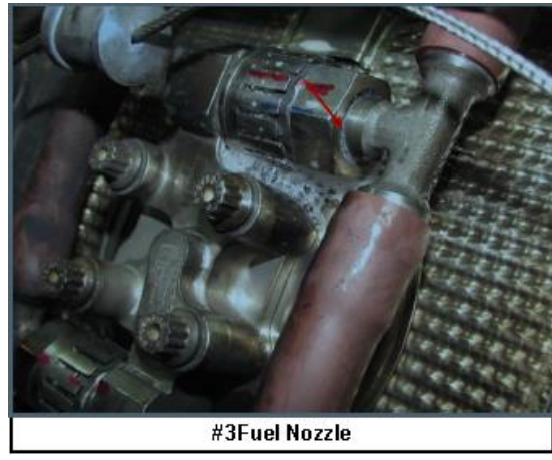
- Post re-torque of fuel nozzle manifold nuts to 260 lb.in observed signs of leakage at #2 and # 3 position on the secondary fuel manifold interface.

- #4 fuel nozzle position observed conical seal on secondary manifold with signs of deformation on the conical surface as well as on the legs.
- #5 fuel nozzle position observed conical seal on secondary manifold with signs of scoring.
- #1 to 5 fuel nozzles were inspected for signs of anti-seize observed threads to be dry and shiny.
- #1 to 5 fuel nozzles were installed with new conical seals on the secondary manifold and nitrogen leak check carried out observed zero sign of leakage.
- #13 and #14 fuel nozzle manifolds disconnected at the secondary side observed threads to be dry with grey deposit indicate possible use of anti-seize at last installation.

- #4 nozzle was observed with the 2 legs of the seal bent inwards into groove on the fuel nozzle interface area. Visible deformation is also observed on the conical sealing surface.

- Light scoring is visible on the conical surface of all five conical seals.
- Fuel manifold and fuel nozzle threads of #1, 2, 3, 4 & 5 are also observed to be dry with no sign of anti-seize compound being applied.

- New conical seals were installed at fuel nozzle position #1, 2, 3, 4 & 5.
- Nitrogen leak check carried out observed zero sign of leakage.
- Secondary fuel manifold was disconnected at #13 and #14 fuel nozzles to inspect for sign of anti-seize previously applied.
