**REPORT
ON
ACCIDENT TO ARCHANA AIRWAYS
L-410 AIRCRAFT VT-ETC
ON 11 JUL 96
NEAR KULLU**

**ACCIDENT TO ARCHANA AIRWAYS
L-410 AIRCRAFT VT-ETC
ON 11 JUL 96
NEAR KULLU**

**Report
of
The Court of Inquiry**

**New Delhi
31 Oct 96**

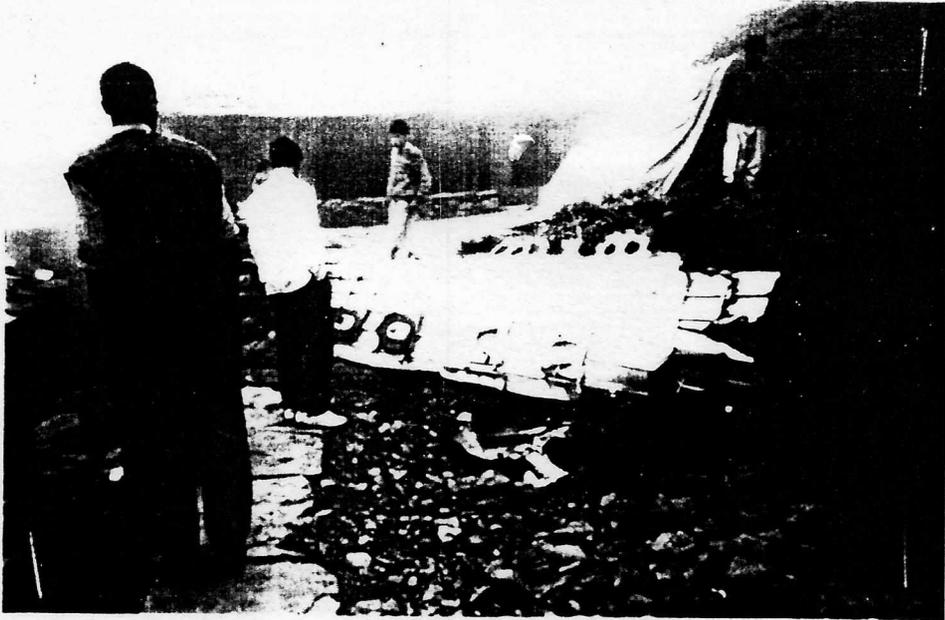
ANNEXURE "F"
(Para 2.12.2 refers)

The aircraft was found to have crashed into terraced fields, on the side of a steep hill, and the wreckage of the aircraft was scattered over an area of about 5,000 sq ft. The aircraft had impacted about 60' below the saddle of a hill which was at 7440'. The aircraft was totally

- The right wing of the aircraft had hit a thick tree trunk, at the edge of a terrace, before impacting the hill.
- The aircraft had broken up and overturned after impact.
- A portion of the right main plane was found in an inverted position, along with the engine, about 10' from the point of impact. The mainplane was badly damaged and skin was compressed and corrugated along the chord. Burning marks were observed on the deicing boots on the leading edge of wing.
- The cockpit and a portion of the fuselage was found about 12' to the left and about 18' ahead of the initial point of impact. The cockpit was found crushed.
- A portion of the left wing was found about 13' to the left and about 25' from the point of impact.
- The left engine was found about 15' to the left of the cockpit. The engine was in one piece but its casing was severely damaged.

- The empennage was found in an inverted position at a distance of about 15' to the left and about 62' from the point of impact. Burn marks were found on the deicing boots on the leading edges and skin of the control surfaces.
- The FDR and CVR were recovered from near the empennage.
- The bodies of the pilot, co-pilot, air hostess and passengers were found badly mutilated.

- The aircraft heading at the time of impact was 062°.
- There was no evidence of in-flight structural failure.
- The condition of the engines and propellers indicated that they were developing power.
- All landing gears were in up and locked position.
- The flaps were in the fully up position.
- The aircraft appeared to have crashed into the hill with wings level.

PHOTOGRAPHS AT ACCIDENT SITE
(VT-ETC ON 11 JUL 96)
