**Government of India**  
**Directorate General of Civil Aviation**

**Investigation Report on Gear-Up landing incident to  
M/s Patiala Aviation Club aircraft VT-PBD at Patiala on  
12.02.2020**

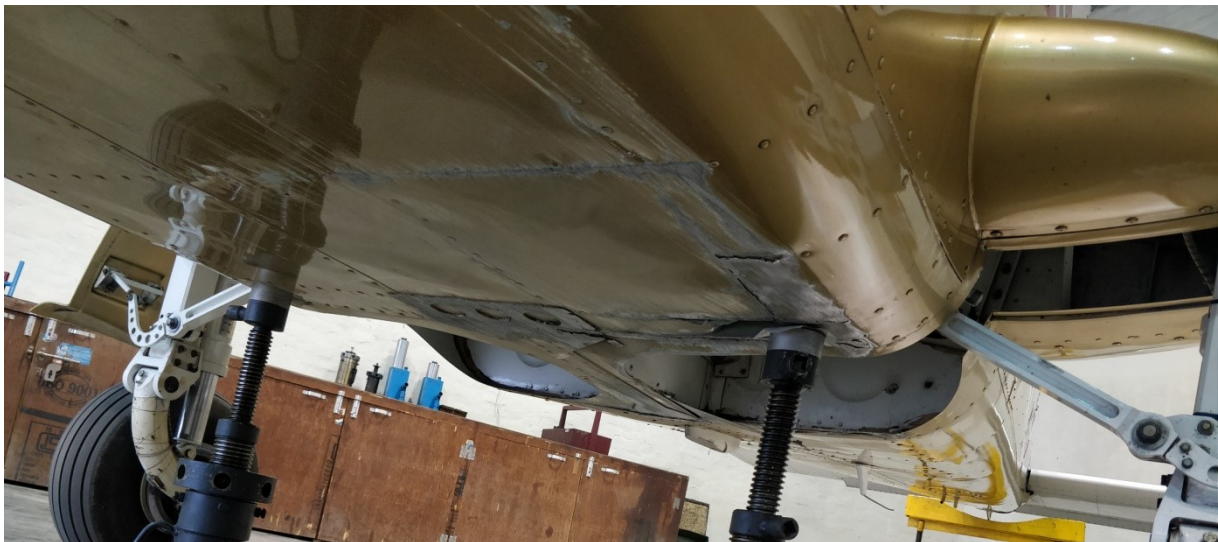
**Damage to aircraft skin on the frame on LH side (13" FWD of aircraft datum) –  
Photograph taken from FWD looking AFT**

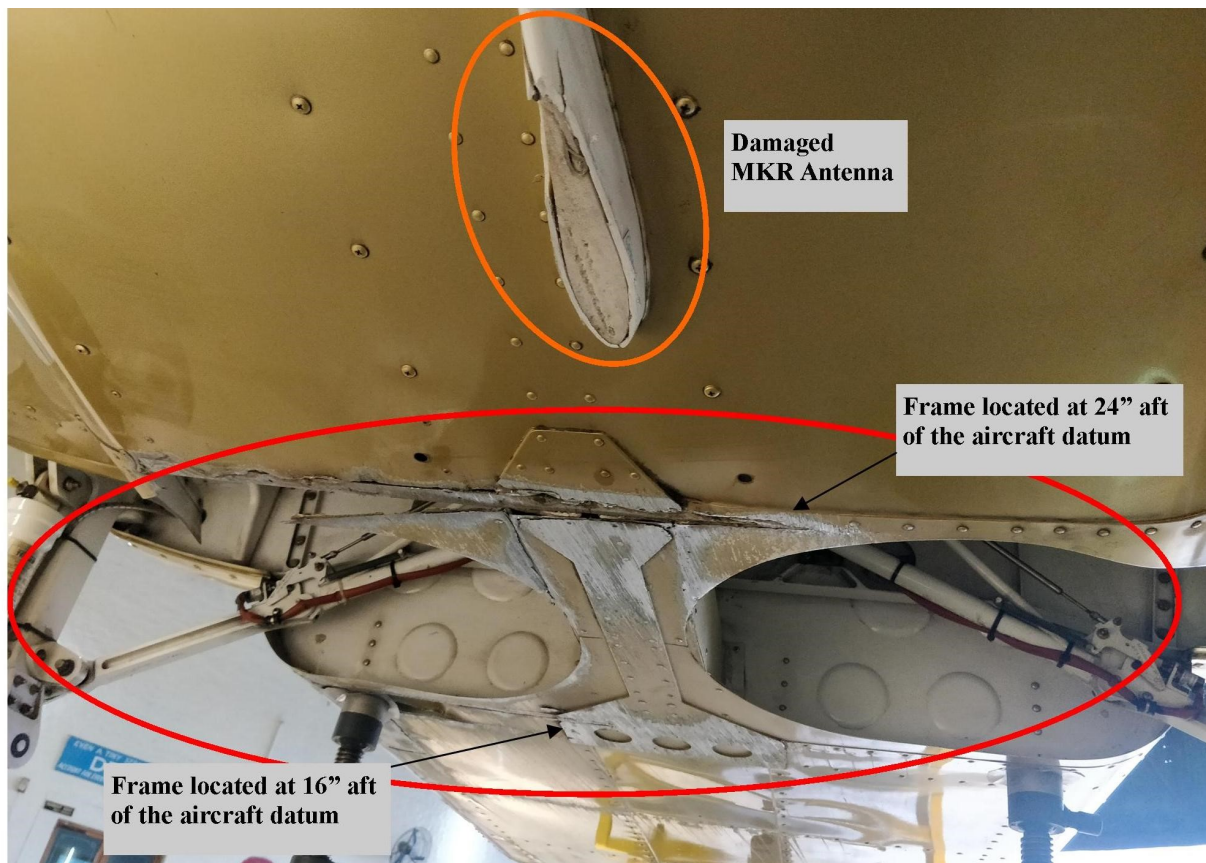
**Damaged aircraft antenna, aircraft skin and frames –  
Photograph taken from AFT looking FWD**

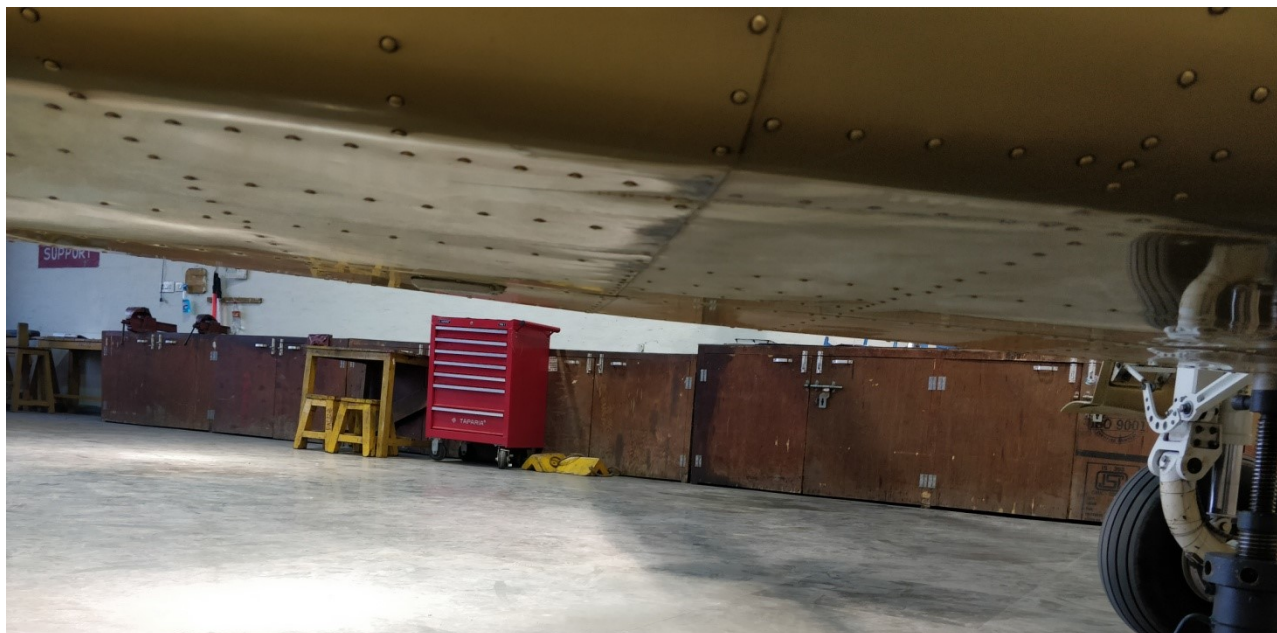
**Damage to aircraft skin on the frame on LH side (23" FWD of aircraft datum) –  
Photograph taken from aircraft LH looking towards RH side**

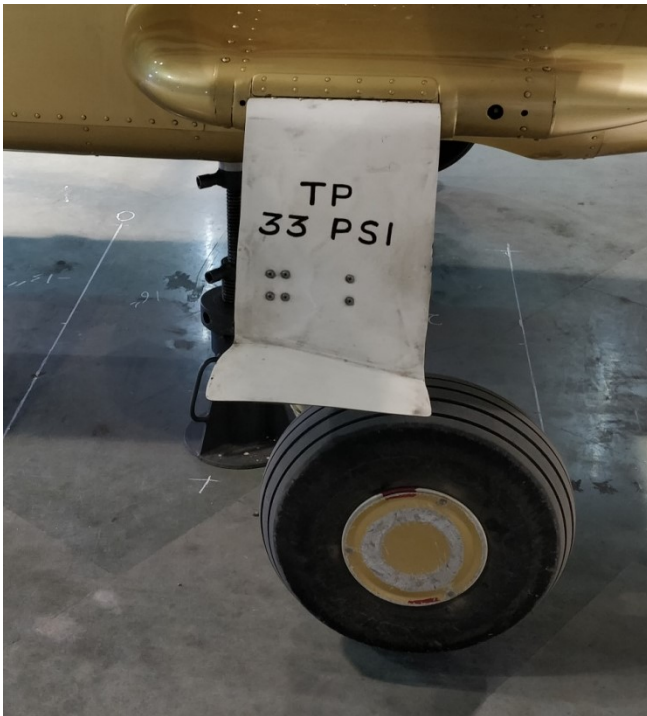
**Scuffing damage on LH MLG Wheel**

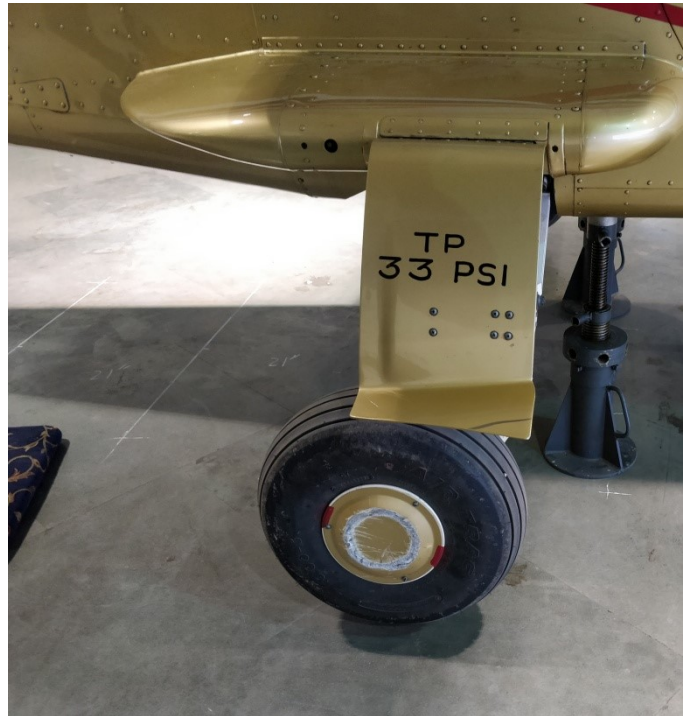
**Scuffing damage on RH MLG Wheel**

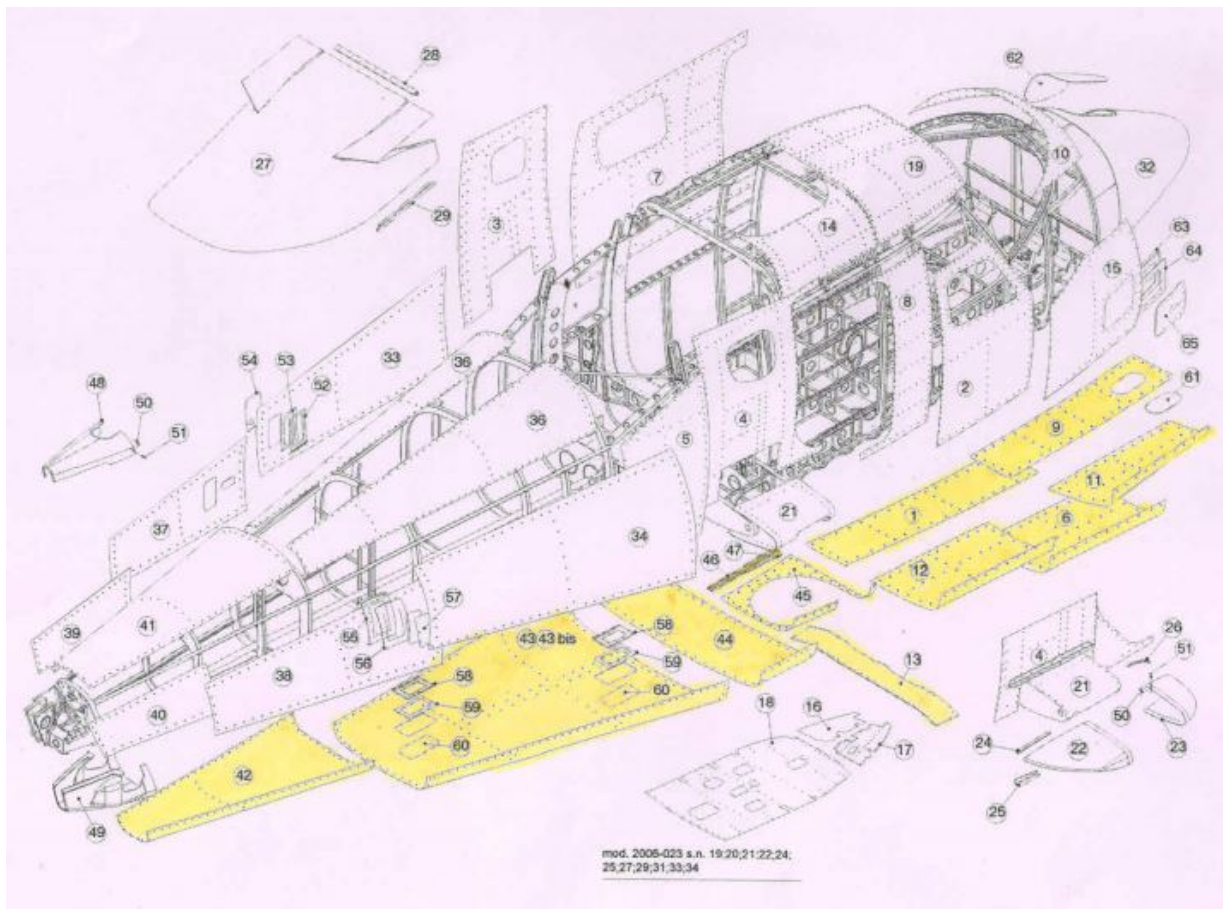
**AIRCRAFT IPC (ILLUSTRATED PARTS CATALOGUE) - SKIN 53-30**

Scuffing of skin was observed on LH/RH Forward side lower skin IPC FIG (11), Side central lower skin IPC FIG (6), LH/RH aft side lower skin IPC FIG (12)

Sever scuffing of skin was reported on Forward Central lower skin IPC FIG(9), Lower Centre Skin IPC FIG (1), External Beam skin IPC FIG (13), Main gear skin IPC FIG (45), Cabin to tail cone lower skin IPC FIG (44), Lower cabin skin IPC FIG (43), Lower stabilator skin IPC FIG (42)

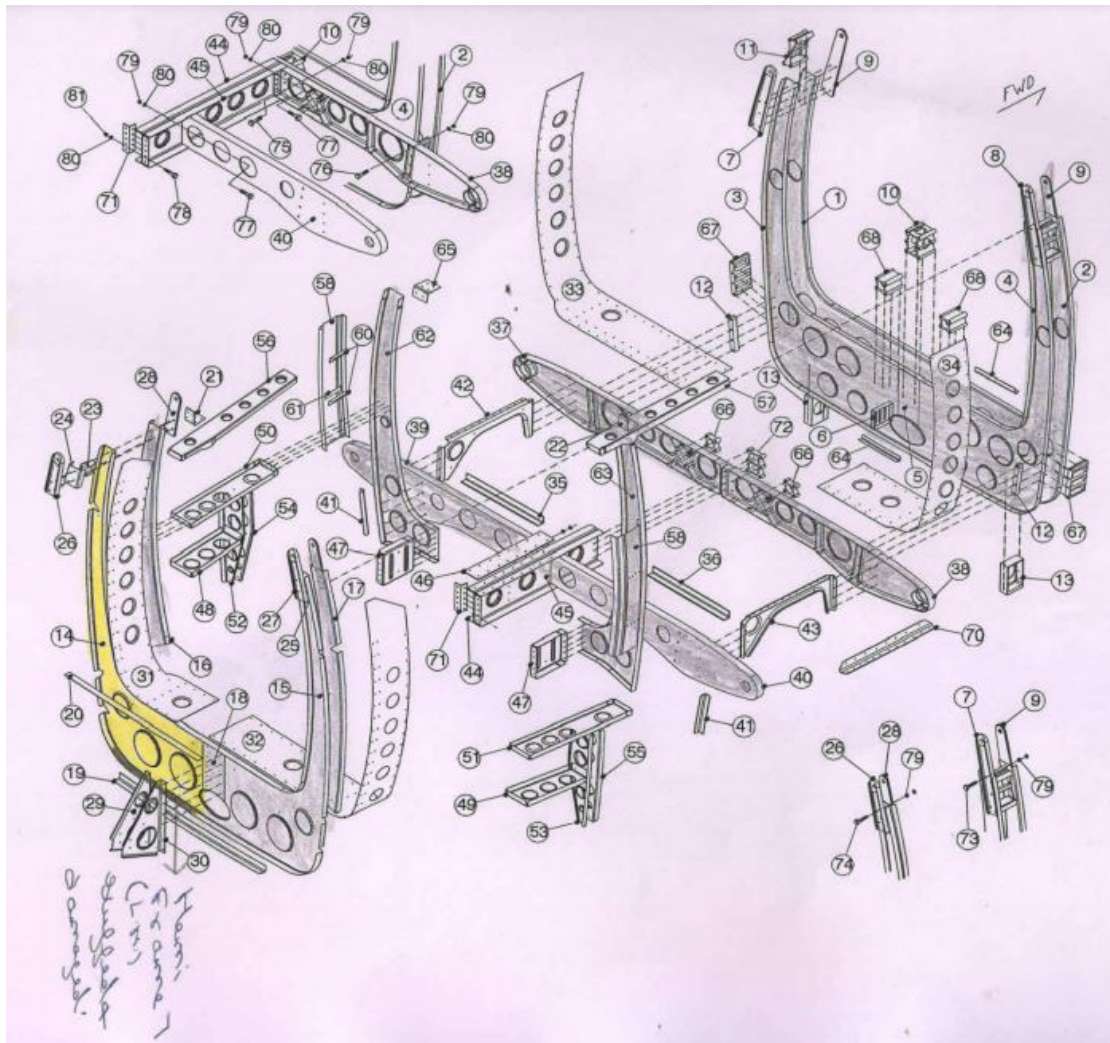
AIRCRAFT IPC (ILLUSTRATED PARTS CATALOGUE)– MAIN FRAME 53-10

Hemi Frame 7 LH IPC FIG (14) was scratched, penetrated to the full thickness from outer bottom of the member for about 4-5 "in length but no damage to doubler (19)

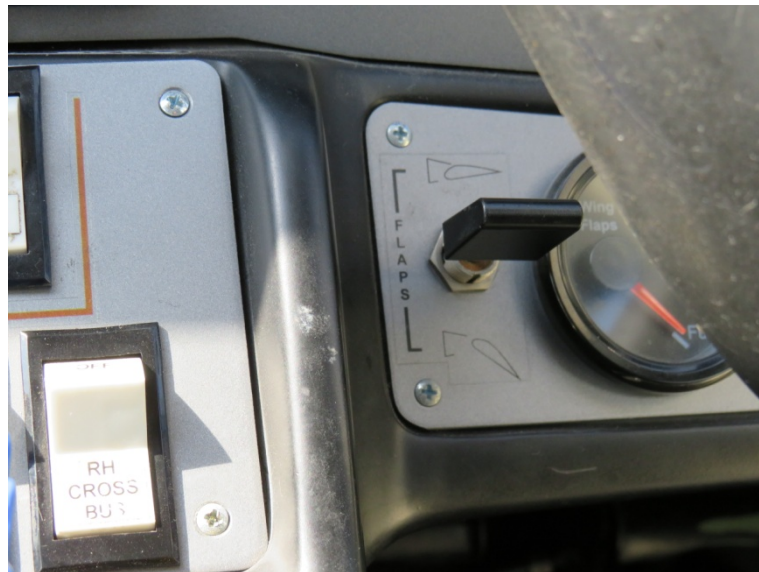
1. The landing gear switch in the cockpit was found in the 'UP' position and the flaps were in the FULL extended position.

**Flap lever and position indicated as FLAPS FULL**

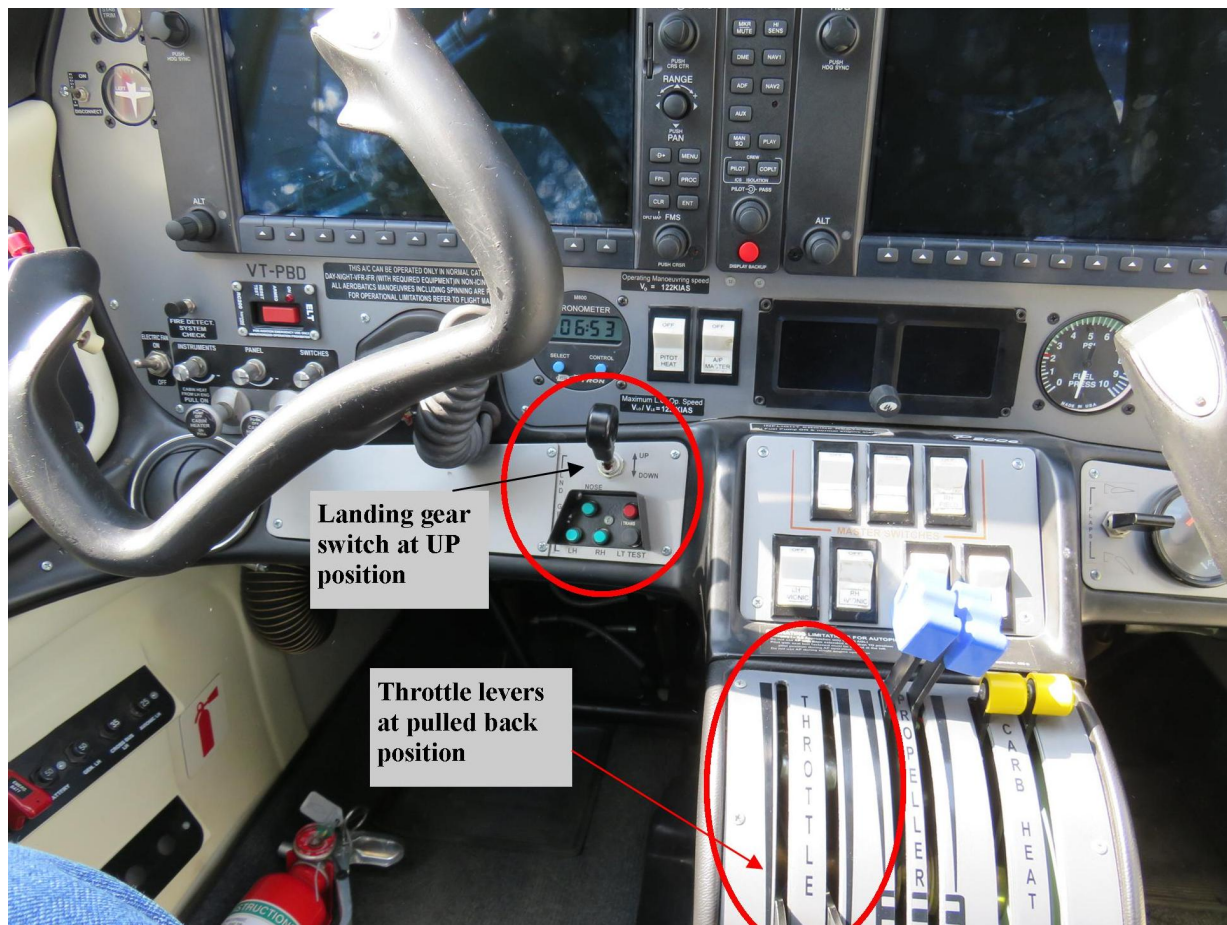
**Landing Gear lever and throttle lever position**

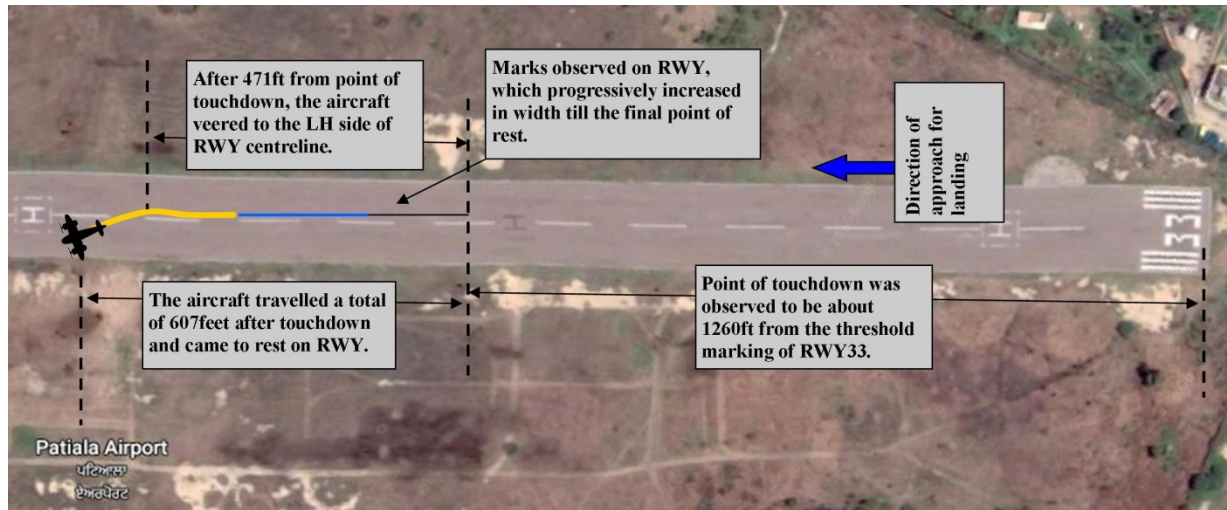
**Figure-I (Not to scale) : Path followed by the aircraft**

- (a) The first point of impact is located on the RH side of the RWY centerline (2ft 6 in, from RWY centerline) at a distance of 1260ft after the threshold marking of RWY33.
- (b) The impact marks progressively increased from a single line to wider markings, including marks of rubber (indicating wheel rub marks).

- (c) Further moving on the runway, the aircraft veered from the RH side of runway centerline to the LH side of runway centerline and came to a rest.
- (d) At the final location, the aircraft nose was 14ft away from the RWY centerline towards RH side and the tail was found 5ft from the RWY centerline. All the landing gears were found to be in a retracted position and the aircraft fuselage lower skin was in contact with the ground. The final location of the aircraft was approximately 607ft from the first point of touchdown.

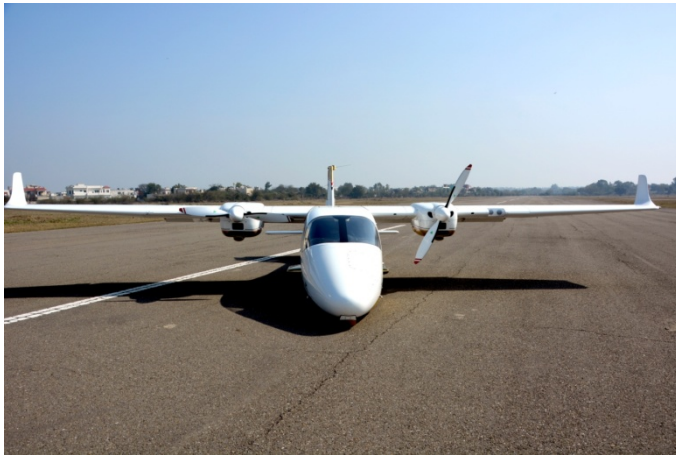
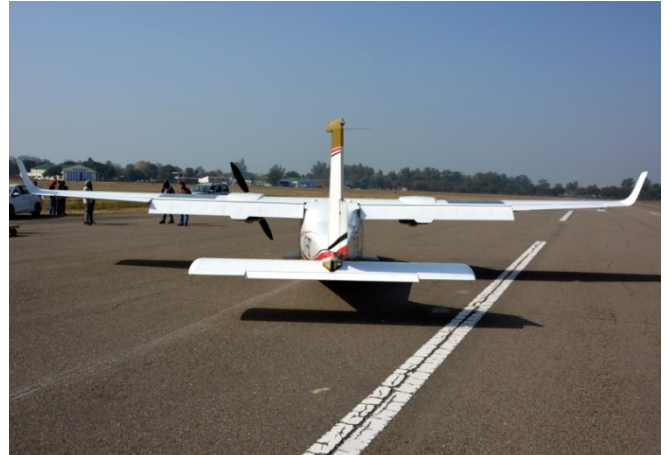
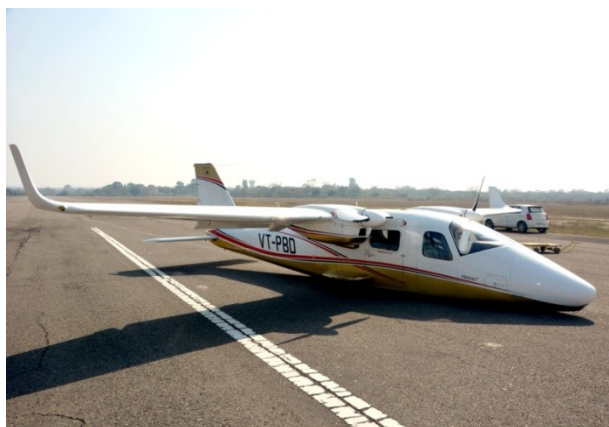
**Final location on the aircraft on runway after 1867 feet from RWY 33 threshold marking**

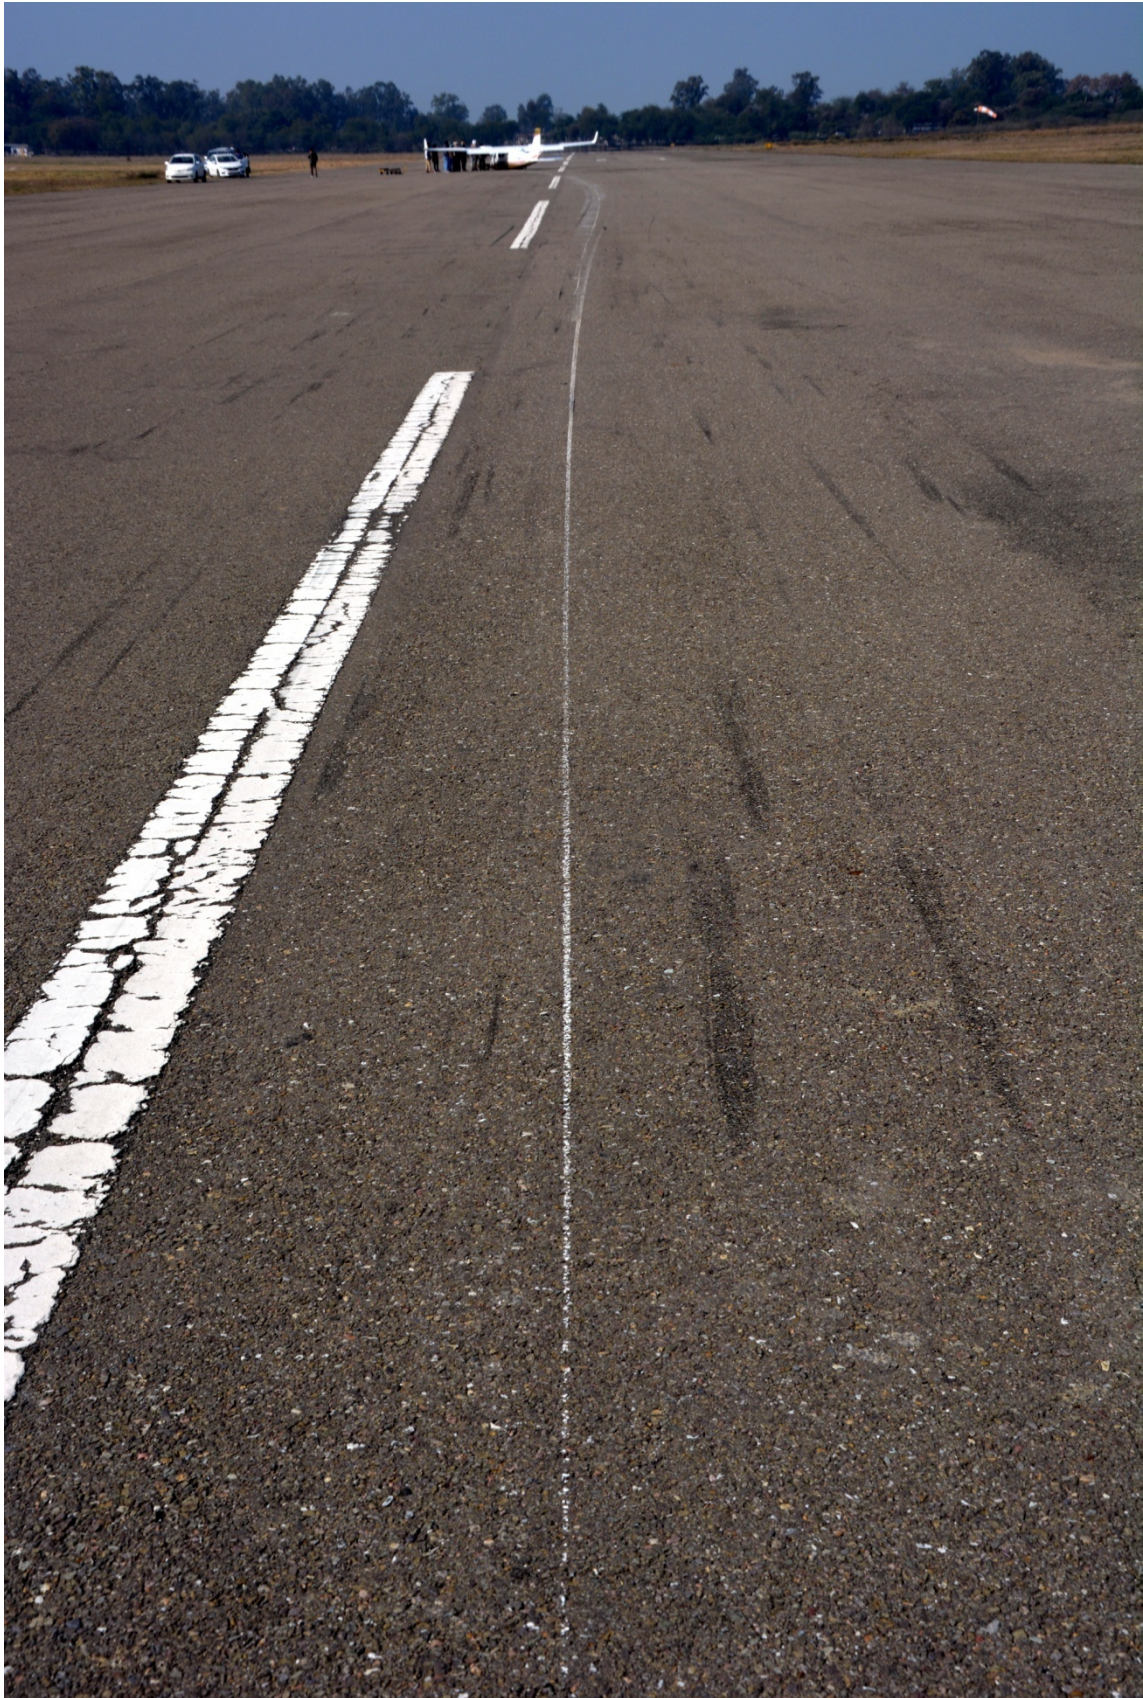
**Aircraft fuselage marks on the RWY33**

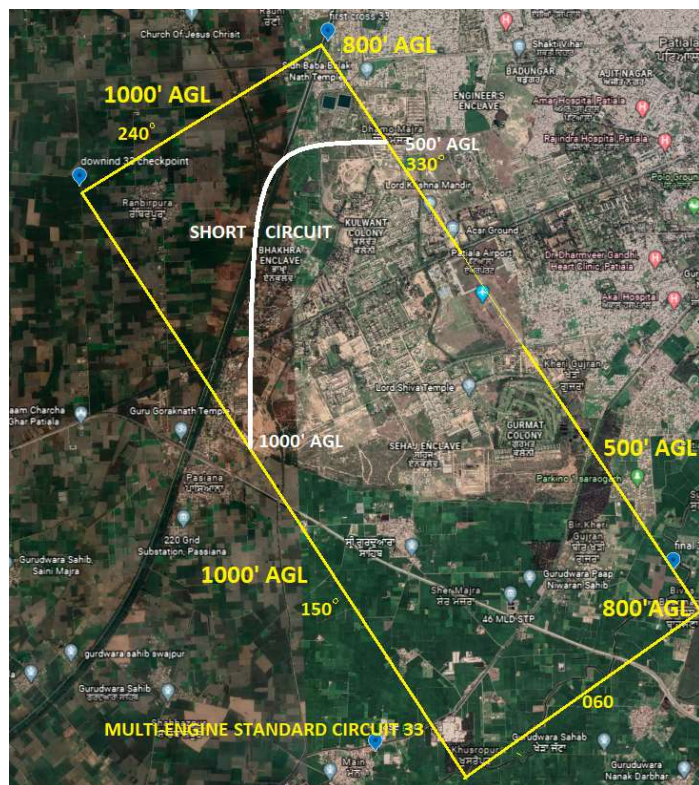
Short Circuit Pattern

Patiala Aviation Club informed that, they also make use of two circuit patterns. A 'SHORT CIRCUIT' pattern, wherein a left turn is taken after 500ft AGL post take-off and a 'STANDARD CIRCUIT' wherein a left turn is initiated after 800ft AGL post take-off. The 'STANDARD CIRCUIT' and 'SHORT CIRCUIT' pattern, as submitted by Patiala Aviation Club is illustrated in page 20. Whereas, the definitions and conditions at which these are followed/used i.e., 'Standard Circuit Pattern' and 'Short Circuit' is not detailed in the approved Training Procedures Manual.
