FINAL INVESTIGATION REPORT

**EMERGENCY LANDING INCIDENT OF M/S ASHLEY AVIATION
FALCON 2000 AIRCRAFT VT-HGL ON 18/07/2023 AT BHOPAL**

DIRECTORATE GENERAL OF CIVIL AVIATION
GOVERNMENT OF INDIA
NEW DELHI-110003

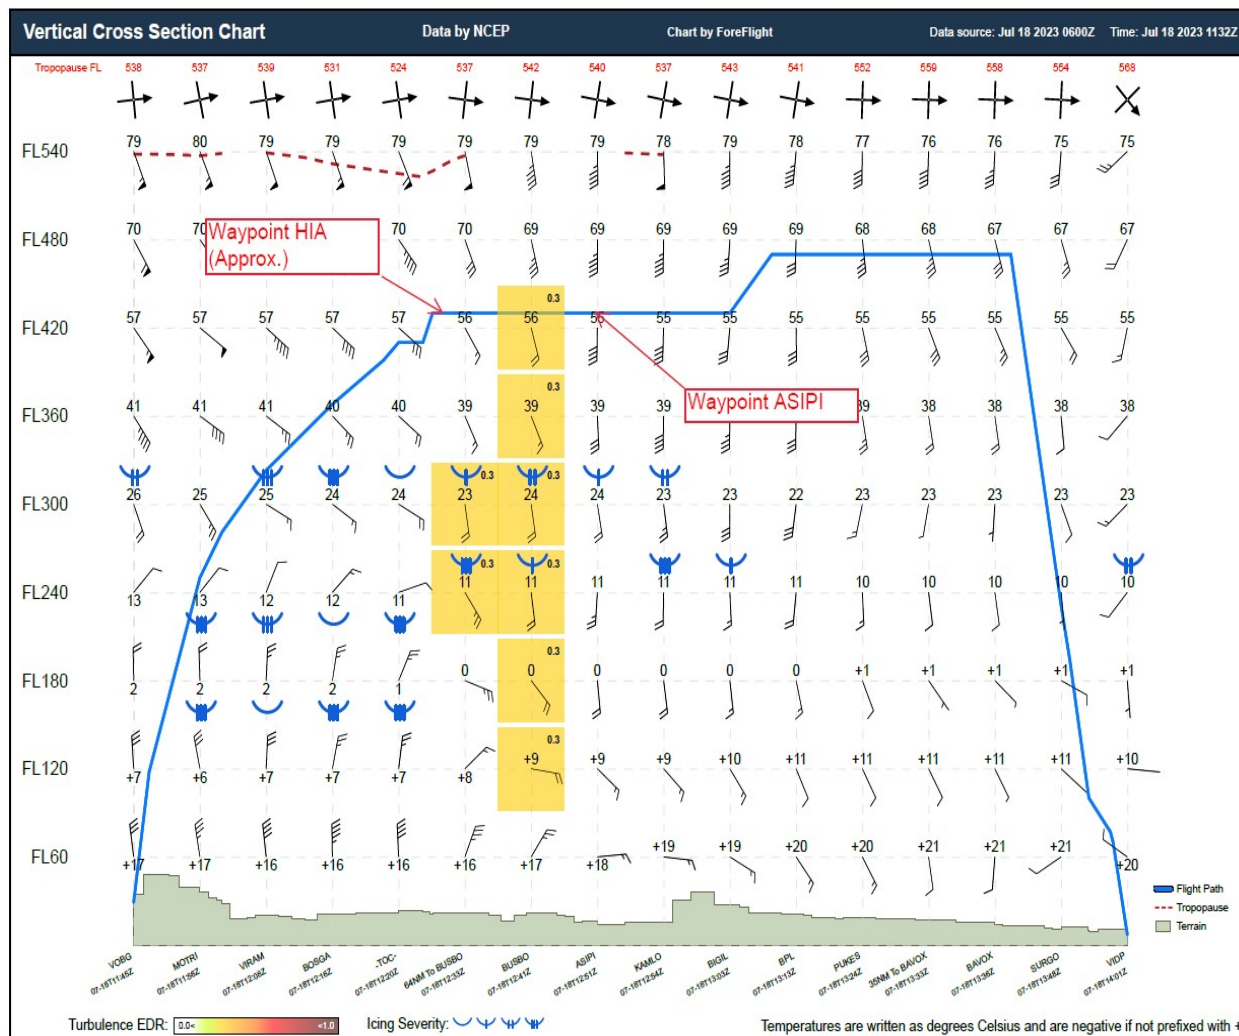
At top of climb short of waypoint HIA winds were about 30 knots from east south with temperature -57 degree Celsius at FL 420 at time 1220 UTC. Weather was there between short of waypoint BUSBO and waypoint ASIPI with light to moderate turbulence (turbulence EDR 0.3) at FL 430.

As evident from above weather forecast chart, short of waypoint ASIPI crew initiated descent from FL 430 to FL 400 due weather. Winds speed was 20kts South east in turbulent zone and the temperature was -56 degree Celsius.
