**INVESTIGATION REPORT**

**INCIDENT TO A109SP HELICOPTER VT-YMA OF M/S**  
**LULU INTERNATIONAL Pvt. Ltd. AT COCHIN ON 11<sup>th</sup>**  
**APRIL-2021**

**OFFICE OF THE DIRECTOR OF AIR SAFETY**  
**(SOUTHERN REGION), CHENNAI**

**Final Investigation Report on Incident to A109SP helicopter VT-YMA  
of M/s Lulu International at Cochin on 11<sup>th</sup> April-2021**

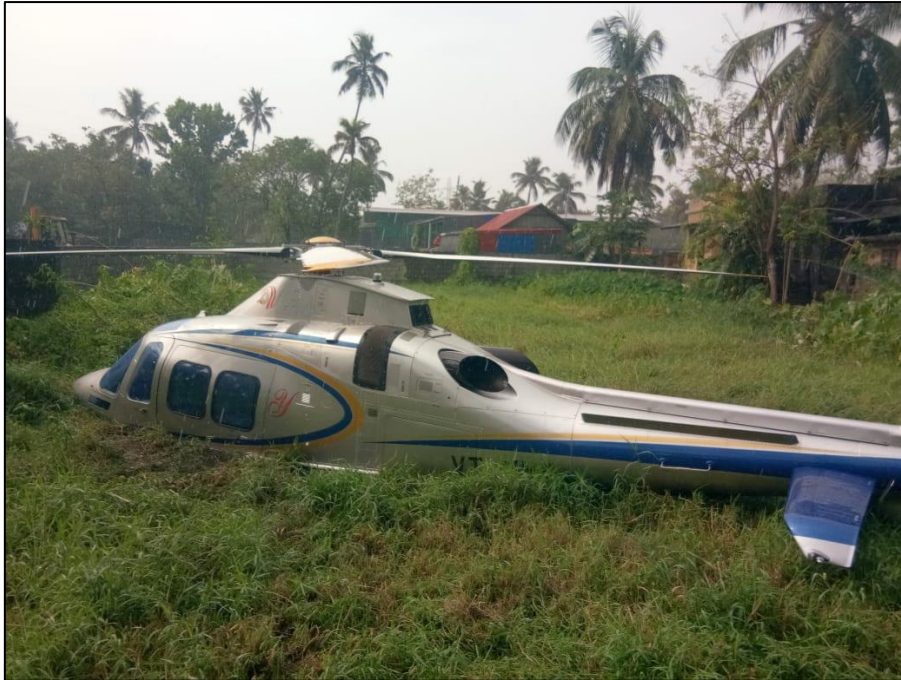
(Fig. 1: Helicopter at Incident site)

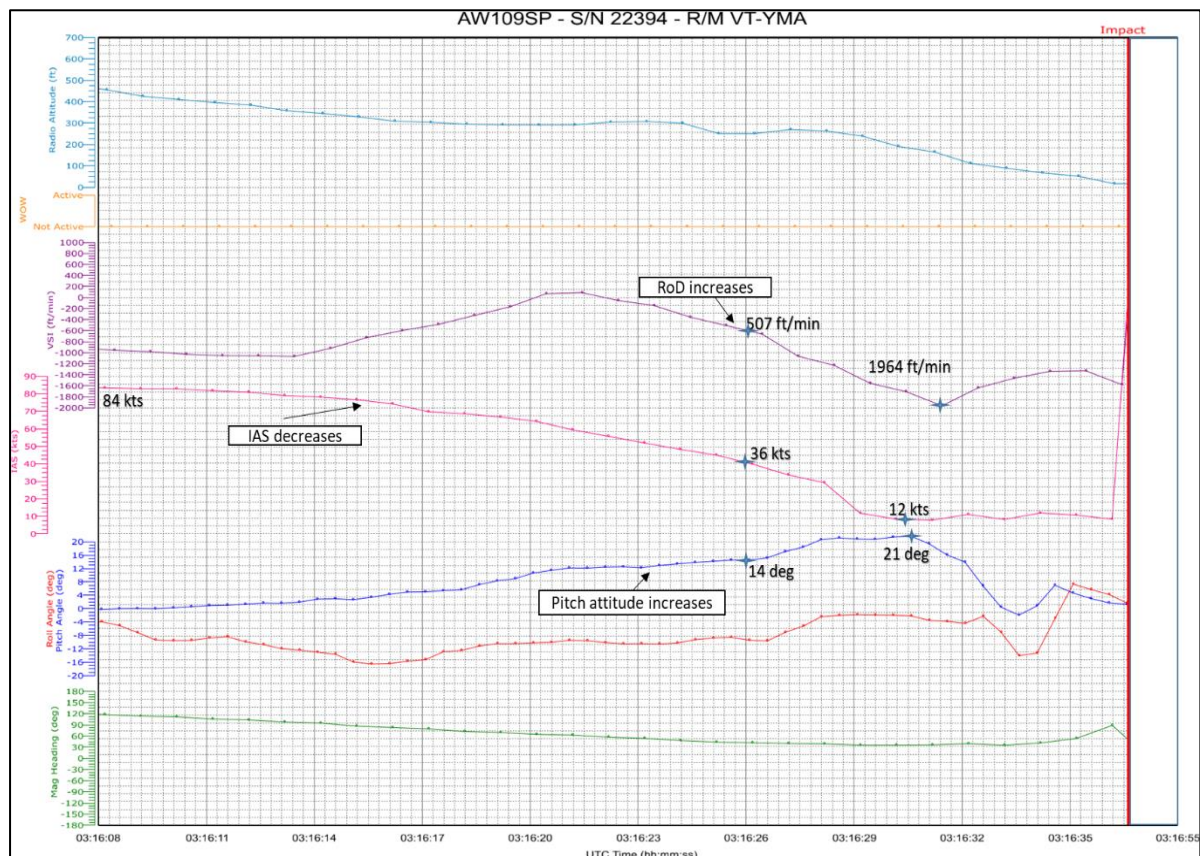
6. During this turn, the PF slowly and progressively increased the Pitch attitude of the helicopter from an initial (almost) level condition up to 15° at 03:16:27 UTC. As the Engine TQ demand was neither increased nor maintained during this time, but instead was slightly decreased down to approximately 30% (TQ reduced from ~50% to 21%) the result was a progressive reduction of IAS from 80kts (at the beginning of the turn) down to ~40kts, and a consequent increase of the Rate of Descend.

(Fig. 9: Flight Control data for final part of flight)

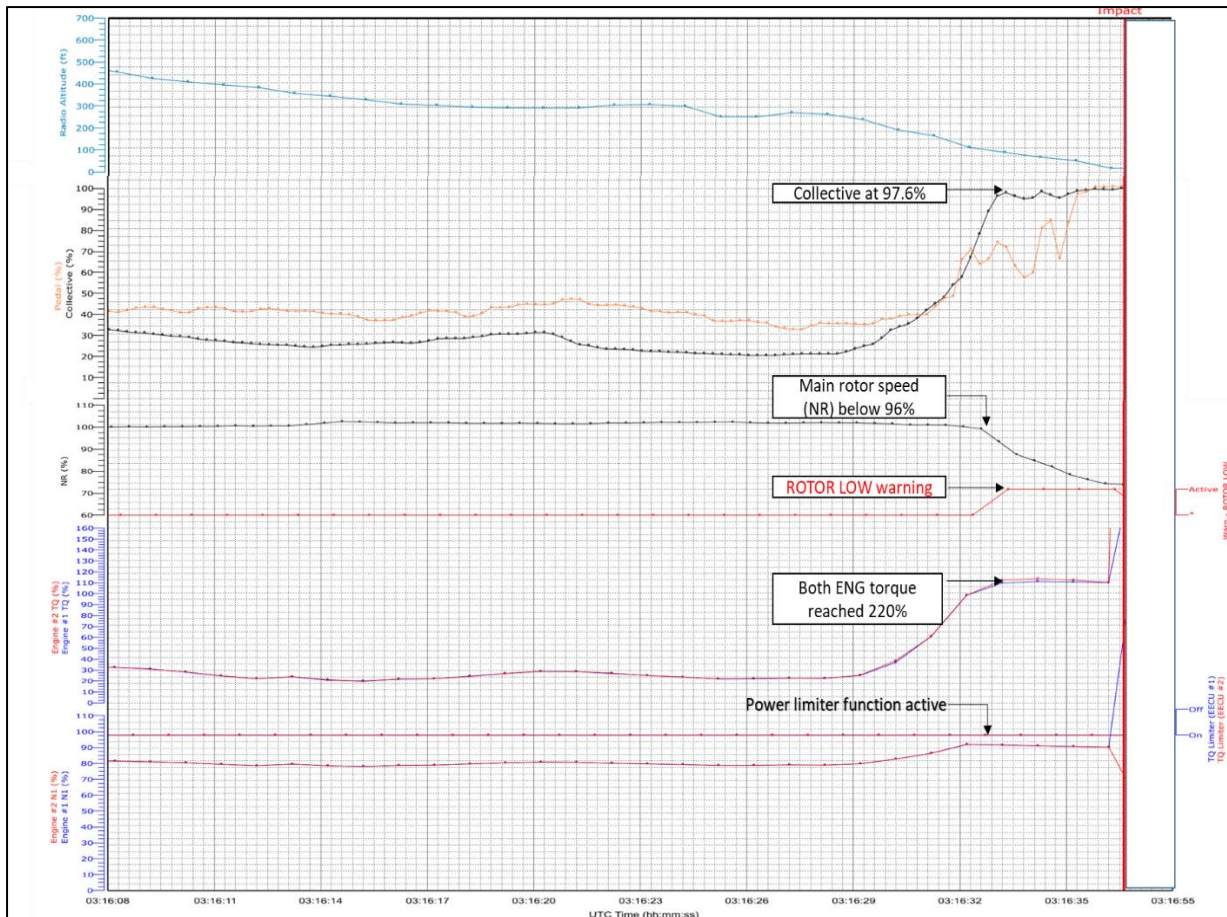
7. At 03:16:30 UTC, around ~260 ft AGL, pitch attitude was being further increased above 15° and reached approximately 21°. As no significant Collective compensation was applied up to that moment, VSI peaked at ~2000 ft/min RoD, while IAS reached 0kts.

(Fig. 10: Power plant data for final part of flight)

8. From this point of time onwards the PF applied almost full Collective (97.6% was reached at 03:16:34 UTC), possibly to try and counteract the perceived sink. The result was an immediate TQ increased by both Engines, which reached the 220% cap less than 1s later, as the Torque limiter was still active.
9. The full Collective application, coupled with the limited power output caused a progressive Main Rotor Speed (NR) droop. The Warning ROTOR LOW activated below 96%, as designed. No other Warning or Caution message was present.
10. As the Pitch attitude remained above 20° and NR speed continued to decrease, the aircraft continued its descent towards the terrain. A final attempt to level off was made below 100ft AGL, but the aircraft impacted the terrain shortly after at 03:16:41 UTC, with a residual ROD of ~1500fpm and NR at approximately 74%.

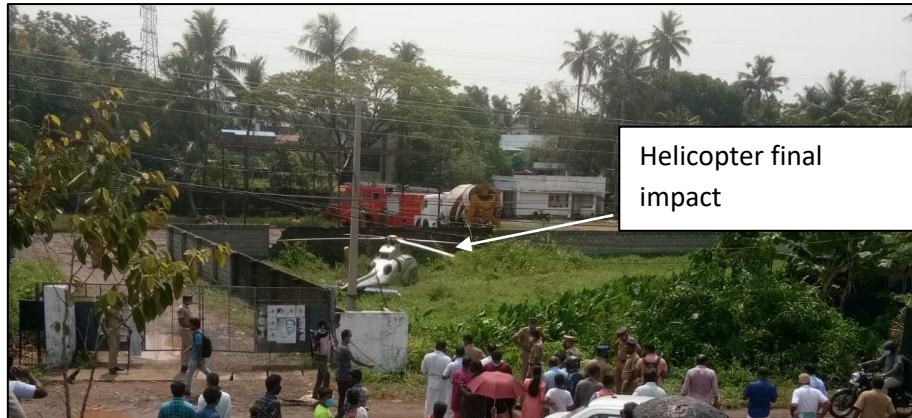
The helicopter settled on a marshy land and partially sank into the mud. Landing gear was in extended position. On impact on land, the helicopter sank up to 2 ft approx. On examination, it was observed that the helicopter suffered only consequential damage post

(Fig. 11: Helicopter final impact)

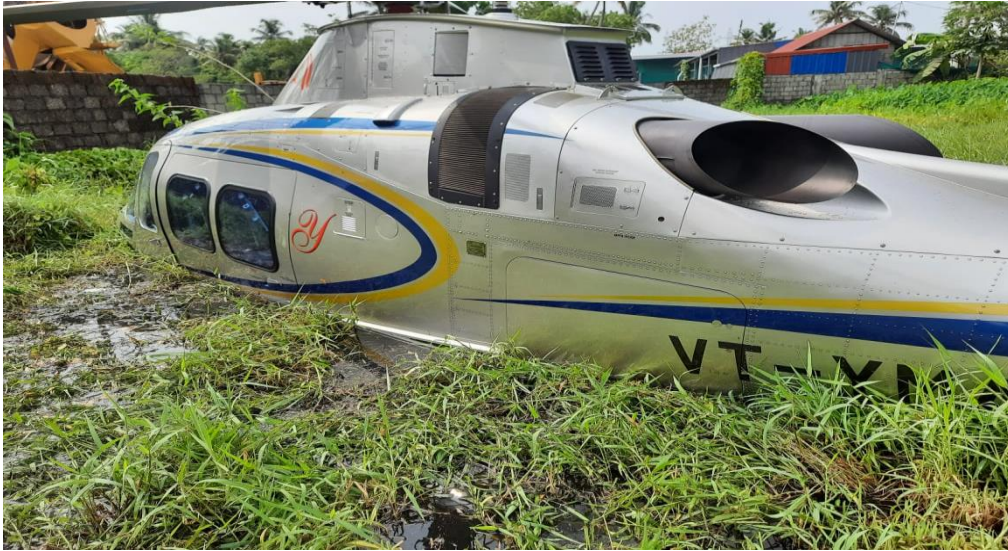
The helicopter settled on a marshy land filled with dirt water. Minor structural damages were observed on the helicopter, mainly on the undercarriage.

Fig. 13: Helicopter final resting position

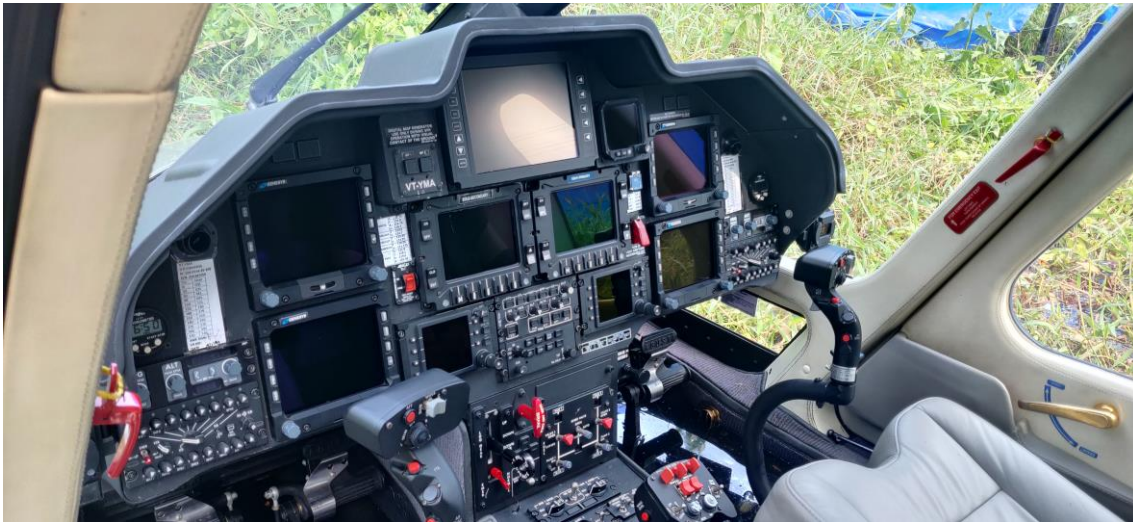
1. The cockpit was flooded with dirt water up 2 ft.
2. Main Rotor Blade s/n-AW1812 found cracked near the Trim Tab.
3. Nose landing gear door damaged.
4. Chin bubbles (Cockpit lower glass) LH & RH found damaged.
5. Access panels damaged
6. Drain and vent lines along the belly found deformed.

(Fig. 14: Cockpit view)

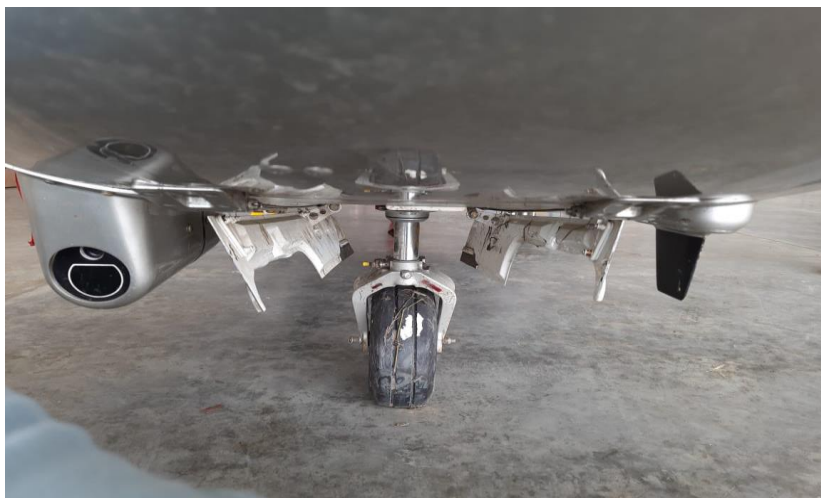
(Fig. 15: Nose Landing Gear doors twisted and broken)

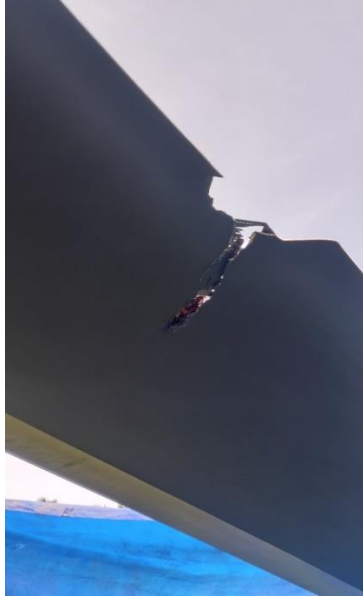
(Fig. 16: Main Rotor Blade s/n-AW1812 found cracked near Trim Tab)

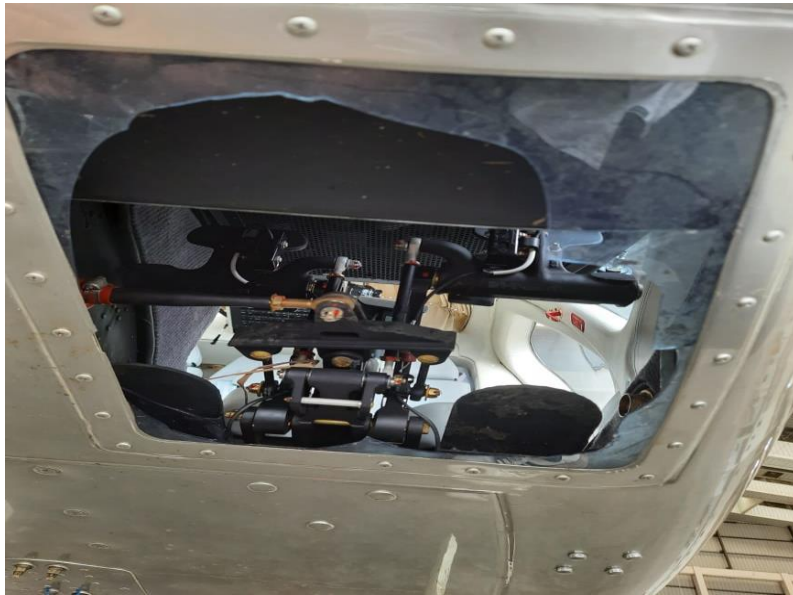
(Fig. 17: Both the chin bubbles (cockpit lower glass) found broken)

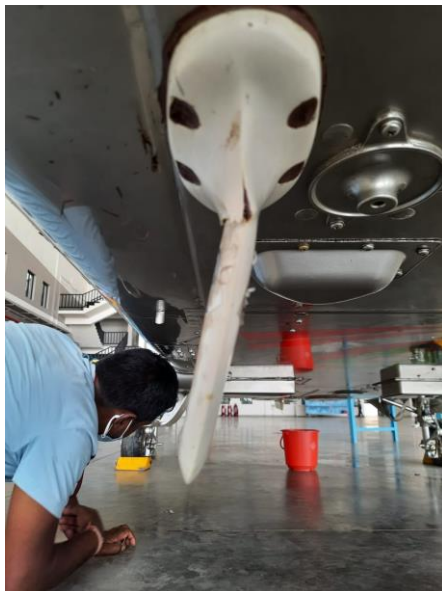
(Fig. 18: VHF Antenna broken)

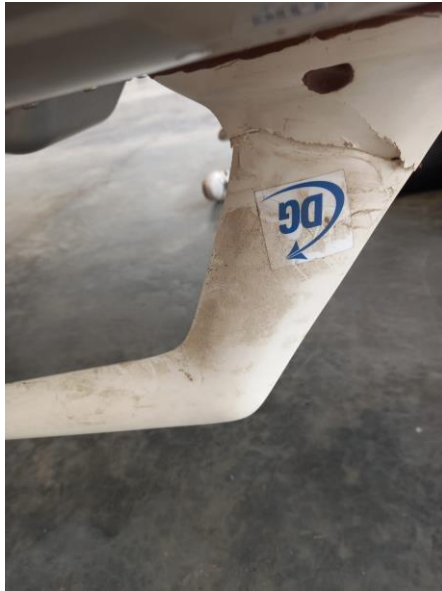
(Fig. 19: VHF 2 Antenna broken)

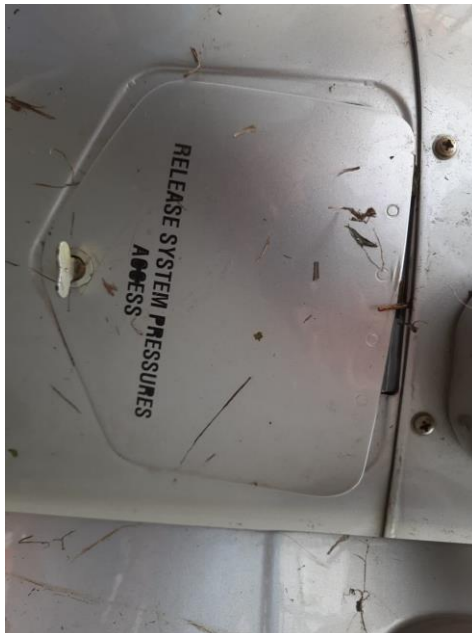
(Fig. 20: Utility accumulator access panel Deformed)

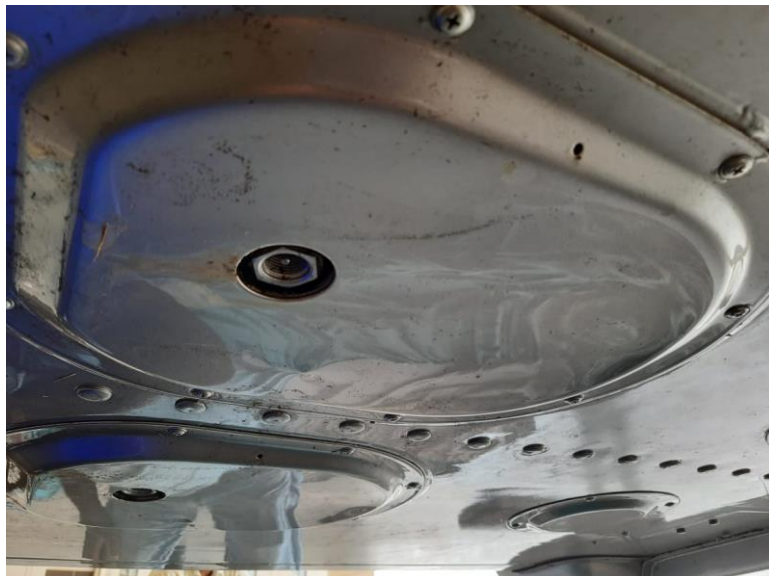
(Fig. 21: Both Fuel Booster PUMP Sump Panel found Deformed)

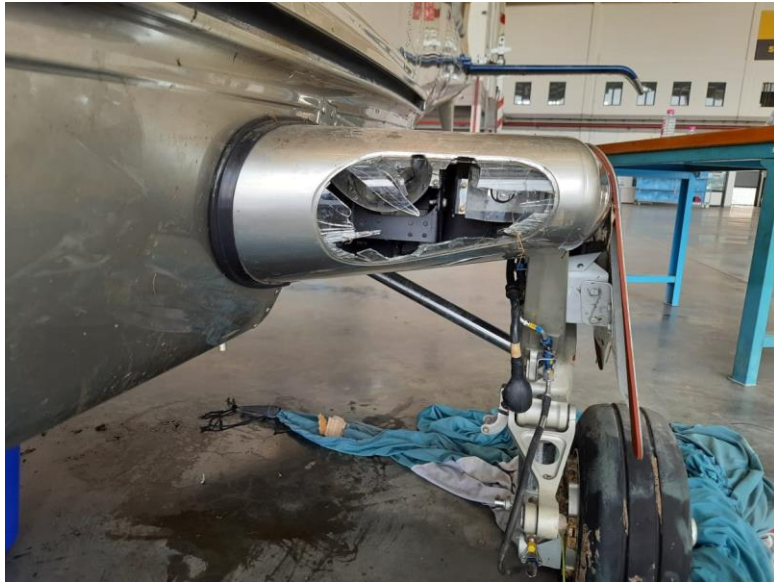
7. LH& RH Sponson Landing/taxi Light Glass found Broken.
8. Lower Fin adjacent to tailskid found Deformed& Cracked

(Fig. 22: LH& RH Sponson Landing/taxi Light Glass found Broken)

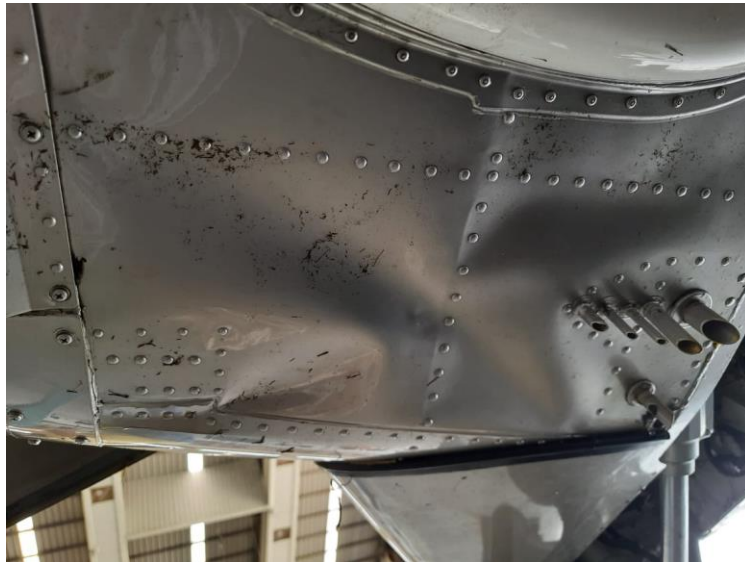
(Fig. 23: Belly, alongside vents line& Drain lines found Deformed)

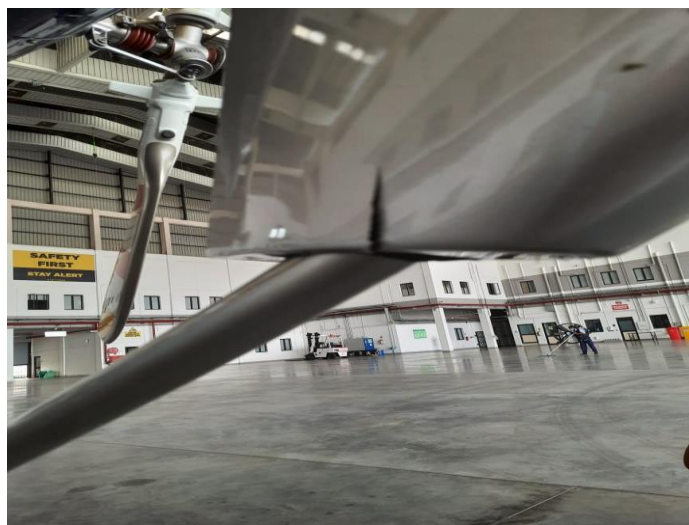
(Fig. 24: Lower Fin adjacent to tailskid found Deformed& Cracked)
