**INVESTIGATION REPORT ON INCIDENT TO  
M/S TATA SIA AIRLINES LTD. (VISTARA) AIRBUS  
A320-232 AIRCRAFT VT-TTF WHILE OPERATING  
FLIGHT UK -733 (SECTOR: CHENNAI - KOLKATA)  
ON 25.02.2019**

**DIRETORATE GENERAL OF CIVIL AVIATION  
GOVERNMENT OF INDIA  
NEW DELHI**

**INVESTIGATION REPORT ON INCIDENT TO M/S TATA SIA AIRLINES LTD.  
(VISTARA) AIRBUS A320-232 AIRCRAFT VT-TTF WHILE OPERATING FLIGHT  
UK -733 (CHENNAI - KOLKATA) ON 25.02.2019**

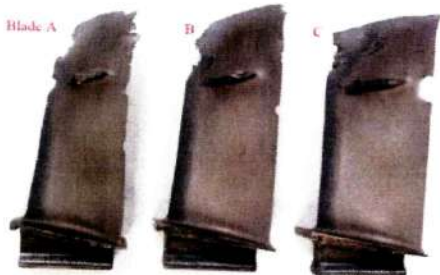
No repair markings were observed on the 3<sup>rd</sup> stage blade set; which is an indication that these are first run blades. Visual examination of the blades revealed widespread impact damage and one blade fractured above the root platform. Contact damage and deformation was observed on the mid-span shrouds (clappers) of the blade set. Three typical intact blades were imaged (Figure 1-5). When the other blades in the blade set were viewed at a similar span location as the fractured blade, no additional cracking was observed on the leading edges (L/Es).

Fig. 1: Stage 3 blades, concave side

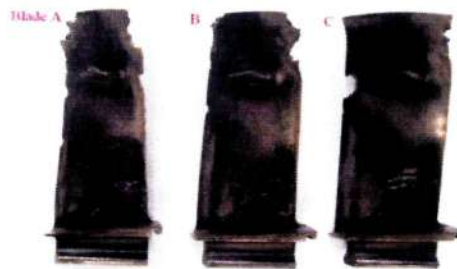
Fig. 2: Stage 3 blades condition

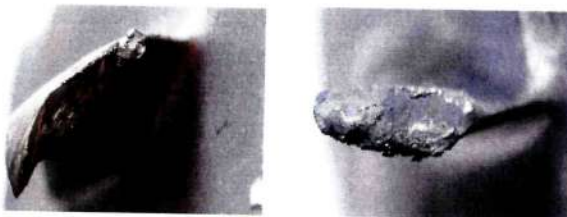
Fig. 3 & 4: Concave & convex side clapper surface of blade A clappers showing deformation and damage

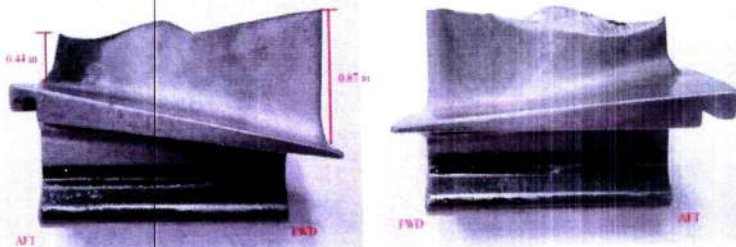
- The 3rd stage blade fracture occurred approximately 0.87 in. above root platform on the L/E of the airfoil and 0.44 in. above root platform on the T/E of the airfoil (Figure 6-8).

Fig. 6&7: Overall image of fractured HPC 3rd stage blade concave & convex airfoil side.

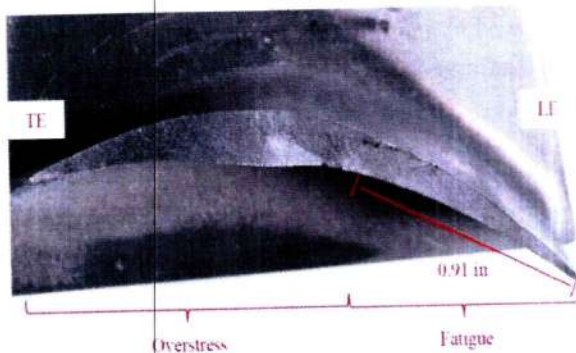
- Binocular examination revealed fatigue originating from the concave (CC) side L/E and extending towards the trailing edge (T/E) approximately 0.91 in. before transitioning to overstress (Figure 9-10).

Fig. 9: Overall image of HPC 3rd blade fracture surface. Fatigue progressed from L/E towards the T/E

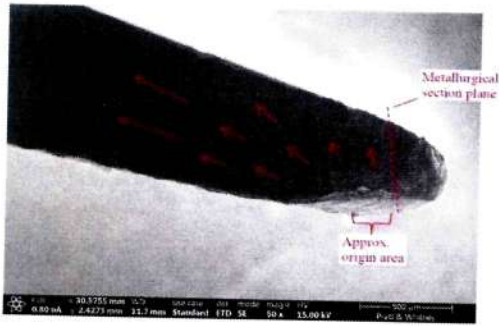
Fig. 11: SEM image of origin area, ~50x magnification  
Arrows denoting fracture progression direction and reference location of metallurgical section shown.

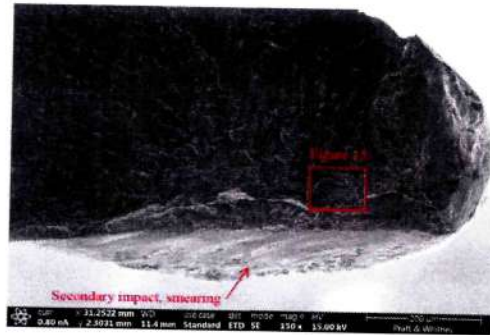
Fig. 12: SEM image of origin area, ~150x magnification. Large area of secondary impact damage smeared over approximate origin.

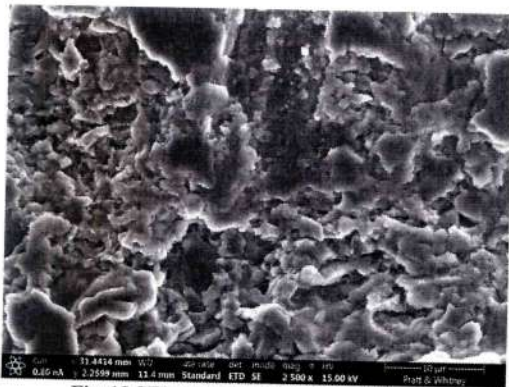
Fig. 13 SEM image adjacent to origin area, ~2500x magnification. Surface appeared rub-damaged

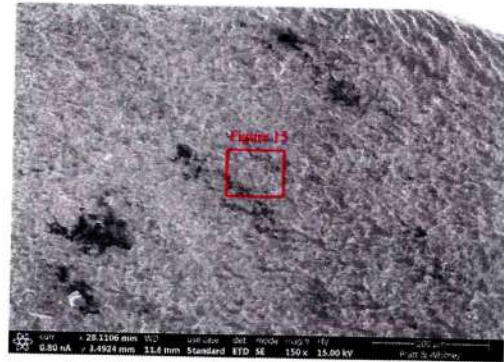
Fig. 14: SEM image of fracture progression, ~150x magnification

- Scanning electron microscope (SEM) examination of the fatigue progression revealed cleavage features indicative of high cycle fatigue (HCF) (Figure 10-16).

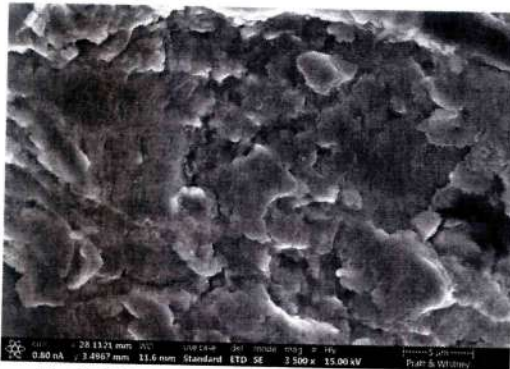
Fig. 15 SEM image of fracture progression, ~3500x magnification. Surface appeared to show a mixture of striations and cleavage-like features

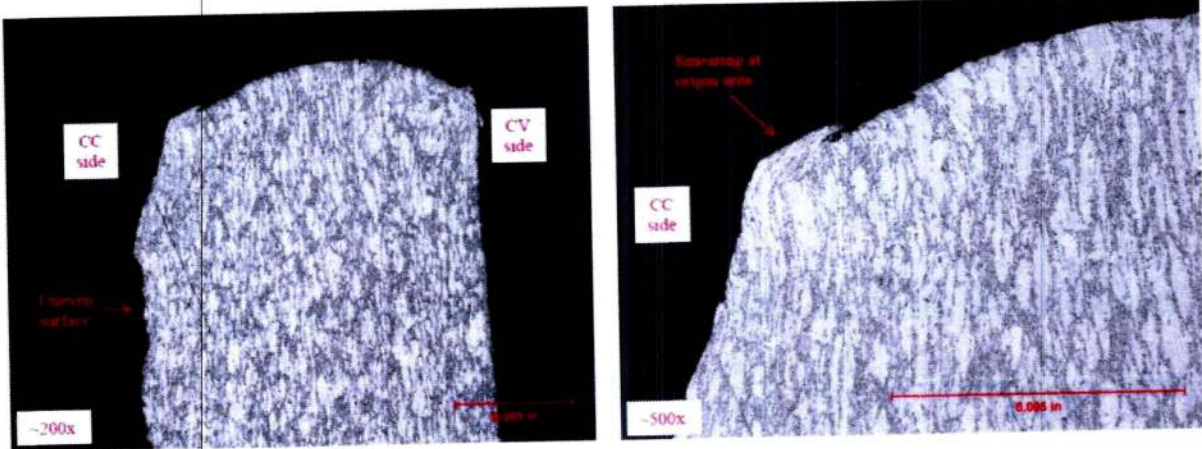
- A radial metallographic section was prepared into the approximate origin area (Figure 17). Bulk microstructure and composition of the blade appeared consistent with manufacturing forging requirements hence no material or processing anomalies were observed on the fractured blade.

Fig. 17: Metallographs of the fractured blade radial L/E section at approximate origin area. Uneven erosion-like appearance of concave (CC) airfoil surface was exaggerated due to the section plane through the L/E radius

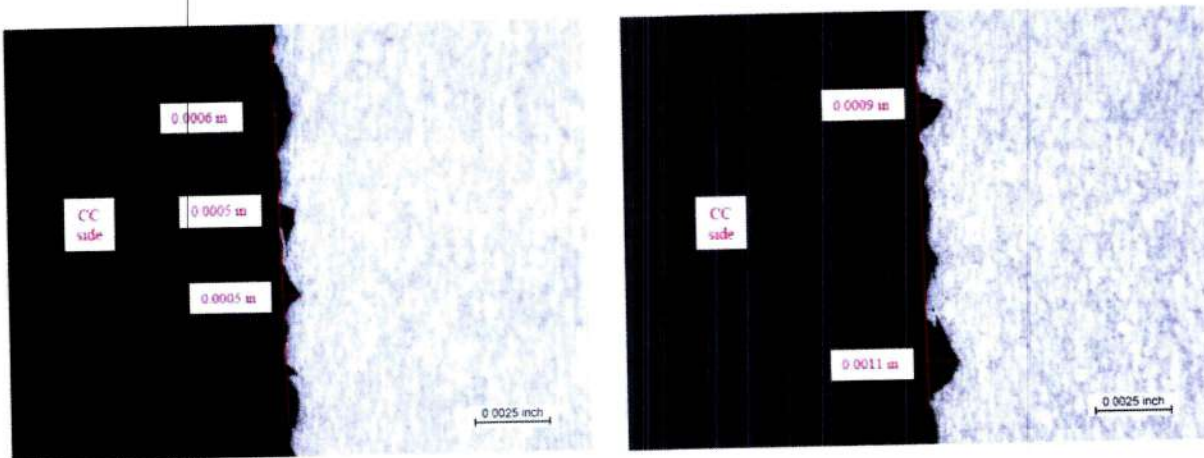
- The radial metallographic section was ground down past the origin/LE radius to examine erosion damage at the concave leading edge (Figure 18). The observed maximum depth of erosion damage was approx. 0.0011 in.

Fig. 18: Metallographs of the fractured blade radial L/E section at approximate origin area to show erosion on the concave (CC) airfoil surface. Typical surface condition (top) and maximum depth observed (bottom).

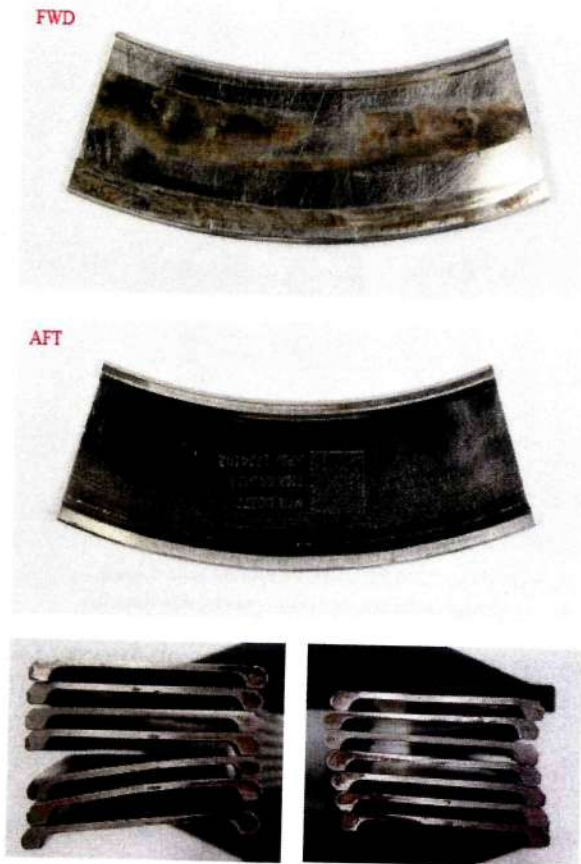
Visual examination of the stage 3 blade retaining plates revealed a polished surface and deformation likely due to removal. Polished surfaces indicated retaining plates may have been partially refurbished following removal. Retaining plate edges showed contact wear (Figure 19).

Fig. 19: Overall images of typical 3rd stage blade retaining plate forward side (top), aft side (middle), and retaining plate edge wear/deformation (bottom).

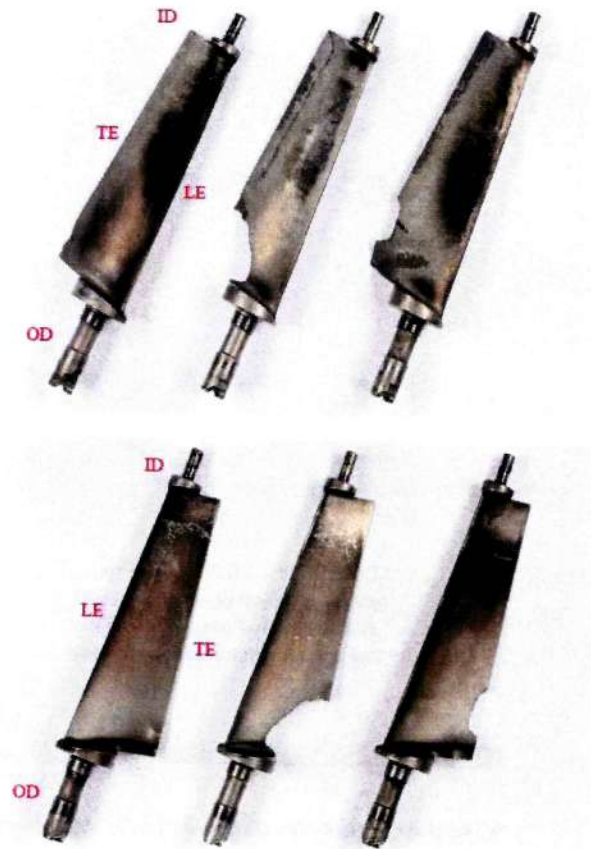
Fig. 20: HPC Variable Inlet Guide Vane overall images concave side (top) and convex side (bottom). No evidence of leading edge erosion was found.

Visual examination of the HPC VIGV set revealed varying degrees of outboard T/E impact damage and cracking. VIGV cracking location and appearance was consistent with overstress fracture due to impact. There was no L/E erosion found (Figure 20).

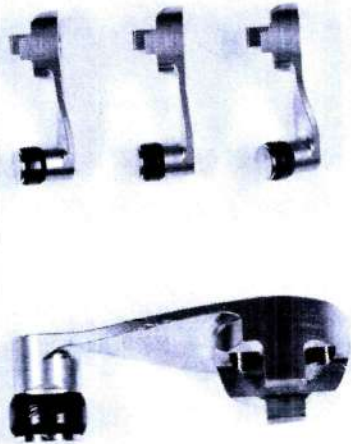
VIGV lever arms showed significant torsional deformation as well as cracked lever arm balls (Figure 21).

Fig. 21: HPC VIGV Lever Arm images of typical deformation (top) and a close-up image of lever arm ball cracking/deformation (bottom)

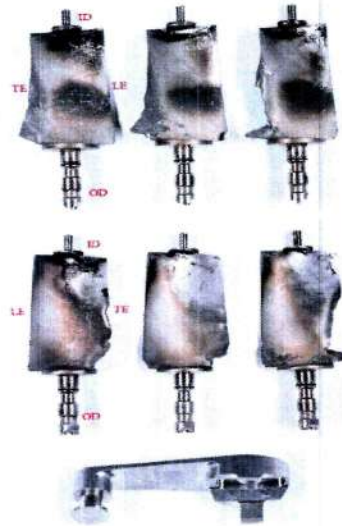
Fig. 22: HPC stage 3 Variable vane overall images concave side (top), convex side (middle), and lever arm (bottom). Heavy trailing edge damage and cracking from impact with liberated blade. Lever arm showed no discernable deformation.

Visual examination of the 3rd – 5<sup>th</sup> stages of variable vanes revealed extensive secondary L/E and T/E impact damage. The singular 3rd stage variable vane lever arm did not appear to have damage or deformation, however, the lever arm ball was missing (figures 22-24).

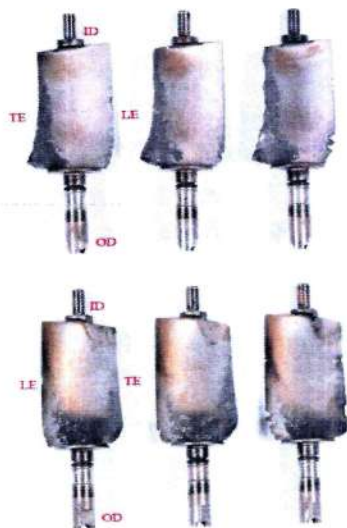
Fig. 23: HPC stage 4 Variable Vane overall images concave side (top) and convex side (bottom). Impact damage was observed on both the leading and trailing edges.

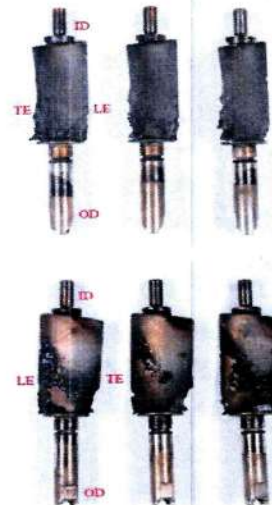
Fig. 24: HPC stage 5 Variable vane overall images concave side (top), convex side (middle), and lever arm (bottom). Heat and impact damage observed.

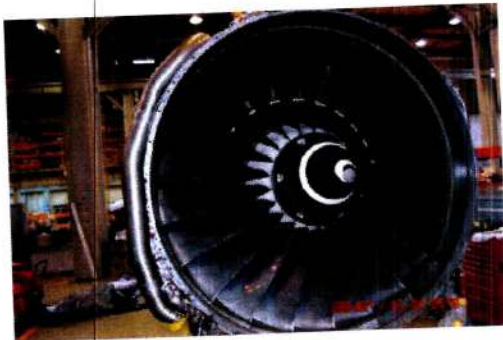
impact damage on leading edge was noted (Figure II & III). Impact damage was also observed on LPC 2.5 blades. Damage to fan and LPC blades suggests that object impacted fan blade then it was ingested in to engine flow path impacting LPC 2.5 blades and likely impacted HPC stage 3 blade. Fractured stage 3 blade tumbled in the engine resulting in secondary damage (Figure VI & VII). Portion of the blade that was intact with the root of the blade also has secondary damage limiting possibility of determining exact crack initiation site. Conclusive root cause of what promoted blade to fracture for this event cannot be determined. However, likely cause for stage 3 blade fracture based on what can be observed on fan and LPC blades is impact damage to the Leading edge due to FO ingestion.

Fig. II: Fan blades before removal

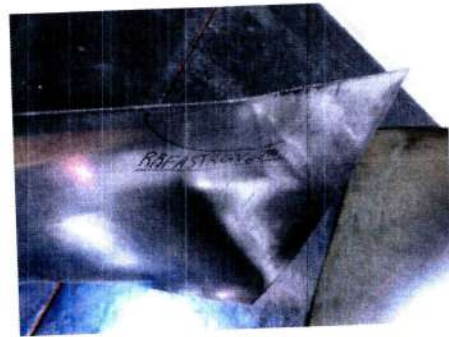
Fig. III: Damaged fan blade (bend on leading edge)

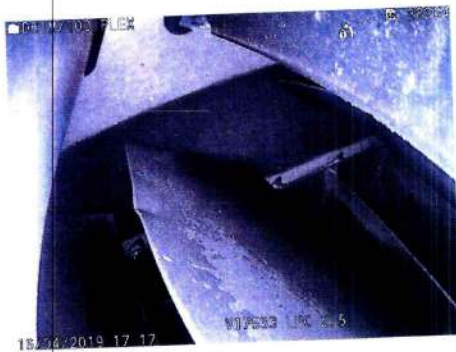
During BSI 2.5 Blades (QTY 04) were noted with dent/bend with deflection on Zone 'C', the worst measured approx. 0.019" depth (noted defect acceptable as per EM limit) (Figures IV & V)

Fig. IV: LPC Stage 2.5 blades with dent

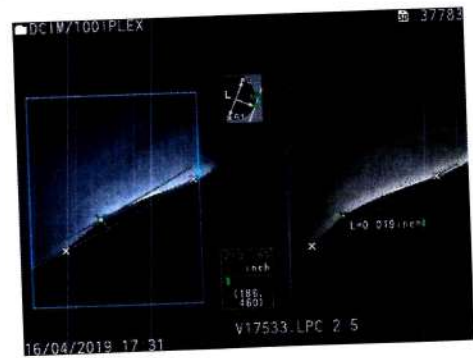
Fig. V: LPC Stage 2.5 blades with bend

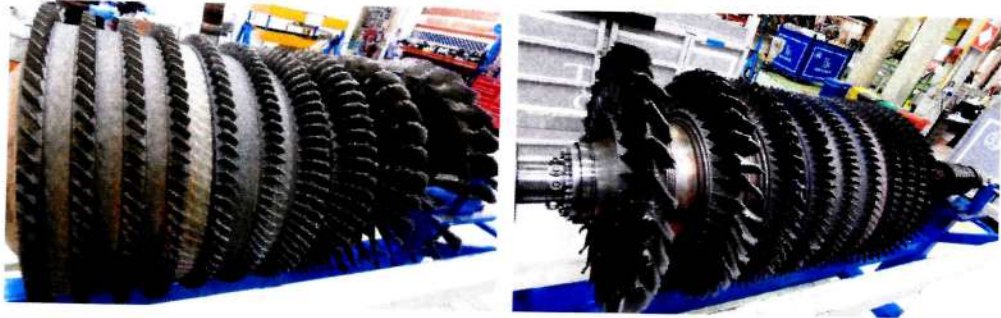
**Fig. VI: HPC rotor blades with distortions**

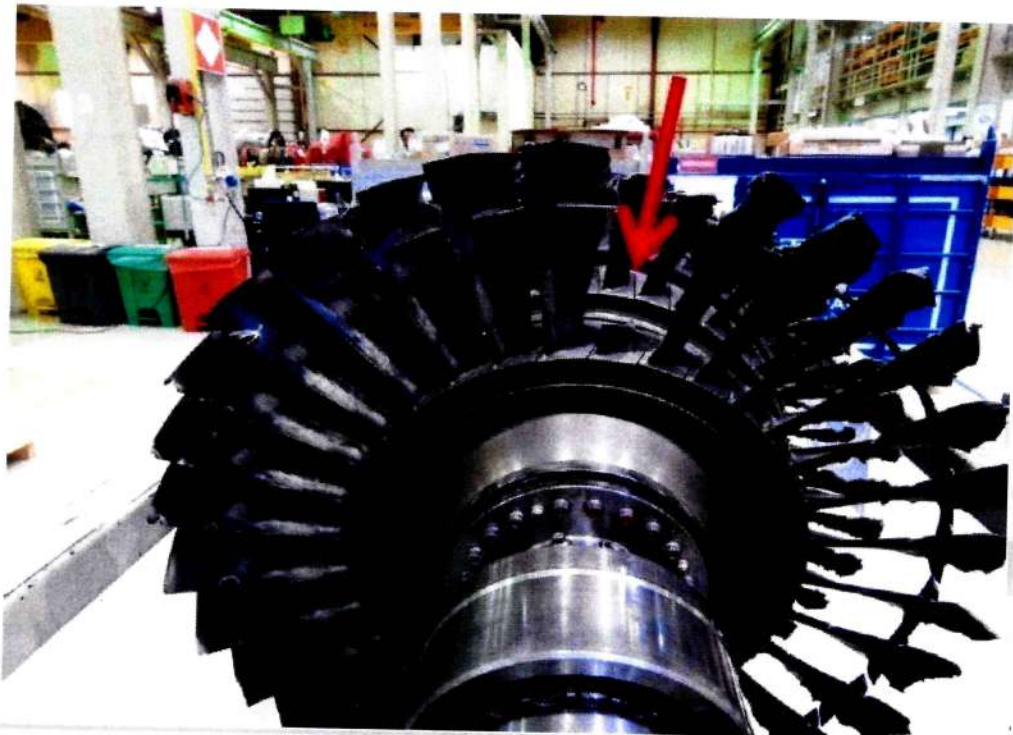
**Fig. VII: HPC rotor blades with distortions/and quantity 01 blade broken off.**

After the incident, borescope inspection on Engine #2 was performed by AME and observed that one of the HPC stage 3 blade was broken near root and damaged the rest of the blades of stage and got ingested inside HPC, blades of all stages of HPC were damaged beyond AMM limits. No bird debris found.
