**FINAL INVESTIGATION REPORT OF
INCIDENT TO
M/s SPICEJET LTD. DHC-8-402, AIRCRAFT VT-SQB ON
12.10.2022 AT HYDERABAD**

**O/o DIRECTOR AIR SAFETY, SOUTHERN REGION,
INTERNATIONAL CARGO COMPLEX, MEENAMBAKKAM,
CHENNAI-600016**

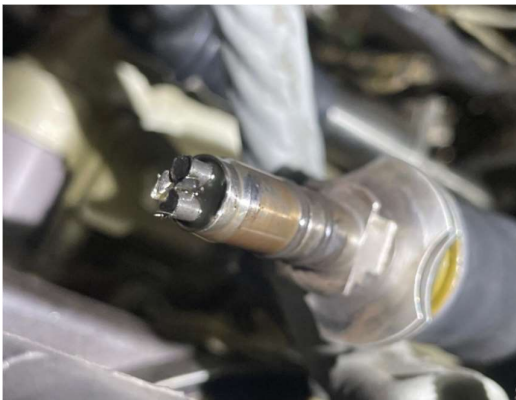
Figure 6: TM Magnetic Chip Detector

- e. Operational test for engine fault code indications carried out and found fault code 938 on both channels of LH Engine. **Metal chips found on the turbo-machinery chip detector.**

- g. **LH ENGINE replaced (WO# 6038907) as per approved schedule Q400/72/EC/03 Issue 1 Rev 2.**

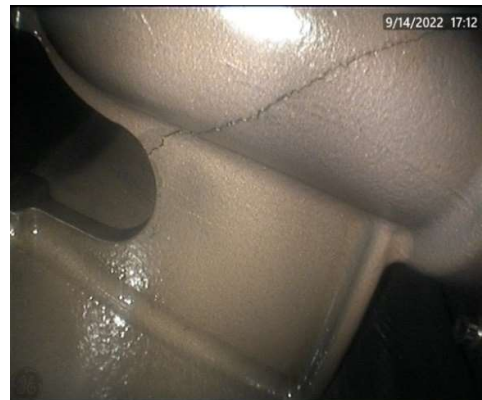
Figure 7: ICC Strut

- f. Further, Boroscopic inspection of HP impeller was carried out and observed oil on the impeller and borescope inspection of Inter Compressor Case (ICC) Strut was found crack in the ICC Strut area.

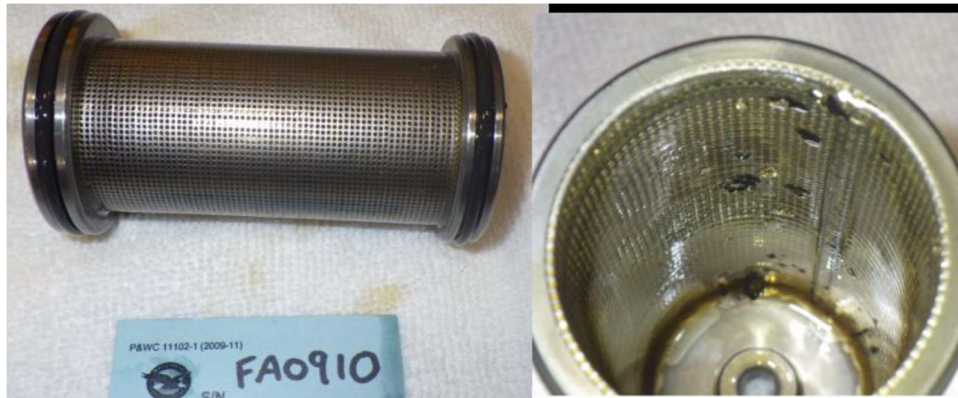
Figure 8: Main Oil Strainer

- The high pressure (HP) spool, low pressure (LP) spool and power turbine (PT) spool rotated freely. A view through the engine inlet showed oil streaks near the bottom dead center. The main oil strainer showed several black particles and a several metallic flakes. The RGB scavenge oil filter was dark with a few non-metallic particles.

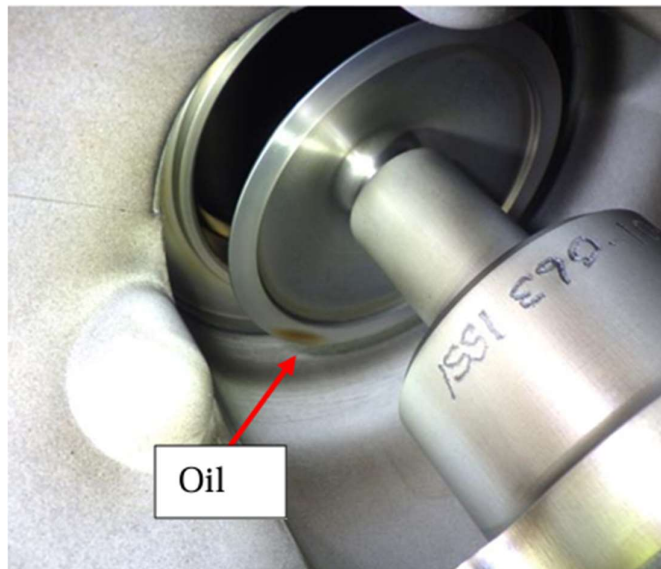
Figure 10: P2.7 Handling Bleed Valve

- The P2.7 handling bleed valve showed oil residue and the P3 air bleed port was dry. The P2.2 interstage bleed valve and adaptor showed oil residue in the inner passage. The P2.2 bleed valve was removed, and oil accumulation was observed in the low-pressure case (LPC) P.2.2 cavity.

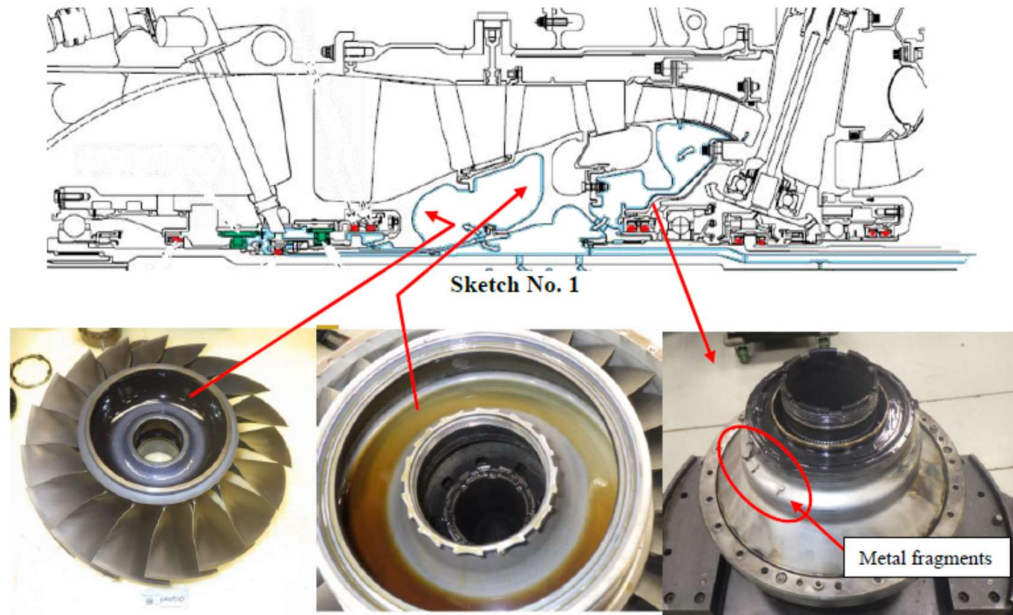
Figure 13: Axial Compressor

- The hot section was removed, and no primary distress was observed. The PT shaft exhibited oil and carbon streaks near the P2.5 air holes.
- Examination of the axial compressor showed oil accumulation in all of the rotor bores. The No. 3 bearing housing and cover showed oil leakage and carbon deposits. Several metallic fragments were found on the No. 3 bearing housing cover.

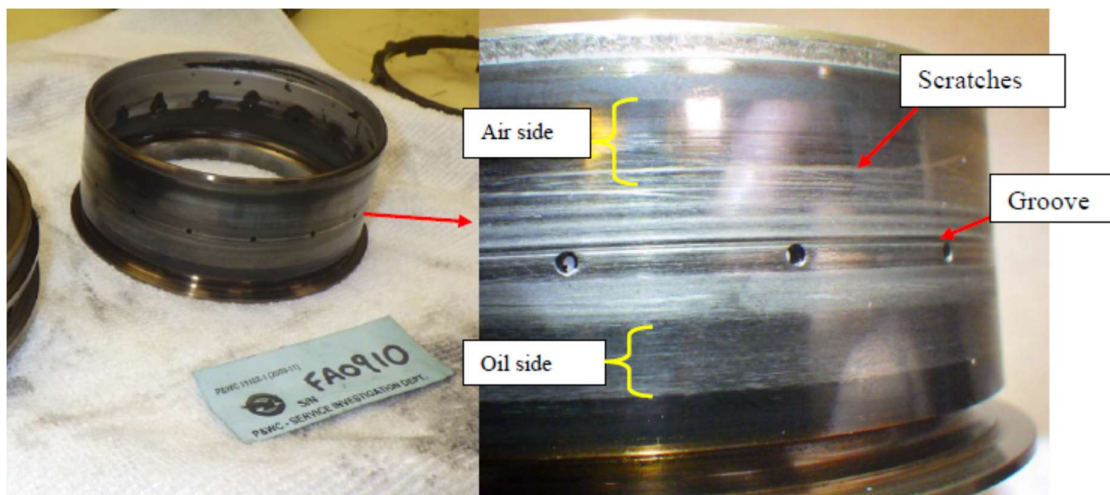
Figure 14: No.3 Carbon seal runner

- The No.3 carbon seal runner was worn including scratches and grooving along the entire circumference. Dimensional measurement of the No.3 carbon seal runner showed that the diameters (carbon seal running land, air side and oil side) were within limits.

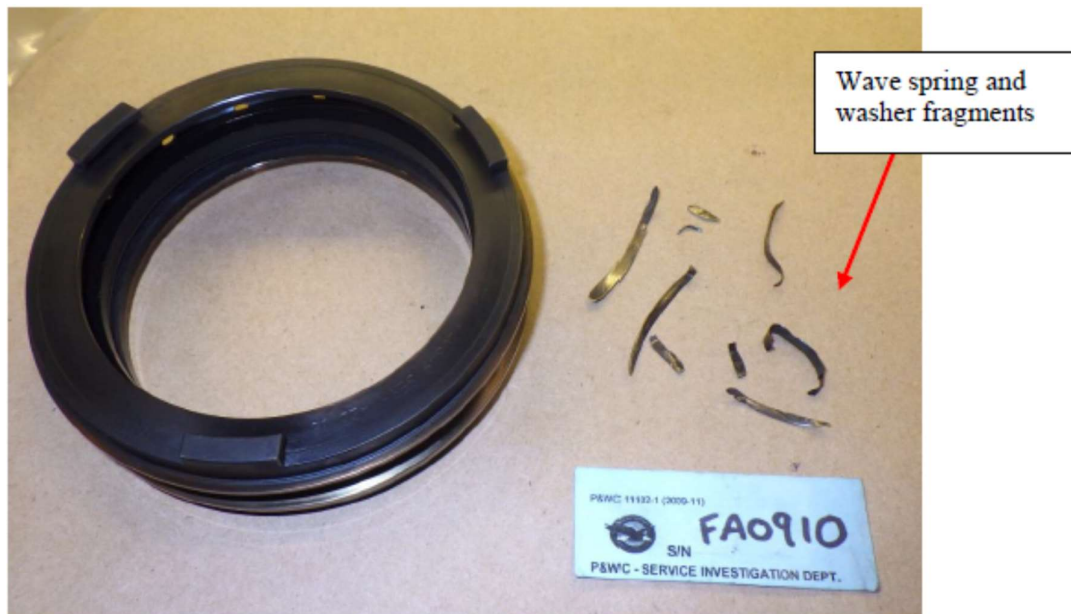
Figure 15: No.3 Carbon Seal wave spring & washer fragments

- Examination of the No.3 carbon seal revealed that the wave spring and oil side washer were worn down to thin fragments, some of which were collected on the No. 3 bearing housing cover and other from behind the carbon elements.

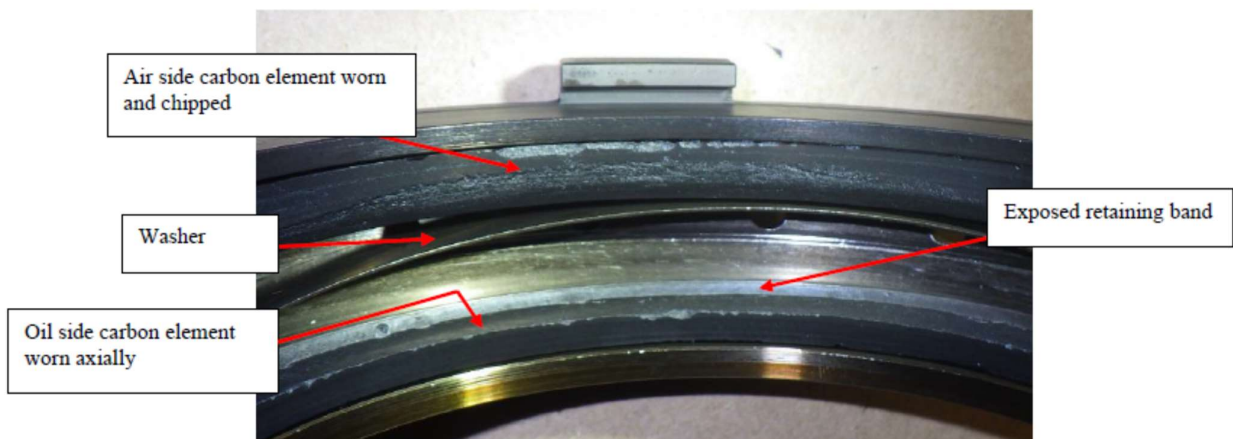
Figure 16: No.3 Carbon Seal

- The No.3 carbon seal oil side carbon element was worn down axially (approximately 30 % of the carbon material was missing) exposing the retaining band as shown in Photo No. 11. Dimensional measurement of the carbon elements showed that the average diameters were 0.0251 inches (air side) and 0.0261 inches (oil side) over the maximum limit.

Further, the OEM concluded in the engine strip report that, the engine internal oil leak was caused by a deteriorated No. 3 Bearing Carbon Seal. Review of the No.3 carbon seal internal elements revealed evidence that the oil side washer and wave spring spun wore down to thin fragments. The exact cause of the wave spring and washer spinning within the housing was not established. The No. 3 carbon seal was a Post SB35341 configuration. Service Bulletin SB35341 (CAT 6) was introduced in October 2016 to improve the carbon grade used in the carbon seal. The distress mechanism of the carbon seal detailed herein does not show the same degradation characteristic of the Pre SB35341 configuration.

During detailed examination, it was identified that the engine internal oil leak was caused by a deteriorated No. 3 Bearing Carbon Seal. Review of the No.3 Bearing carbon seal internal elements observed that the oil side washer and wave spring spun wore down to thin fragments. The exact cause of the wave spring and washer spinning within the housing could not be established.

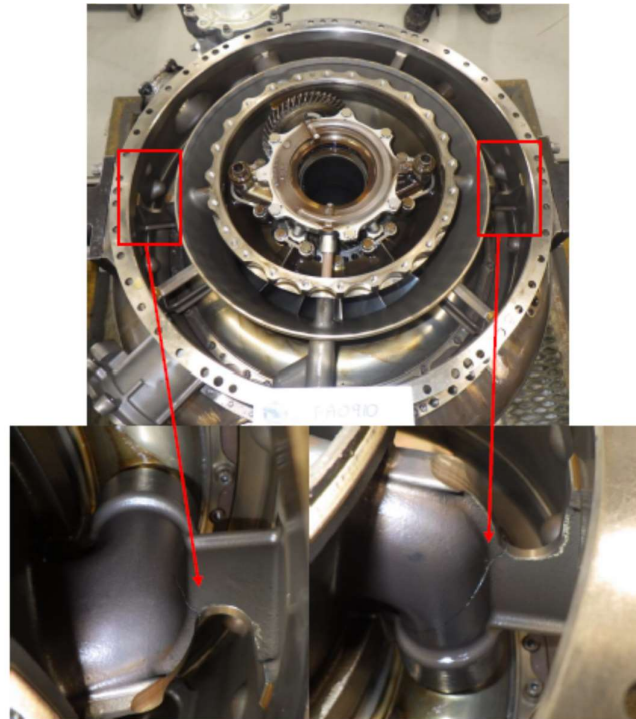
Figure 17: Inter Compressor Case (ICC) strut

- The Inter Compressor Case (ICC) showed oil wetting in the P2.7 cavity and the ICC struts (P2.8 air passages) were fractured.
