**INVESTIGATION REPORT ON HARD LANDING INCIDENT TO M/s INDIGO,
AIRBUS A320 AIRCRAFT, VT-ITK FLIGHT 6E-923 ON 15TH SEP, 2021 AT
KOLKATA**

**GOVT OF INDIA
DIRECTORATE GENERAL OF CIVIL AVIATION
AIR SAFETY DIRECTORATE
AURBINDO MARG
OPP SAFDARJUNG AIRPORT
NEW DELHI-110003**

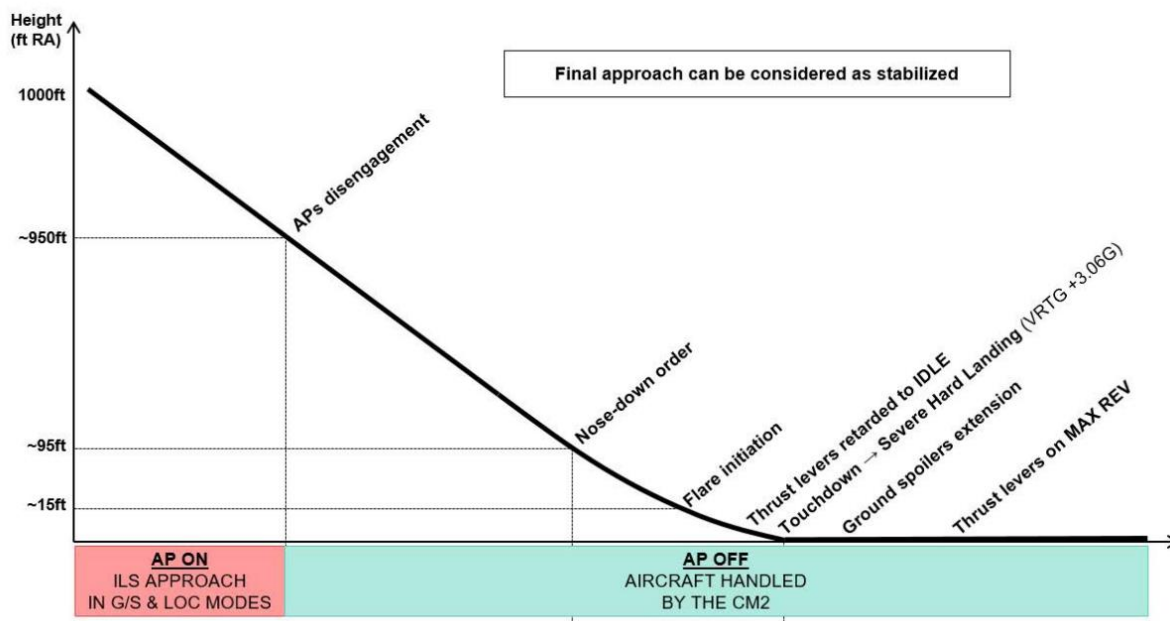
At 95ft, above the runway, the sudden pitch input (nose down) was recorded by the PF. The pitch angle reduced from 4.5 degree to 3 degree, resulted in an increase of vertical speed from 600 ft to 850 ft. The PF initiated the flare at around 15ft RA. The pitch angle increased to 4 degree before reducing to 3.5 degree. The rate of descent reduced to 600ft/min. The vertical acceleration at the time of touch-down was recorded 3.066g against the structural limit 2.6g as specified by the manufacturer. No input from the PIC was recorded till touchdown. After landing the PIC took over the controls.

The increased vertical speed required an earlier flare. PIC advised PF to flare. However, PF initiated the late flare at around 15 ft RA and gave inadequate flare input with a half of full back stick order then released it slightly. Subsequently, pitch angle increased from +3° to +4° before decreasing to +3.5° (nose up). Rate of descent decreased towards ~600ft/min.

The delayed and inadequate flare input by the PF applied from a significant rate of descent did not enable to sufficiently change the aircraft trajectory before the touchdown to avoid the hard landing.

Necessary corrective training to be given to the involved crew.
