**FINAL INVESTIGATION REPORT OF
IN-FLIGHT ENGINE SHUTDOWN INCIDENT TO
M/s SPICEJET LTD. BOEING B737-8, AIRCRAFT VT-MXA ON
03.05.2022 AT CHENNAI.**

**O/o DIRECTOR AIR SAFETY, SOUTHERN REGION,
INTERNATIONAL CARGO COMPLEX, MEENAMBAKKAM,
CHENNAI-600016**

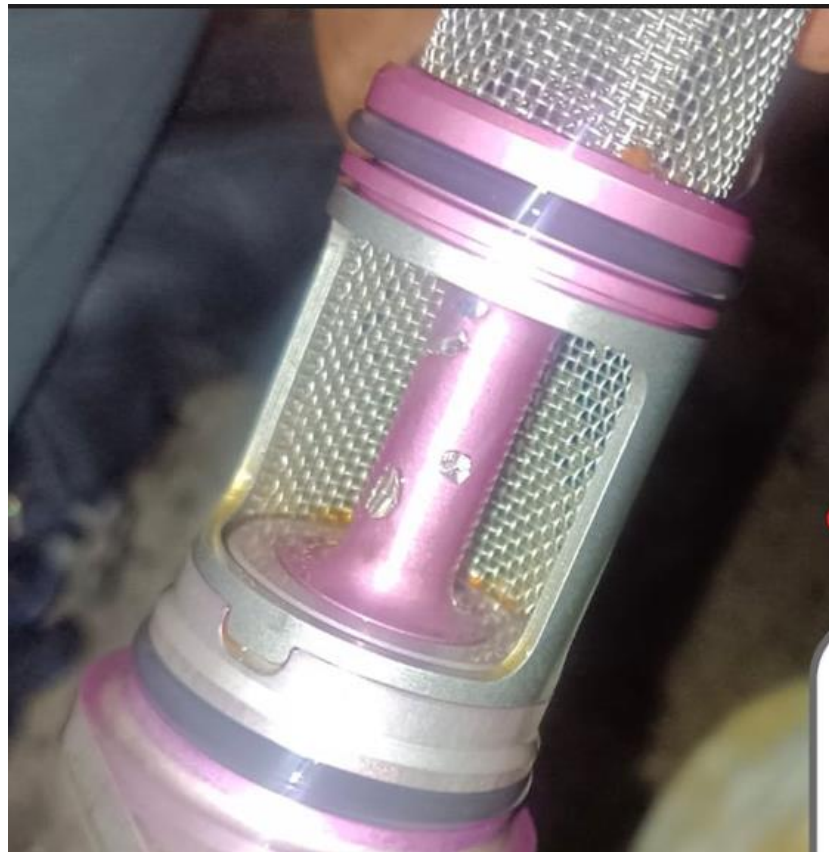
Figure 6: AGB Sump

1. On board maintenance function interrogated and found Flight Deck Effect- (FDE) -: ENG #2 OIL FILTER BYPASS IND with Maintenance Message: 79-42895 CLIMB - OIL FILTER IMPENDING BYPASS ENG#2 ON.
2. Oil quantity Indication and physical level found satisfactory (ENG#1=20, ENG#2=21).
3. No evidence of oil leaks observed upon visual inspection.
4. Engine Air inlet area is clean.
5. Oil Debris Monitoring System (ODMS) sensor inspection carried out and found more metal particles on the magnetic tip. (Refer: Figure 2)
6. Scavenge screens plug inspection carried out & observed that
 - a. Sump A, B, and C - NIL particles observed.
 - b. Accessory Gear Box (AGB) –Sump - found with less metal particles (Refer: Figure 1)
 - c. Transfer Gear Box (TGB) - TGB 1 & TGB 2 sumps– were found with more metal particles (Refer: Figure 3)

On examination of Engine#2 ODMS sensor found metallic debris on the magnetic tip and further on scavenge screen inspection found metallic particles in Accessory Gear Box (AGB) Sump, Transfer Gear Box sumps i.e., TGB1 & TGB2. The involved ENG#2 S.no 602691 was sent to manufacturer facility for investigation.

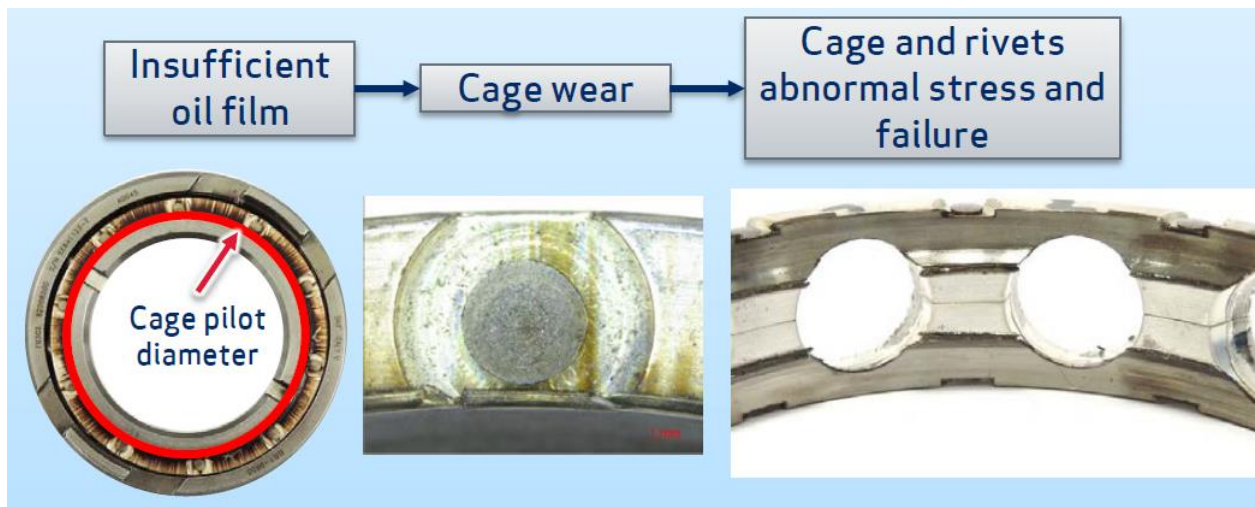
Figure 10: Cage wear (Source: M/s CFM)

1. Cage inner diameter wear mode –

Wear replicated in bearing rig test and the wear progression monitored on an endurance engine showed the cage wear progress was linear and then it slows down.

The above two failure modes were addressed by M/s CFM through Service Bulletins SB 72-0222 & 72-0317 – TGB screen inspections during early life.

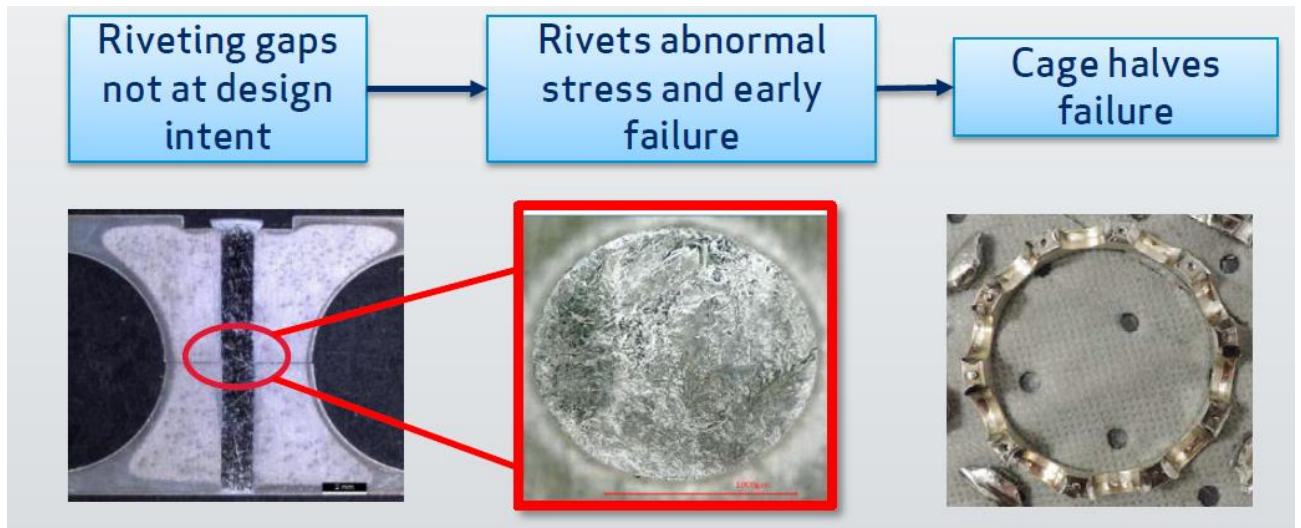
Figure 11: Rivet fatigue (Source: M/s CFM)

2. Rivets fatigue mode –

Fleet engines investigations identified few cases of cage halves assembly not at design intent but the riveting process is human factor dependent. Riveting gaps contribute to rivet abnormal stress, which is a potential early life failure.

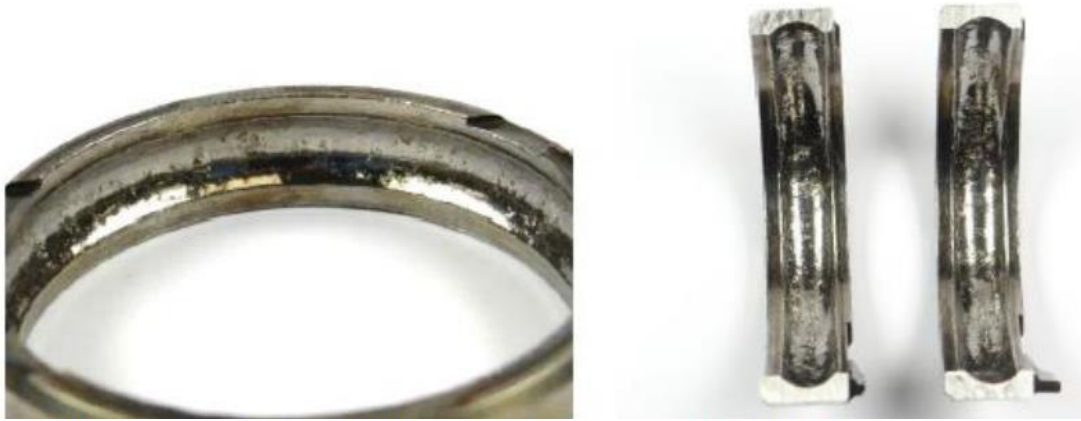
Figure 14: RDS Bearing outer ring Characterization (raceway & shoulders)

- Strong wear and spalling on outer ring raceway with a strain hardening on the surface of the raceway and shoulders over the circumference. The strain hardening covered 1/3 of the total thickness of the ring and shows a second quenching then an over tempering on hardness profiles. Raceway with wear (burrs observed on raceway edges) and spalling all over the circumference.

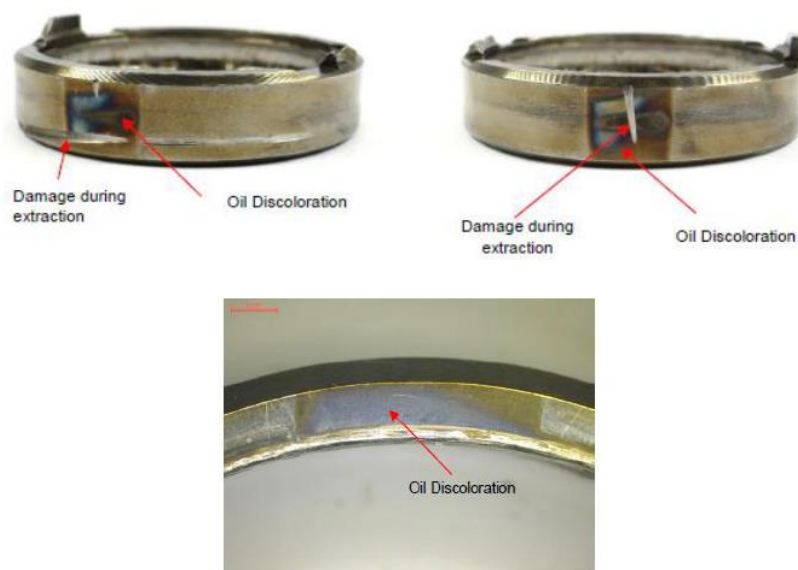
Figure 16: RDS Bearing Outer ring Characterization (Outer ring lateral face, TGB side)

- Overheating signs are also visible on the outer diameter, in regard with the exhaust oil grooves. Rupture of outer ring slots. Blue and brownish strong oil discoloration on the external diameter and the lateral face corresponding to lubrication slot's location.

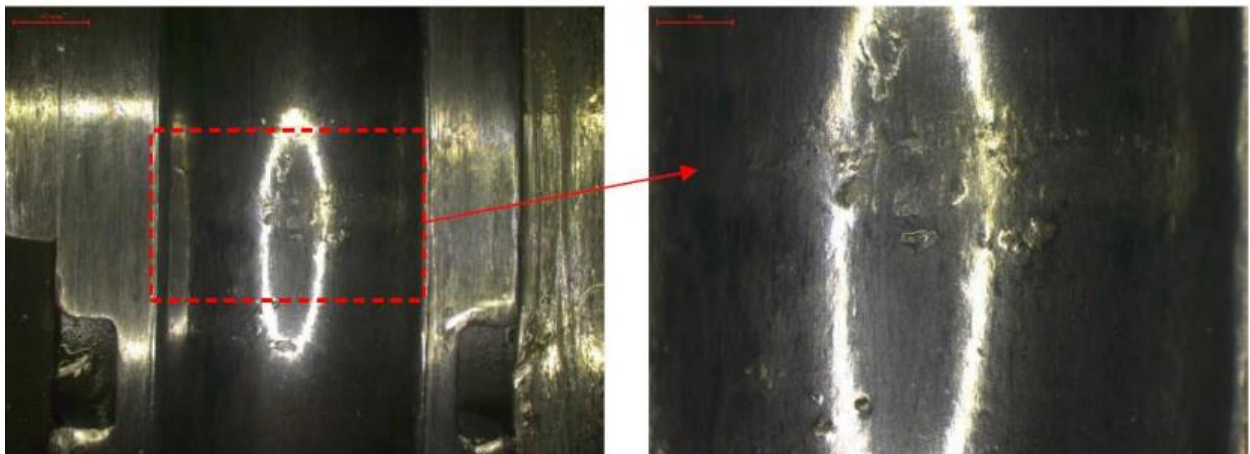
Figure 18: RDS Bearing Inner ring Characterization (raceway & shoulders)

- Global wear over the circumference of the inner ring raceway and presence of linear axial marks on the raceway on 270°, mostly with a spacing like distance between balls. Heavy wear of shoulders and washer.

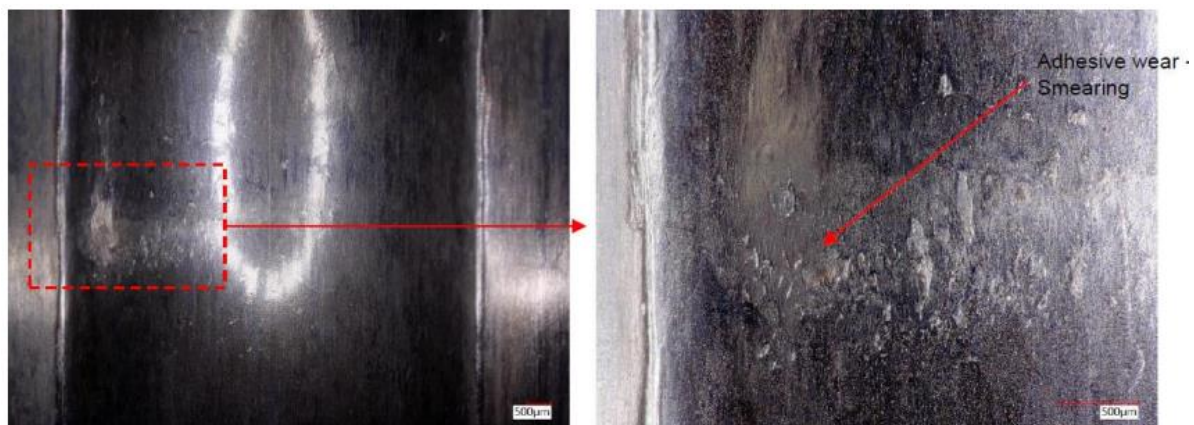
Figure 19: RDS Bearing Inner ring Characterization (raceway details)

- Some (8 or 9) axial marks on the raceway show smearing (adhesive wear probably due to sliding) or spalling next to them. Those axial marks show a strain hardening area on the surface. These deformations take an axial shape on the raceway and are distributed all over the circumference, probably at the ball space. Inner ring expanded by global overheating with loss of shrinking.

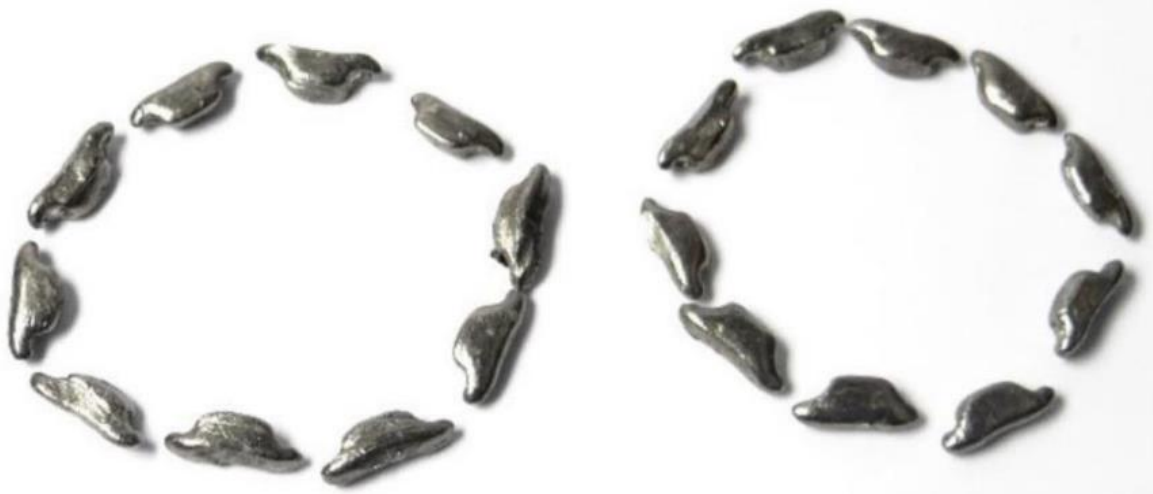
Figure 20: RDS Bearing Cage Characterization (cage fragmented)

- Cage totally fragmented. Heavy wear on each fragment, no fracture surface or pocket surface is still visible.

1. The progressive rupture of the rivets and pockets of the cage and blocking the balls in position.
2. There were inner ring axial marks and sliding all over the outer ring raceway circumference and observed total cage rupture.
3. There was overheating & ball sliding on inner and outer rings.
4. And, secondary spalling on outer ring raceway and balls was observed.

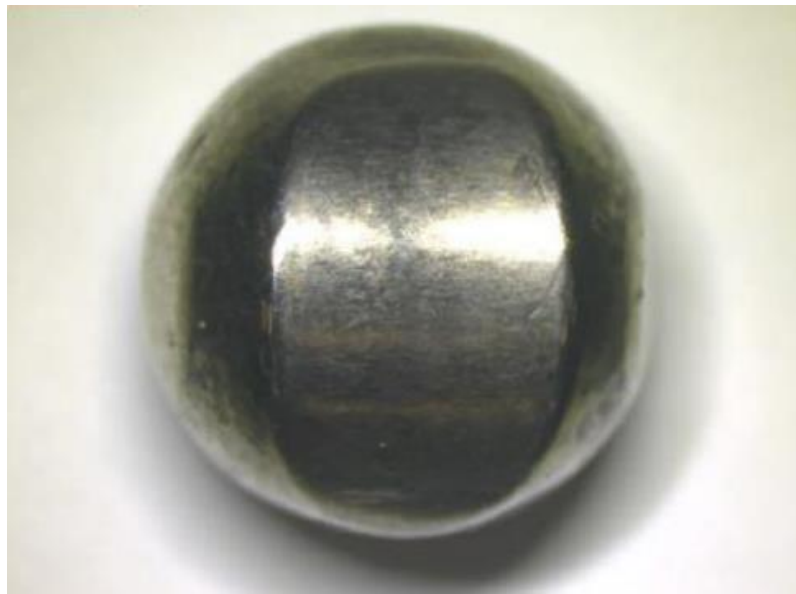
Figure 21: RDS Bearing Ball Characterization (cage fragmented)

- Balls are totally worn, 2 of them up to a cylinder shape. Others with scattered spalling on most of them. Most of the spalling are partially covered due to balls rotation or sliding on raceways.
