**INVESTIGATION REPORT  
ON  
HARD LANDING INCIDENT TO  
M/S SPICEJET LTD, B-737-800 AIRCRAFT VT-SFF  
WHILE LANDING AT  
CHHATRAPATI SHIVAJI INTERNATIONAL AIRPORT, MUMBAI  
ON  
23.09.2020**

**DIRECTORATE GENERAL OF CIVIL AVIATION**  
OPPOSITE SAFDARJUNG AIRPORT, AUROBINDO MARG, NEW DELHI-110003

**INVESTIGATION REPORT ON HARD LANDING INCIDENT TO**  
**M/S SPICEJET LTD. B-737-800 AIRCRAFT VT-SFF AT MUMBAI AIRPORT**  
**ON 23.09.2020**

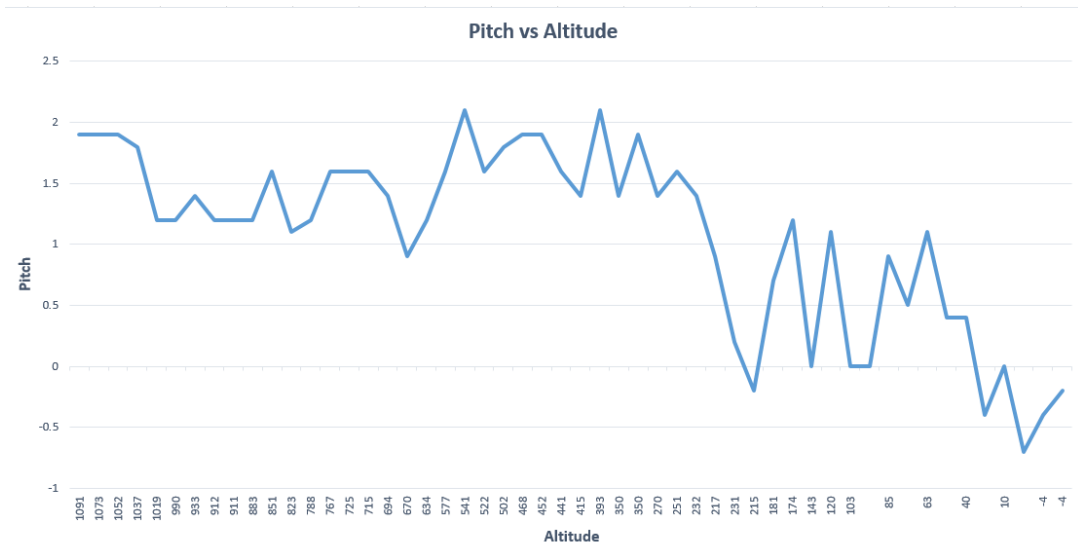
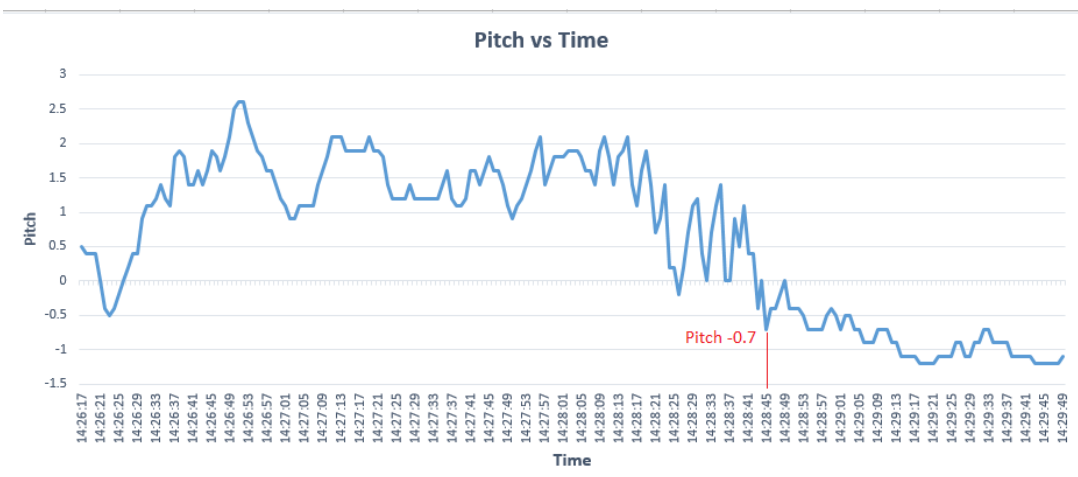
As per DFDR data, the aircraft approach was observed at very low pitch and mostly the aircraft remained in level flight configuration. The approach at low pitch or negative pitch remained continue below 100 ft RA and maximum pitch recorded was 1.1 for a fraction of second. Before touch down the aircraft was in nose down tendency and at the time of touch down the pitch input changed from -0.7 to +0.4 which was also very low. No flare was observed before allowing the aircraft to touch down. As per Flight Data limits defined by the operator touchdown with pitch below 0.5 is classified as amber exceedance and pitch below 0.3 is classified as Red exceedance.

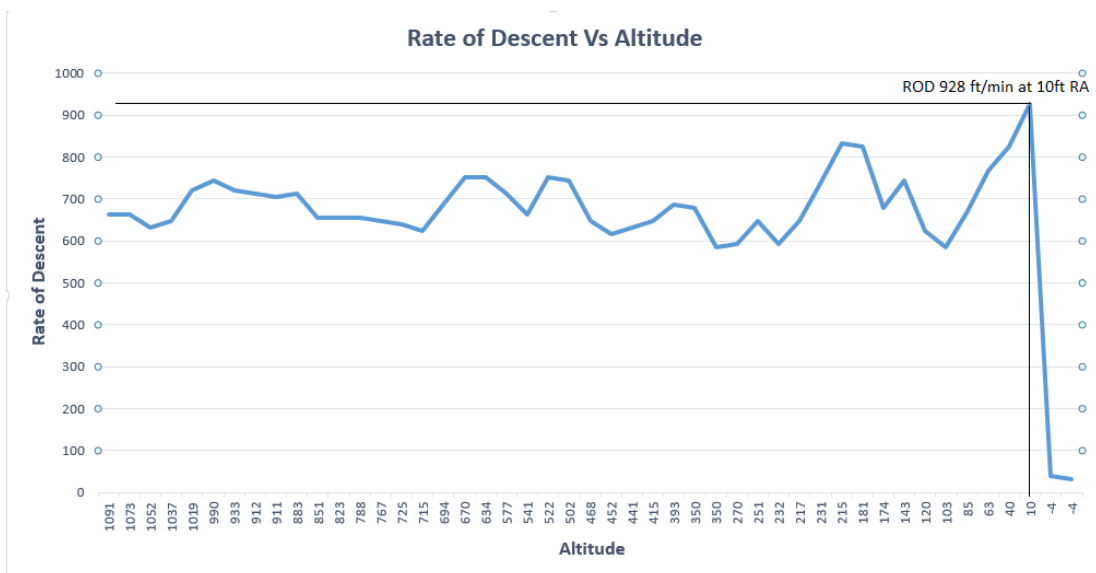
An increase in rate of descent was also observed from the flight data below 100ft RA. The maximum rate of descent was recorded 928 ft/min just before the touchdown.
