ACCIDENT TO SAHARA INDIA AIRLINES
B-737-200 AIRCRAFT DURING THE TRAINING
FLIGHT ON 8.3.1994 AT IGI AIRPORT, DELHI

REPORT OF
THE
COURT OF INQUIRY

BROAD DETAILS OF THE ACCIDENT TO SAHARA INDIA AIRLINES
B-737-200 AIRCRAFT DURING THE TRAINING FLIGHT ON 8.3.94
AT IGI AIRPORT, DELHI.

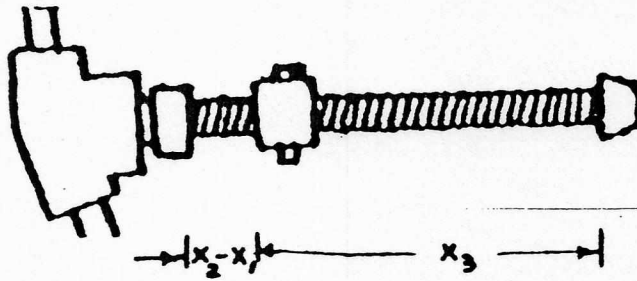
The system consists of four flaps, two on each wing which are operated hydraulically through mechanical transmission. Each flap has two flap screw jacks. Thus there are a total of eight flap screw jacks.

Three flap screw jacks (No. 6, 7 and 8) on the starboard wing were found intact. No. 5 flap screw jack, which was not intact, was identified from the part number. Three screw jacks (No. 1, 3 and 4) were identified from their orientation and attachment. No. 2 flap screw jack could not be located. The measurement of various recovered screw jacks of accident aircraft, as recorded, are given below;-

Jack No.	1	2	3	4	5	6	7	8
Dimension-	X2-X1			25.25		25.258		
	(inch)							
	X3	5		6		7	6.25	4.6
	(inch)
