**FINAL REPORT ON RUNWAY EXCURSION INCIDENT
TO
M/s. INTERGLOBE AVIATION LIMITED AIRBUS A 320 AIRCRAFT,
VT-IFN
ON 12.09.2022 AT AHMEDABAD**

**GOVERNMENT OF INDIA
OFFICE OF DIRECTOR AIR SAFETY (WESTERN REGION)
INTEGRATED OFFICE, NEW AIRPORT COLONY, MUMBAI-400099**

FINAL INVESTIGATION REPORT ON LATERAL RWY EXCURSION TO M/s. INTERGLOBE AVIATION LIMITED, AIRBUS-320 AICRAFT VT-IFN AT SARDAR VALLABHAI PATEL INTERNATIONAL AIRPORT, AHMEDABAD ON 12.09.2022

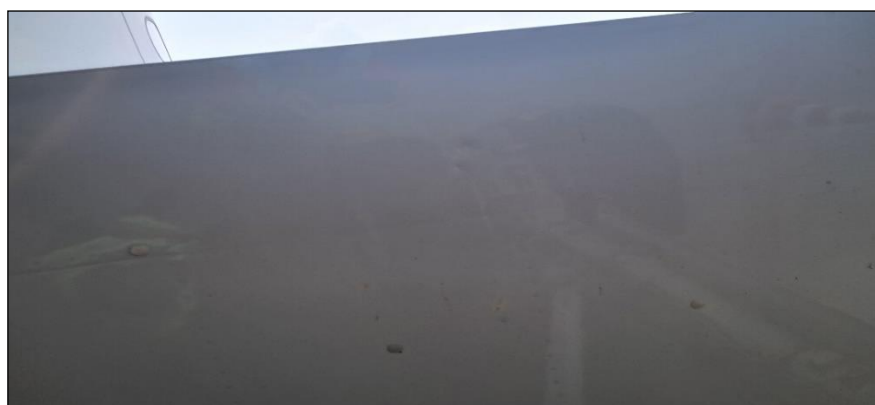
Figure 1

- 02 dents observed on RH inboard flap trailing edge, same within AMM limit (figure 1).
- Observed multiple cuts on #2 nose wheel assembly, however damage within AMM limit (figure 2).
- 02 dents observed in belly area, same within AMM limit (figure 3).

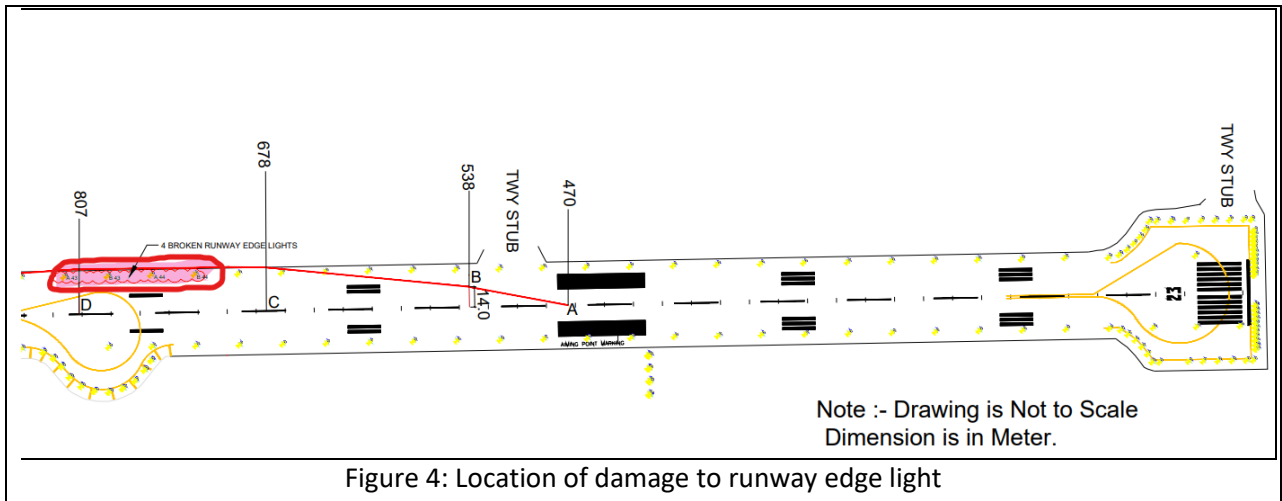
time simultaneously the Nose wheel went over the runway edge lights and damaged 04 runway edge lights(refer figure 4) B44,A 44, B43 and A43. (Refer figure 5, 6, 7 & 8).

00:46 – 01:30 IST; On Runway inspection it was found that total no. of 04 runway edge lights were found broken (A-43/44 & B-43/44) and found tyre marks on edge of runway shoulder and same has been informed to ATC that it will take 30 minutes approximately to rectify it. Immediately informed to electrical department to rectify the lights and same has been informed to Head Ops/Head Airside and CAO. Runway Lights were rectified, replaced and cleared FOD at 01:30 IST.

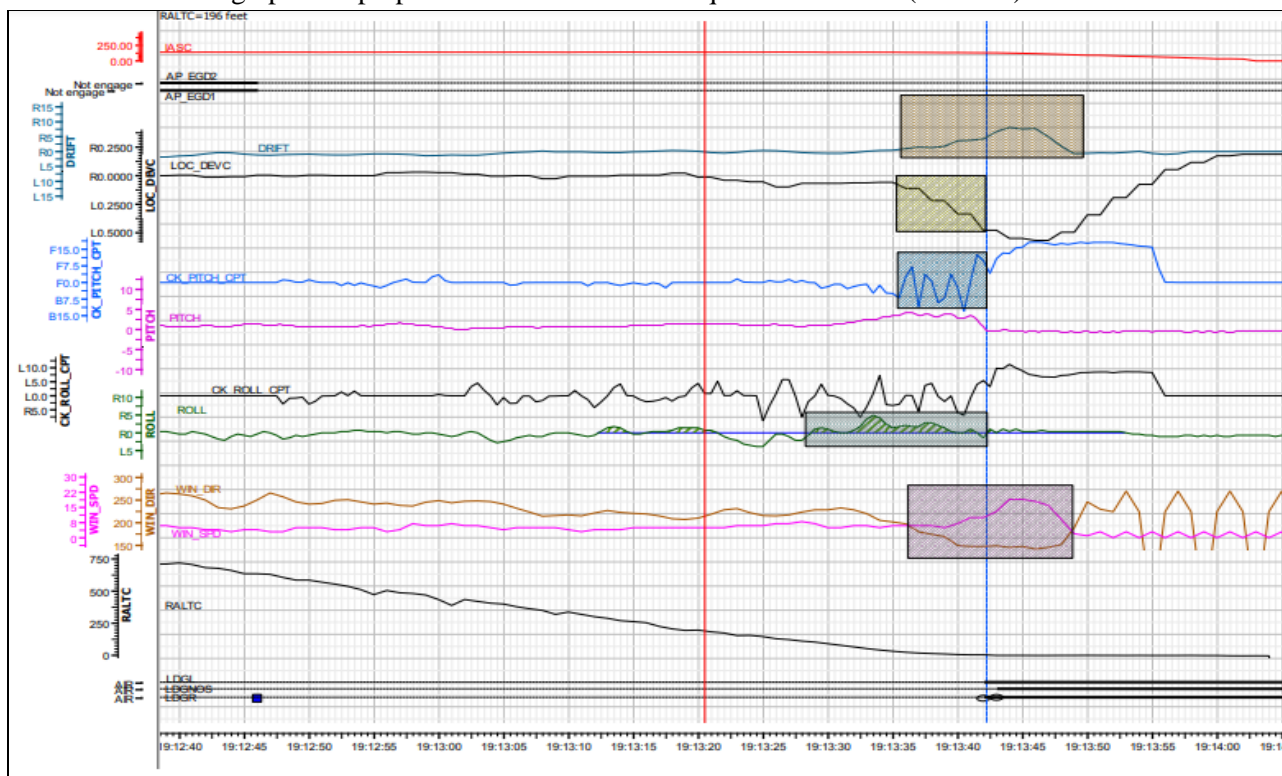
As observed from the highlighted areas, there is a significant right roll (event 1) observed prior to the flare at 19:13:35 UTC .Further during the initiation of flare at 19:13:38 UTC, 4 events are observed simultaneously, i.e, the winds start to abruptly change directions with increasing strength(event 2),Nose up and nose down pitch is seen applied 3 times(event 3), Localizer indication shows aircraft moving to right of runway centerline(event 4) and aircraft drifting towards right of runway centerline(event 5) . From the above it is evident that there was a right roll input given which has resulted in the aircraft drifting towards the right after 3 seconds, also confirmed by the localizer indication inputs. It is simultaneously that the gusty cross winds from left starts changing direction with increasing strength and the nose up and down pitch inputs are observed. This continues till touchdown and subsequent 4 seconds after touch down.

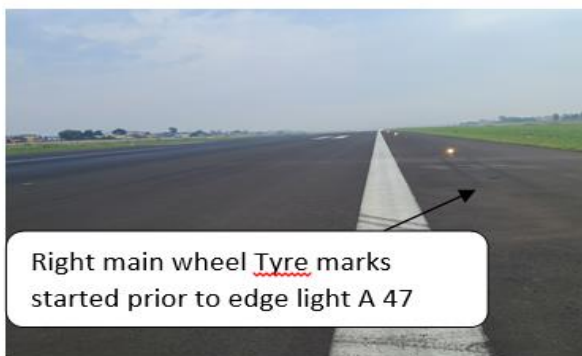
Fig 9

- The aircraft touched down at the right side of the RWY 23 beyond Aiming point (400m) and just before touch down zone 2 (600m) as its Starboard wheel tyre first marking started seeing approximately 538 m from RWY 23 threshold and 22 m laterally away from runway centerline, where the tyre is first crossing the runway edge line and rolled exactly over the runway edge light A 47 without damaging the light. (refer fig 9)

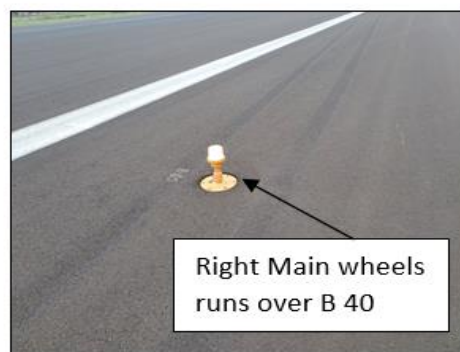
fig 10

- Simultaneously, the adjacent 4 edge RWY lights (B44, A44, B43, A43) had been damaged by the Nose landing gear wheels going over.
- VT-IFN right main wheel after entering into the paved surface rolls over the B 40 edge light towards the center line of the runway (refer fig 10).

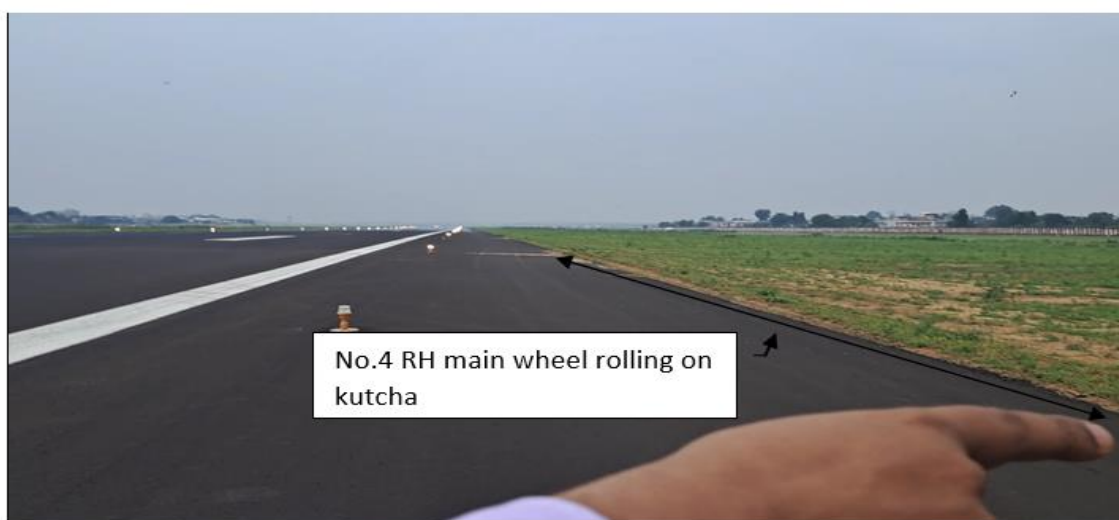
Fig 11

- On 12.09.2022, the aircraft touchdown at RWY 23 of Ahmedabad Airport and tyre Markings and 04 runway light damages were observed and their measurements are with the reference to RWY 23 threshold. Total landing distance available at RWY 23 was 3505m.

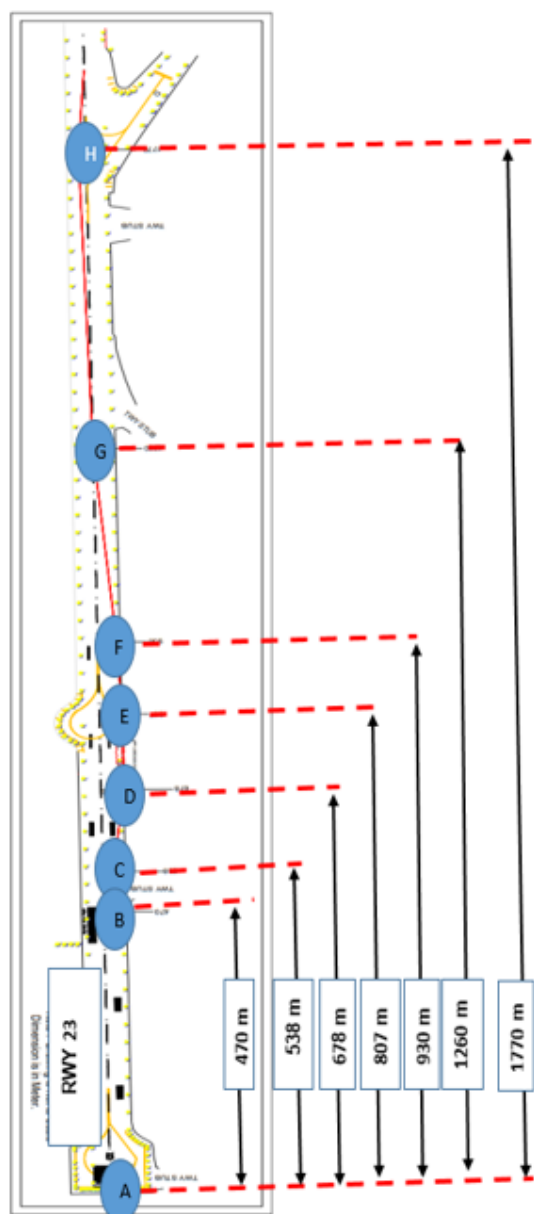
Illustration of the entire track followed by the aircraft on runway

H- 1770 m from threshold is the point where the right main wheel are observed reaching to a maximum of 10 m left side of the runway centre line. Further the aircraft has come back to the centre line.
G- 1260 m from threshold is the point where the Right main wheel are observed crossing over the runway centre line.
F- 930 m from the threshold is the point where and Right Main wheel tyre marks observed rolling over the RWY edge light B40 without damaging and moving towards centre line.
E- 807 m from threshold is the point where the aircraft right main wheel no.4 enters back to the paved surface. Meanwhile, when the aircraft right Main wheel rolled between Point D and Point E, the Nose wheel has broken the Runway edge lights B 44, A 44, B 43, A 43.
D- 678 m from threshold is the point where the aircraft right main wheel no. 4 has exited the paved surface
C- 538 m from threshold is the point where the aircraft touch down is registered(Landing gear compressed) and Right Main wheel tyre marks observed(22 m lateral distance from centre line) which subsequently rolls over the RWY edge light A 47 without damaging.

B- 470 m from threshold is the point wherein the aircraft has started floating very close to runway surface and RA is shown as "-ve" value in DFDR.
A- Runway 23 threshold of Ahmedabad Airport (Reference for all measurements)
