SYNOPSIS:

On 7th May 2017, M/s. Jet Airways Boeing 737-700WL aircraft VT-JGY Operating service 9W-730, sector Delhi to Patna, while taxiing on Taxiway 'Z' to 'Z3' holding point for Runway 29, hit with the another aircraft of M/s. Jet Airways Boeing 737-700WL aircraft VT-JGX Operating Service 9W-603, sector Delhi to Srinagar which was on taxiway 'Z4' short of holding point Runway 29 at around 0930UTC.

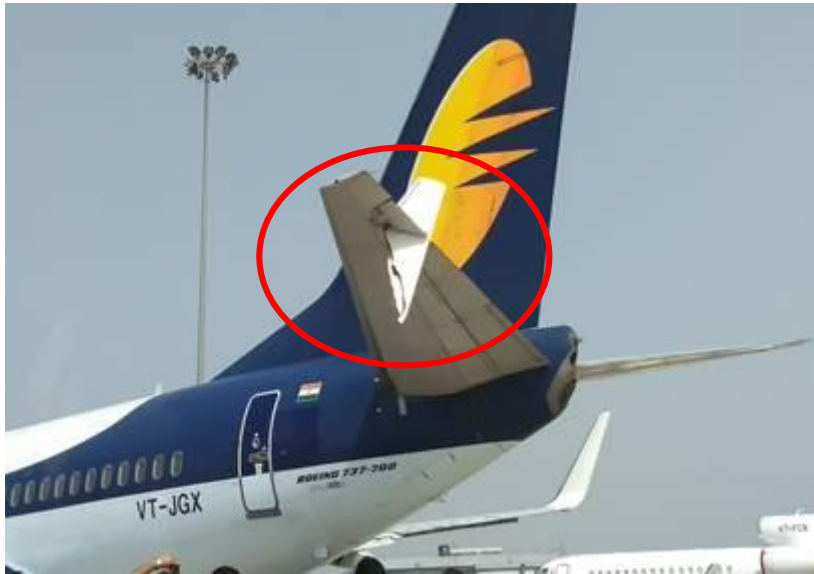
VT-JGX's LHS elevator got damaged and few scratches found on lower spar skin and LH stabiliser leading edge. Winglet of VT-JGY's more than half portion of the upper side got damaged and detached.

Fig.1:- Detached portion of winglet of VT-JGY intact with the elevator if VT-JGX

RH winglet more than half upper portion of wing tip got detached and stuck in the elevator of VT-JGX.

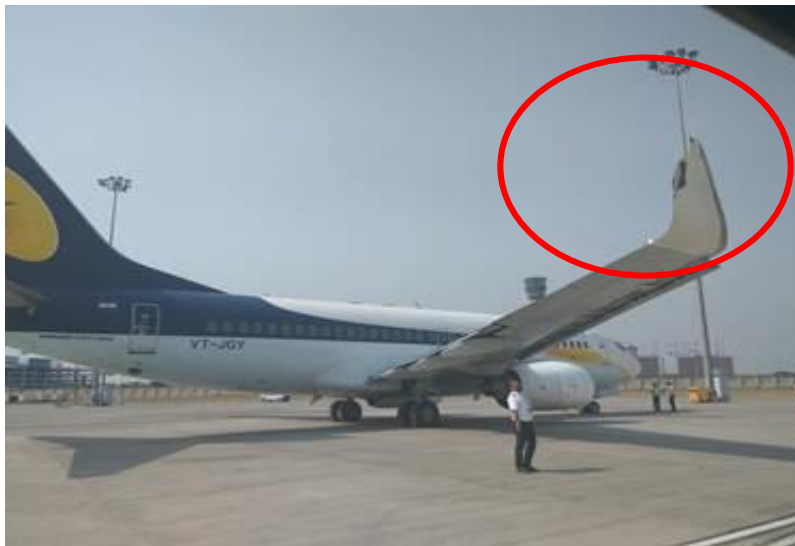
Fig.2:- Damaged winglet of VT-JGY

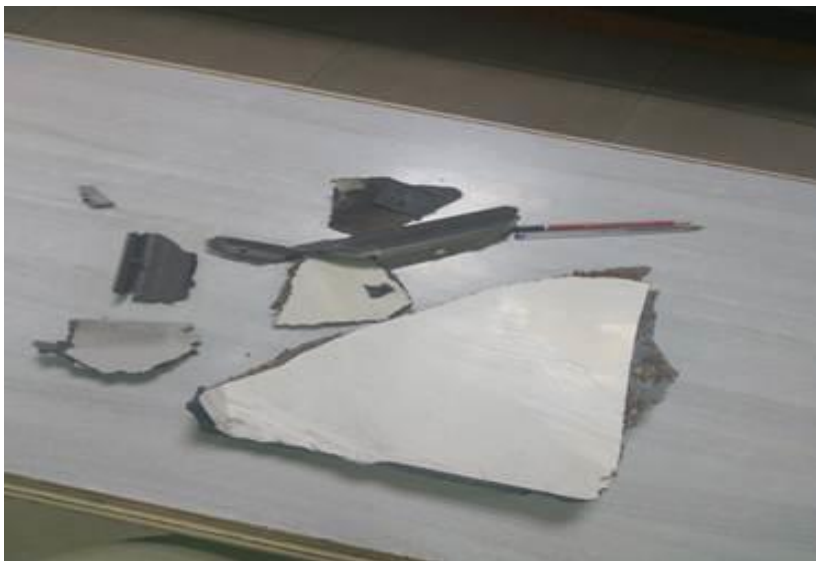
Fig.3: Debris collected from Taxiway

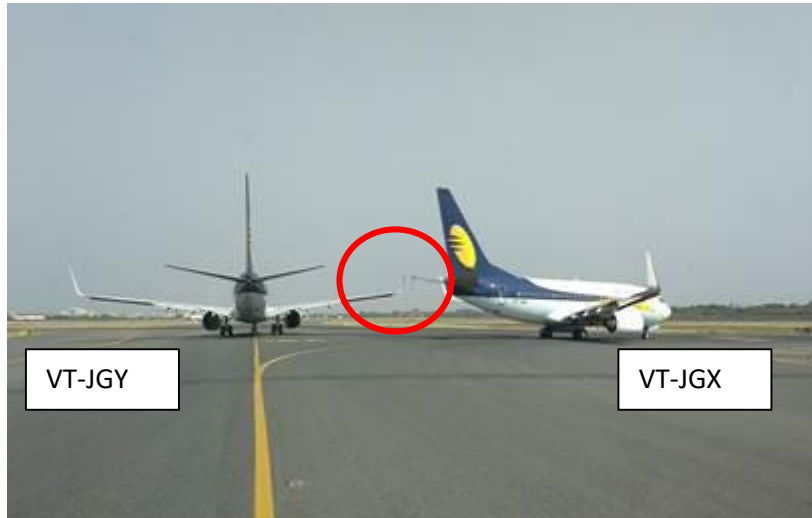
Fig.4: Rear view of VT-JGY and VT-JGX position from Taxiway Z (post incident)

From the photographs it could be noticed that the aircraft VT-JGX was offset to the right of its track and not exactly on the holding point. DFDR of VT-JGX also confirms that the final heading of the aircraft was 180Deg.

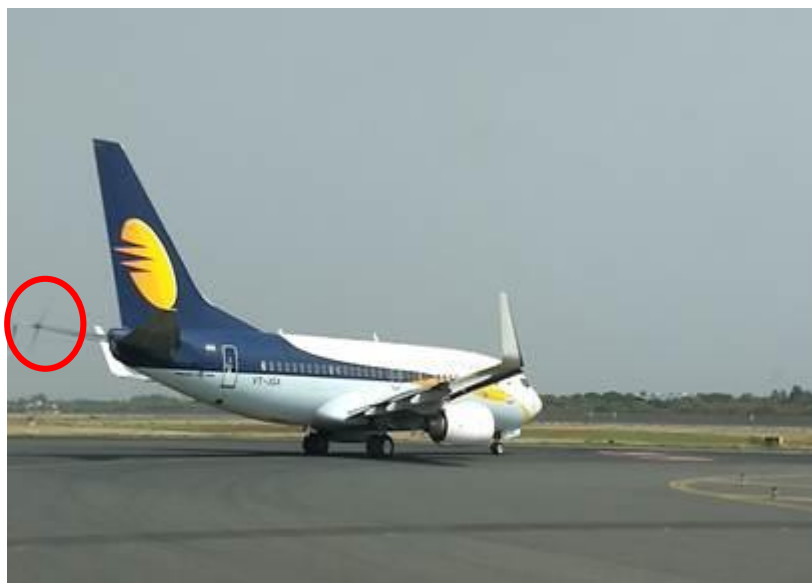
Fig.5: side view of VT-JGX holding position (post incident)

8. Ground controller gave all the instructions as per the existing NOTAM and proper guidance was provided to the departing aircrafts.
9. VT-JGX was holding on Taxiway Z4 little short of Runway 29 and at an angle offset to right and VT-JGX crew could see the runway holding point stop bar i.e. the aircraft

was not exactly on the holding point and which was holding well behind the holding point.

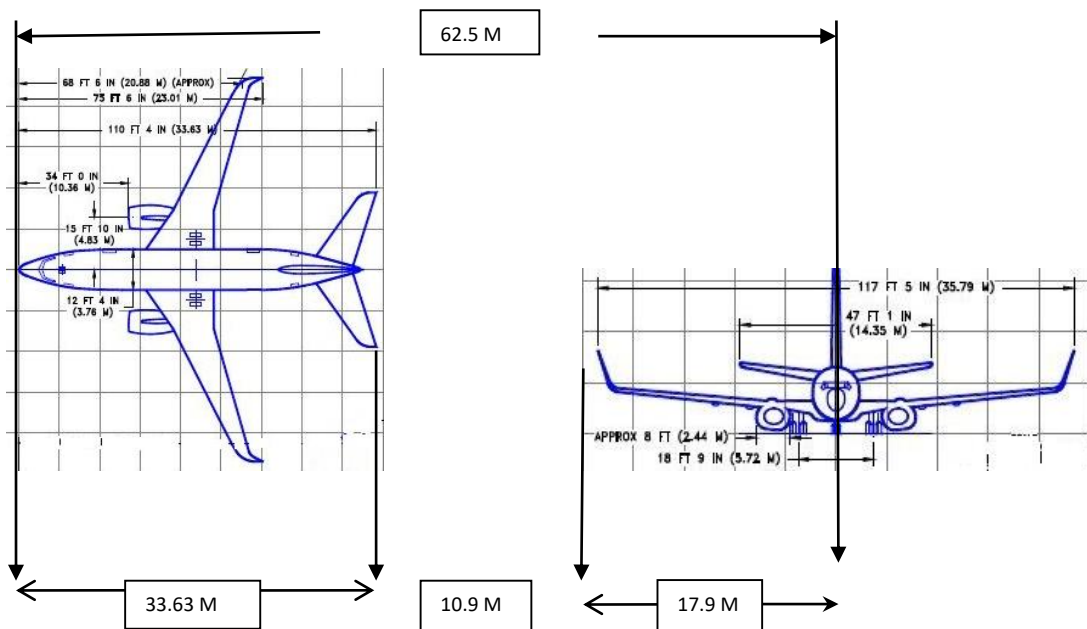
Aircraft clearance between both the aircraft of similar type were checked and observed that had it been the first aircraft, ie, VT-JGX, exactly on the holding point, the second taxied aircraft, ie., VT-JGY, might have got wing tip clearance of 10.9m.

From the actual measurements, the distance between, taxiway 'Z4' holding point and taxiway 'Z' centreline found as 62.5meter. As calculated under 1.17 paragraph, had there been VT-JGX was exactly on the holding point, there would have been enough (approx. 10.9 meter) clearance existed.

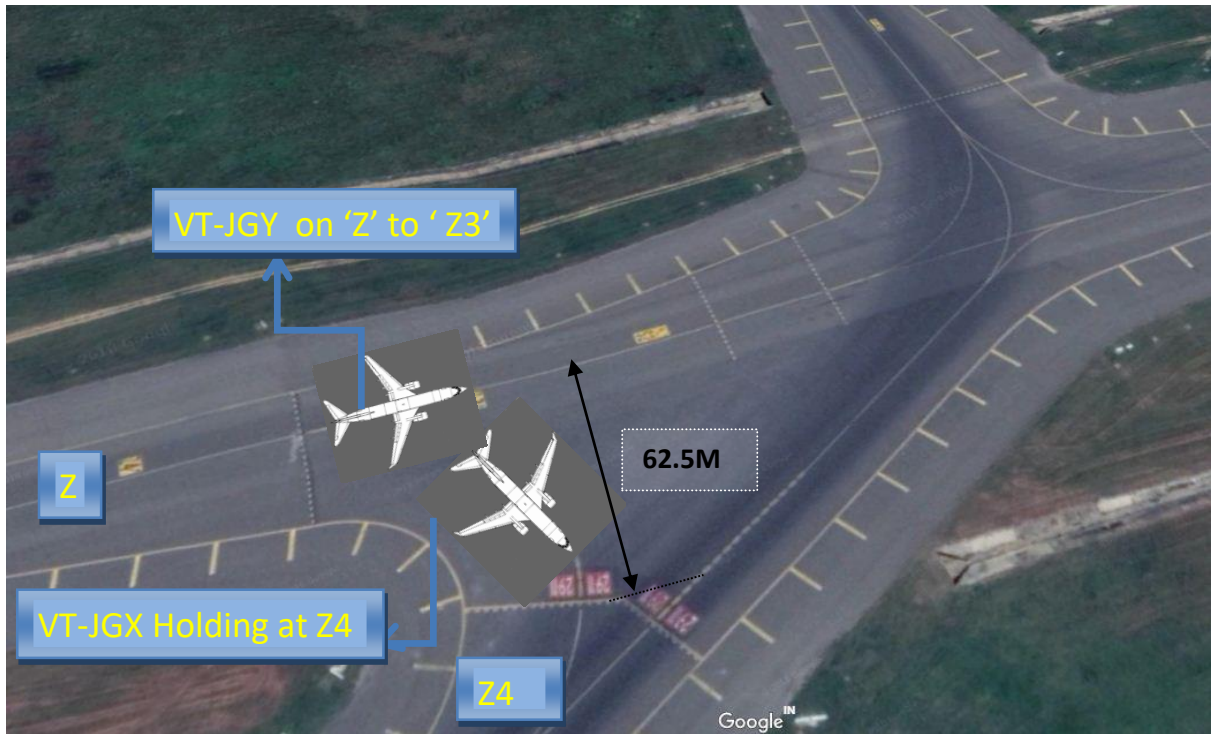
Measurement of taxiway of Z, Z4.

As stated earlier, the actual distance measured between Taxi way centreline and Z4 holding point marking was 62m. As VT-JGX was having length of 33.63m, the remaining distance available was approximately 28m for taxing aircraft on taxi way Z. However, as per the ICAO DOC9157, Table 4.1, the minimum separation required is 26m. This indicates that the aircraft VT-JGX was holding well ahead of the Z4 holding point and there was no required clearance available to VT-JGY to taxi.
