REPORT
OF
THE COMMITTEE OF INQUIRY

ACCIDENT INVOLVING INDIAN AIRLINES
DORNIER AIRCRAFT VT-EJW
AT KOCHI
ON
30th July, 1998

Decision of Government of India on the report of the Committee of Inquiry which investigated accident to Indian Airlines (SHOD) Dornier aircraft DO-228 VT-EJW at Kochi on 30th July, 1998.

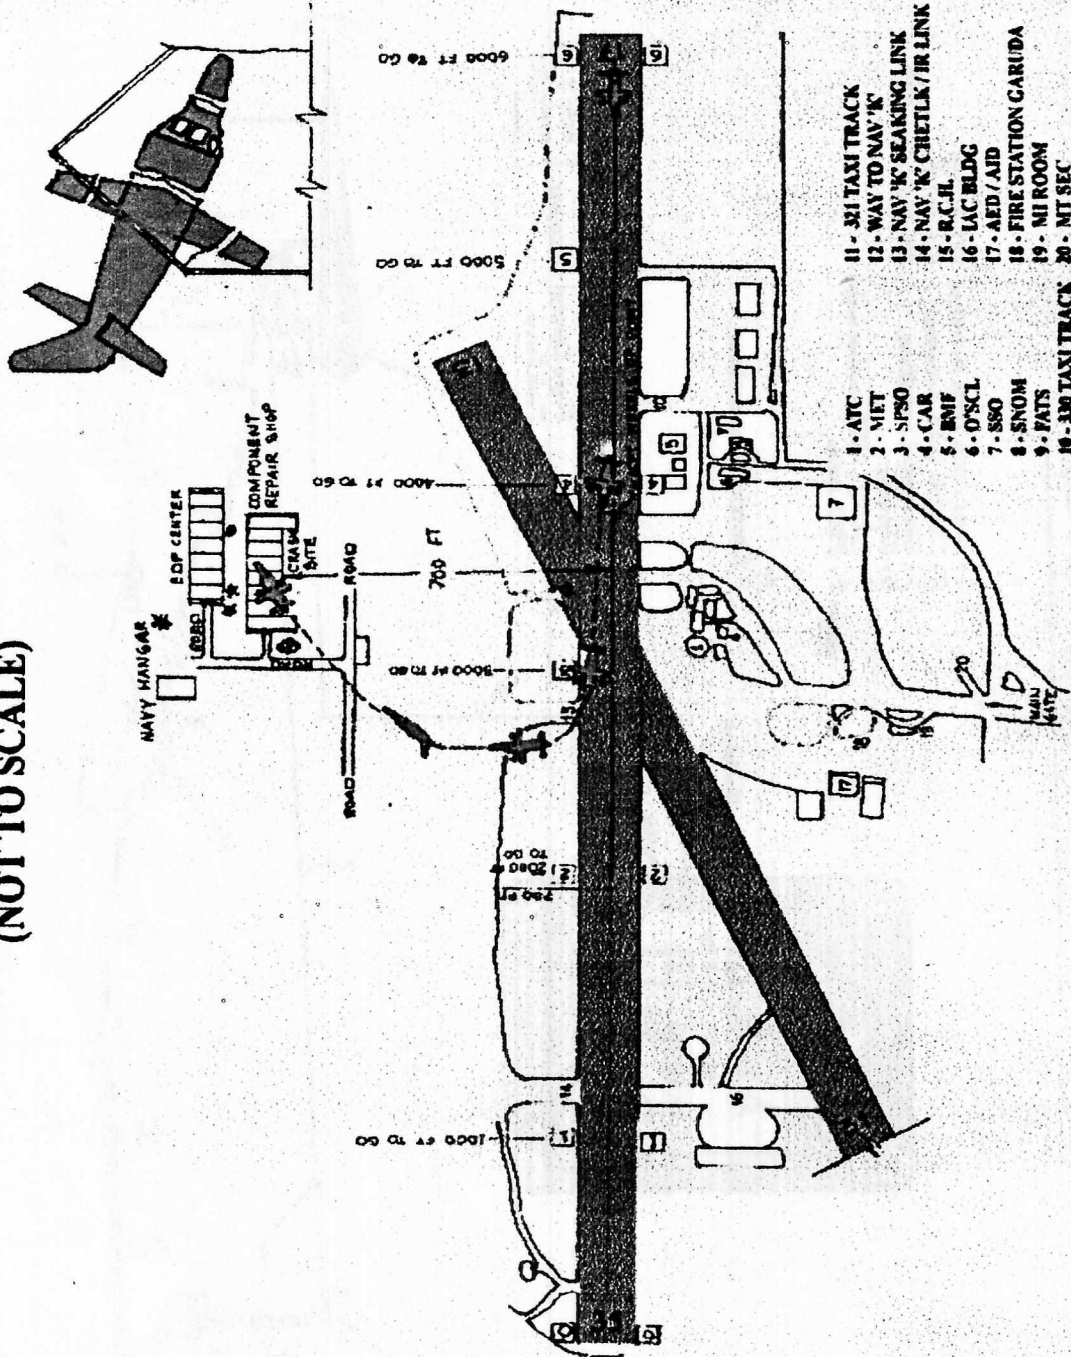
SKETCH SHOWING CRASH SITE
(NOT TO SCALE)

1.12.1 The aircraft crashed on a heading of 290° on the roof of the CRS of the NAY(K) located at a distance of about 700' to the right of RWY 17. The sides of the CRS building had high buttresses approx. 7-8 ft. higher than the highest point of the roof. The aircraft caught fire after impact with the CRS building and the entire wreckage was confined at one location only in the building. There was no damage to the trees and buildings surrounding the CRS building. The final position of the aircraft wreckage indicated that the aircraft had nose dived into the CRS building at an angle of about 20° . The tail portion of the aircraft was up in the air on top of the roof at a height of about 30' (Refer Photograph 1). The sketch showing the crash site is at Annexure 2.
