**INVESTIGATION REPORT ON INCIDENT TO
M/s SPICEJET LTD. BOEING 737-800 AIRCRAFT, VT-SZM
ON 23.07.2021 AT YEREVAN - ZVARTNOTS
INTERNATIONAL AIRPORT, ARMENIA**

**GOVERNMENT OF INDIA
DIRECTORATE GENERAL OF CIVIL AVIATION**

**Investigation Report on incident to M/s SpiceJet Ltd. Boeing 737-800 aircraft
VT-SZM at Yerevan, Armenia on 23.07.2021**

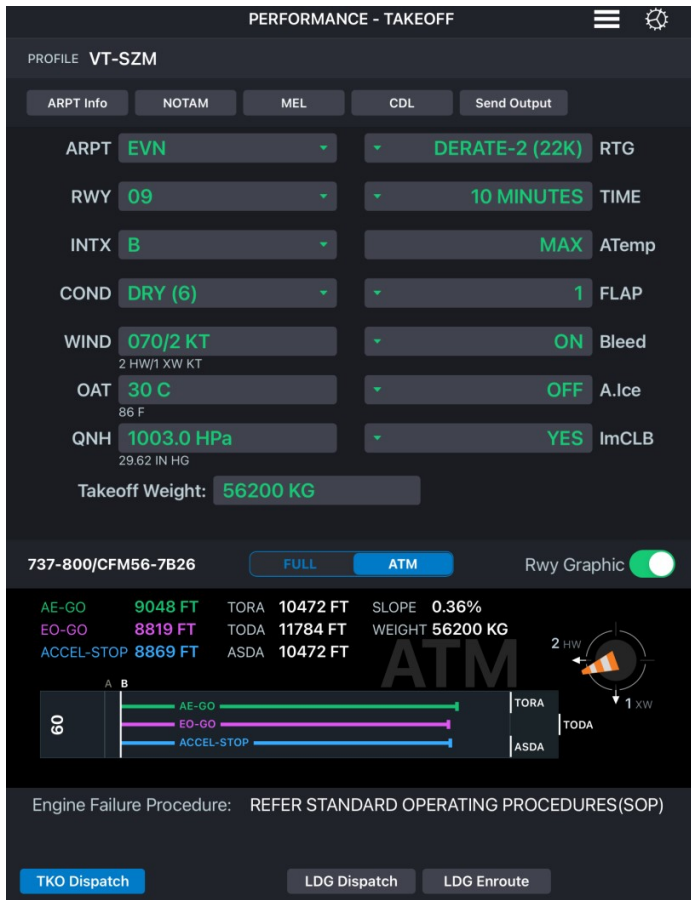
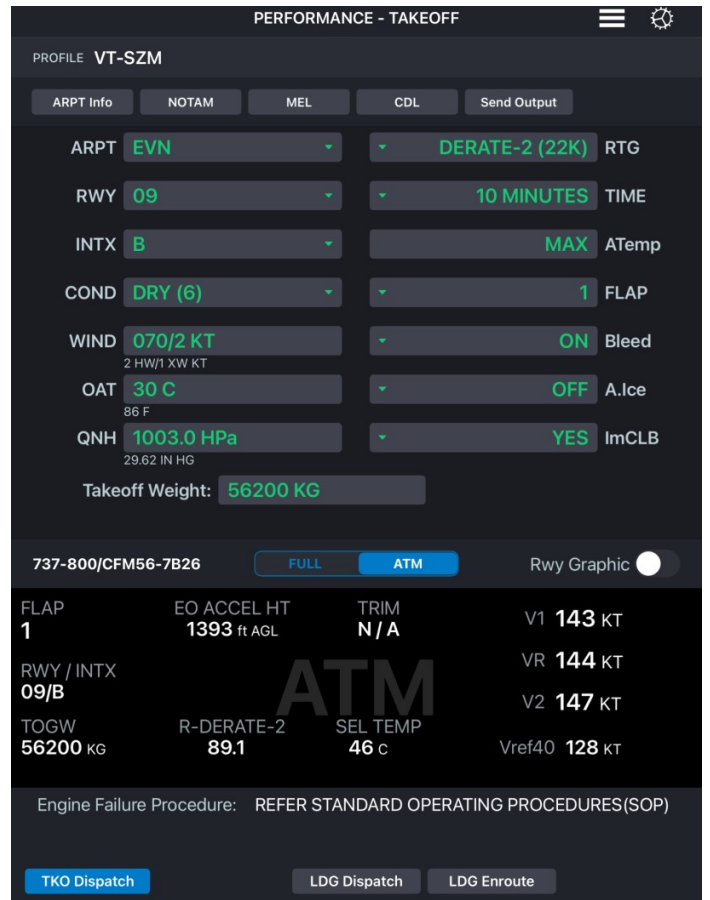
OPT input data and its output used for take-off from Yerevan (UDYZ)

14. The TWY 'B' RWY09 intersection departure with selected configuration (Derate#2) did not meet performance requirements for a safe take-off, rejected take-off or continued take-off following an engine failure. The required distance to balanced decision speed (V_1) was 5817ft; required distance to V_R was 6001ft and distance required for a safe rejected take-off was 8869ft.

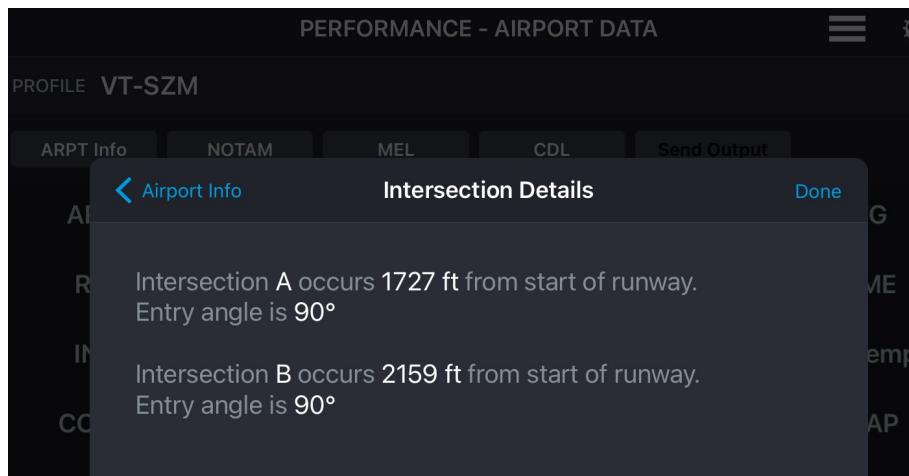
Runway intersection details indicated in OPT

It can be seen that the output also gives a 'Rwy Graphic' representation. This indicates the declared distances for the selected runway and taxiway intersection, along with relative locations of the taxiways.

- Error in configuration of the OPT tool, i.e., the location of TWY 'B' - RWY 09 intersection was erroneously configured in the OPT data which resulted in TWY 'B' being indicated as a viable option for departure to the operating crew.
- Lack of awareness of the aerodrome layout due to inadequate review of the aerodrome chart by the flight crew.

1. Airport data for EVN airport has been revised to remove the RWY 09-B intersection departure in the Boeing OPT application.
2. The performance engineer who prepared the EVN airport database for OPT and the performance engineer who crosschecked the EVN airport database for OPT have been subjected to corrective training for points detailed in findings and cause.
3. Necessary corrective actions have been taken on the operating crew w.r.t points detailed in findings and cause.

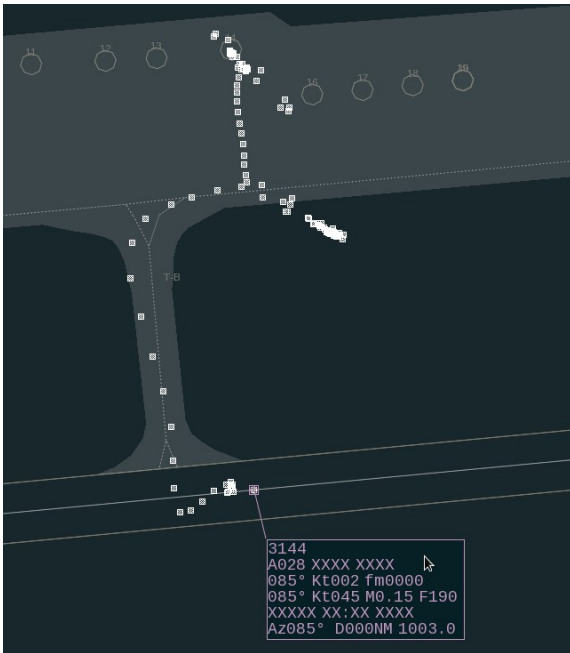
Radar playback image indicating position of SG9029 at beginning of take-off run (11:49:40 UTC) after line-up on RWY09 from TWY B intersection.

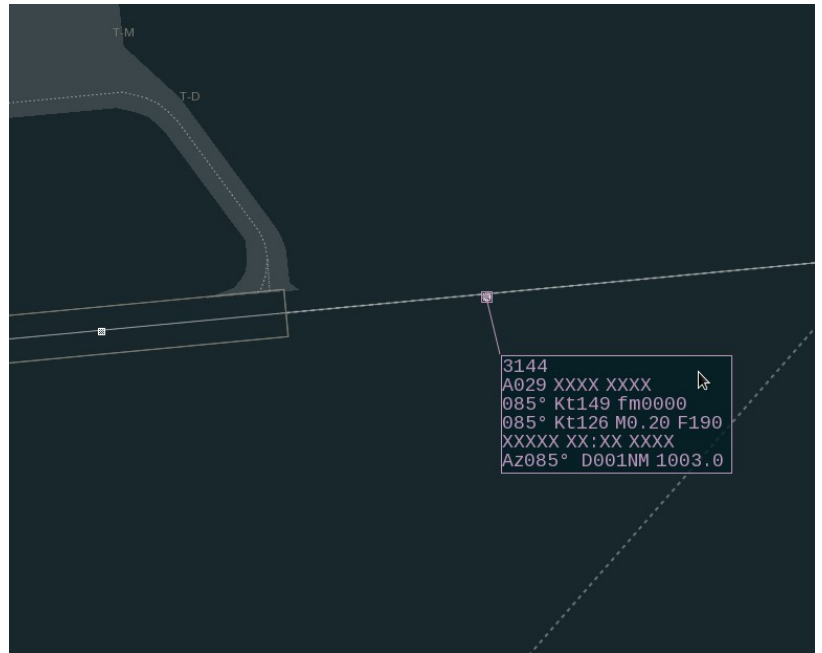
Radar playback image indicating position of SG9029 (11:50:12 UTC) at liftoff beyond TORA of RWY09.
