FINAL INVESTIGATION REPORT

**INCIDENT OF RUNWAY EDGE LIGHT DAMAGE BY M/s SPICE JET
B-737-800 AIRCRAFT VT-SYI AT KOLKATA ON 02-07-2019**

O/o Dy. Director General of Civil Aviation (ER)

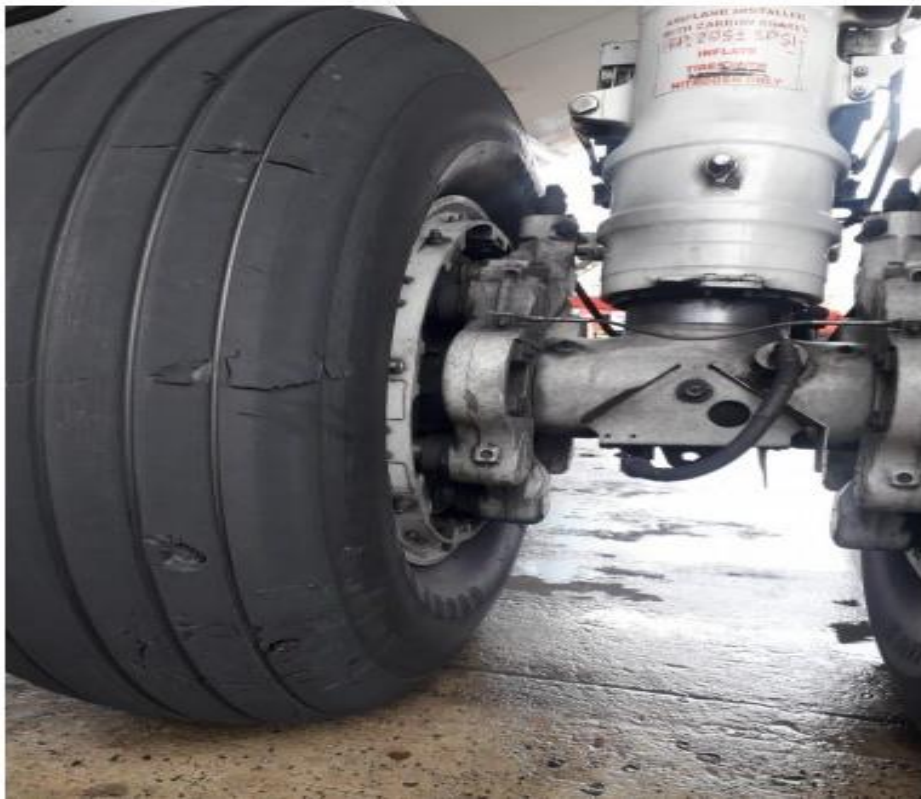
1.3 Damage to the Aircraft: There were cut marks on several places on No. 03 and 04 tyres of the RH main wheel. The bearing cover of No. 02 main wheel was found damaged.

Cut Marks on no.3 main wheel tyre

Following was the rectification carried out on the aircraft before release, “Noted, on T/S found #2 MWA bearing and tube cap damaged, and #3 & #4 MWA tyre having multiple cut marks. None tyre found deflated. External visual inspection carried out on Engine and fuselage, found no damage. DFDR & CVR down loading carried out. Found ‘g’ value 1.5 at roll angle 7. Hard landing / Overweight landing inspection carried out as per AMM 5-51-01 Phase -1A & 1B. Found no damage. Both 1& 2 MWA replaced. Wheel #2 brake replaced. #3 & #4 MWA replaced. AMM 32-45-11 & 32-41-41.”

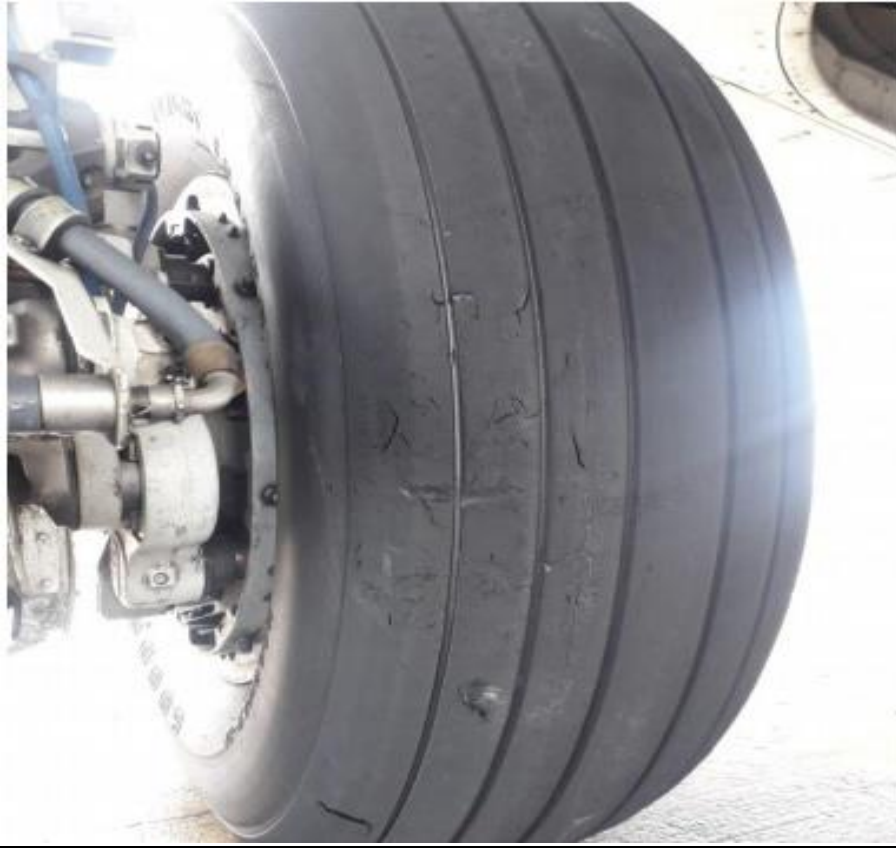
Cut Marks on no. 4 main wheel tyre.

the runway. As all cut marks on tyres were confined to main wheel no. 3 and no. 4; it implied that main wheel no. 3 and no. 4 only damaged the runway edge lights.

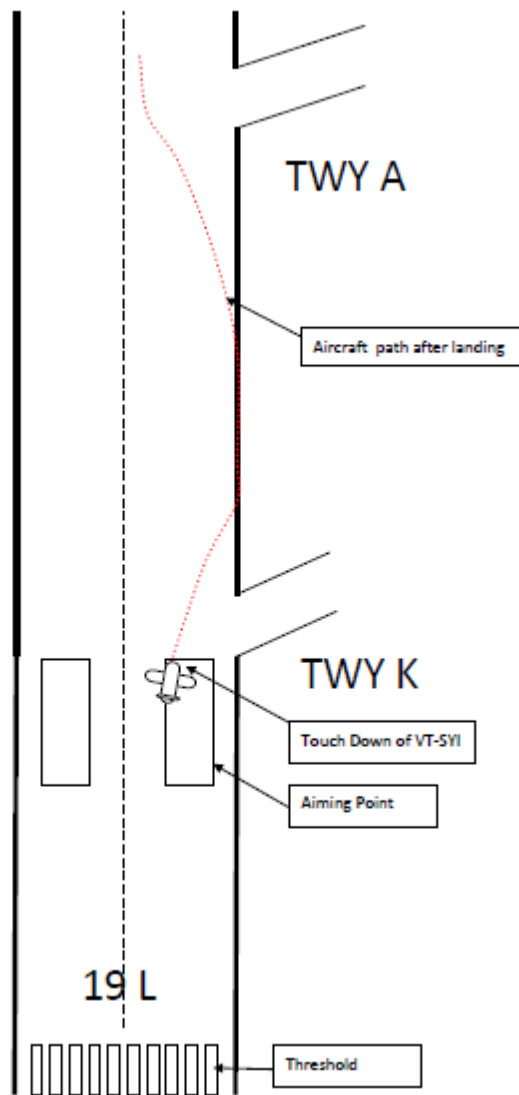
3.1.6. The aircraft touched down on runway near 'Aiming Point' marking on the right hand side abeam taxiway 'K' which is close to the right edge of the runway.

3.1.7. The aircraft landed with an effective heading of 188.81°. At this heading, the aircraft rolled obliquely towards right edge of the runway.

Schematic Diagram of the touchdown and landing roll of the aircraft VT-SYI.

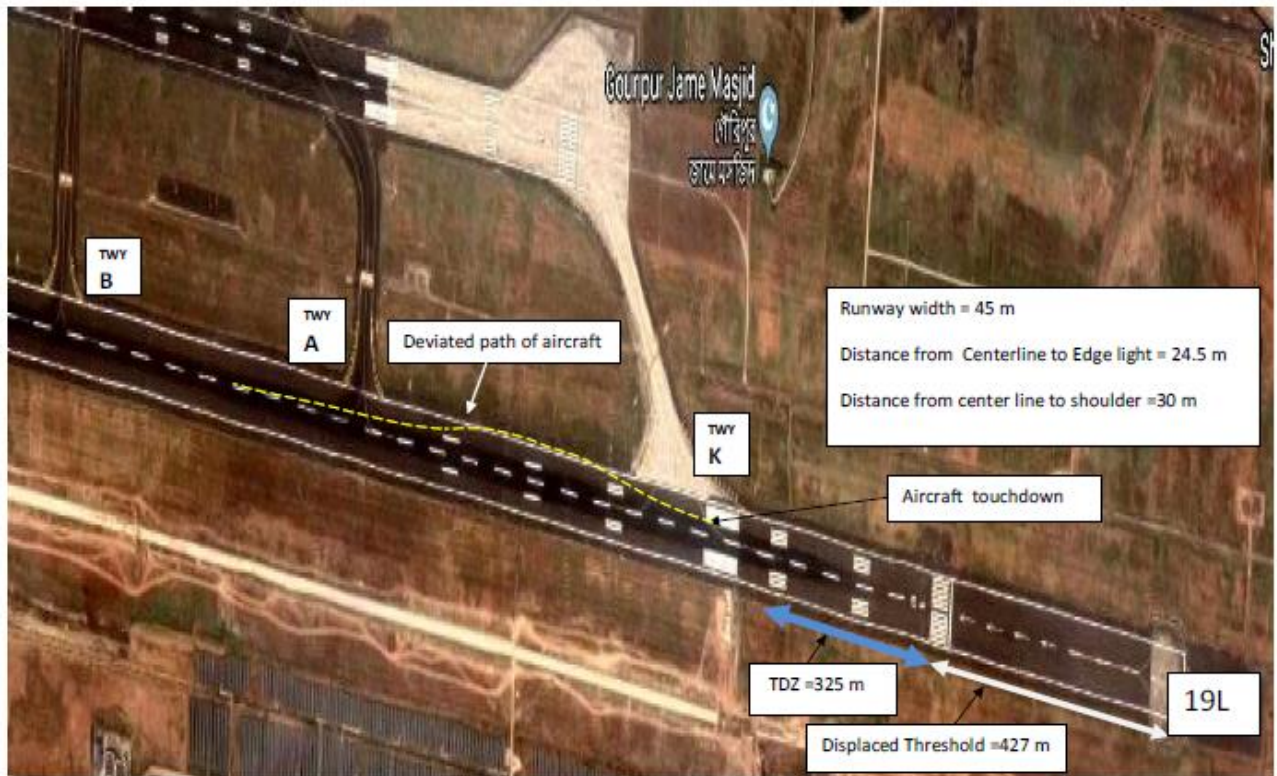
1.19.1 Advanced Surface Movement Guidance & Control System (ASMGCS) replay was analysed. It was observed that the aircraft touched down near taxiway 'K' and after touchdown it continued to roll towards right edge of runway. Its heading was gradually becoming parallel to the runway centre line and the aircraft rolled on the right outermost edge (shoulder) of the runway. It rolled on the right shoulder of the runway between taxiway 'K' and taxiway 'A'. After crossing taxiway 'A', the aircraft came on centreline of the runway.

Deviated path of aircraft VT-SYI after touchdown on runway 19L of Kolkata
(Deviation from centreline shown by yellow dashes).

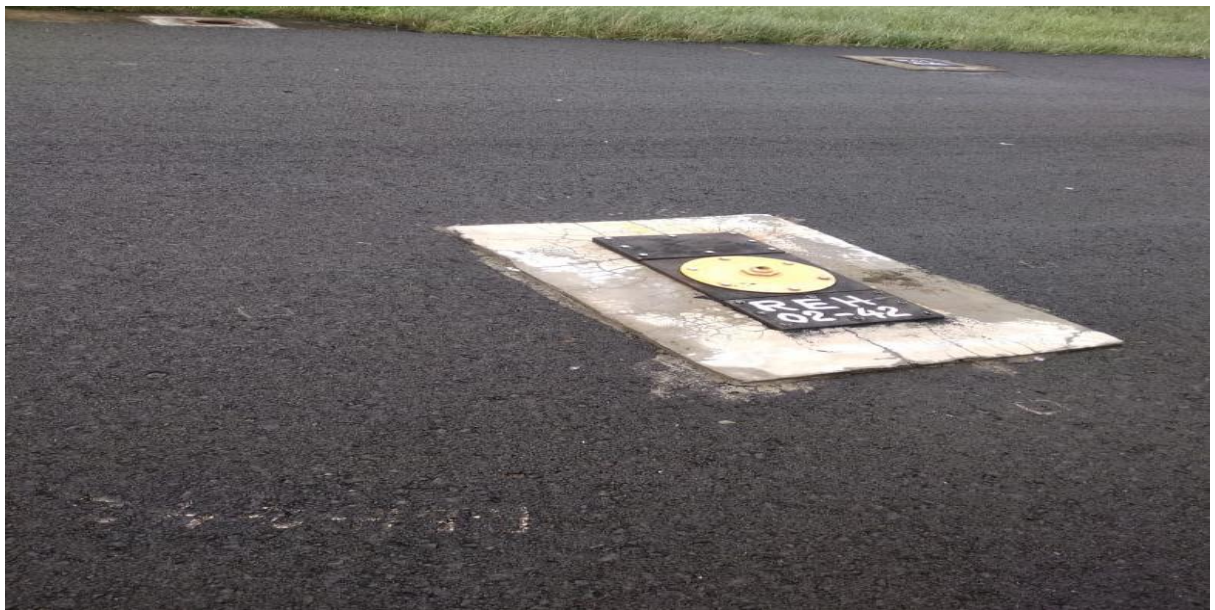
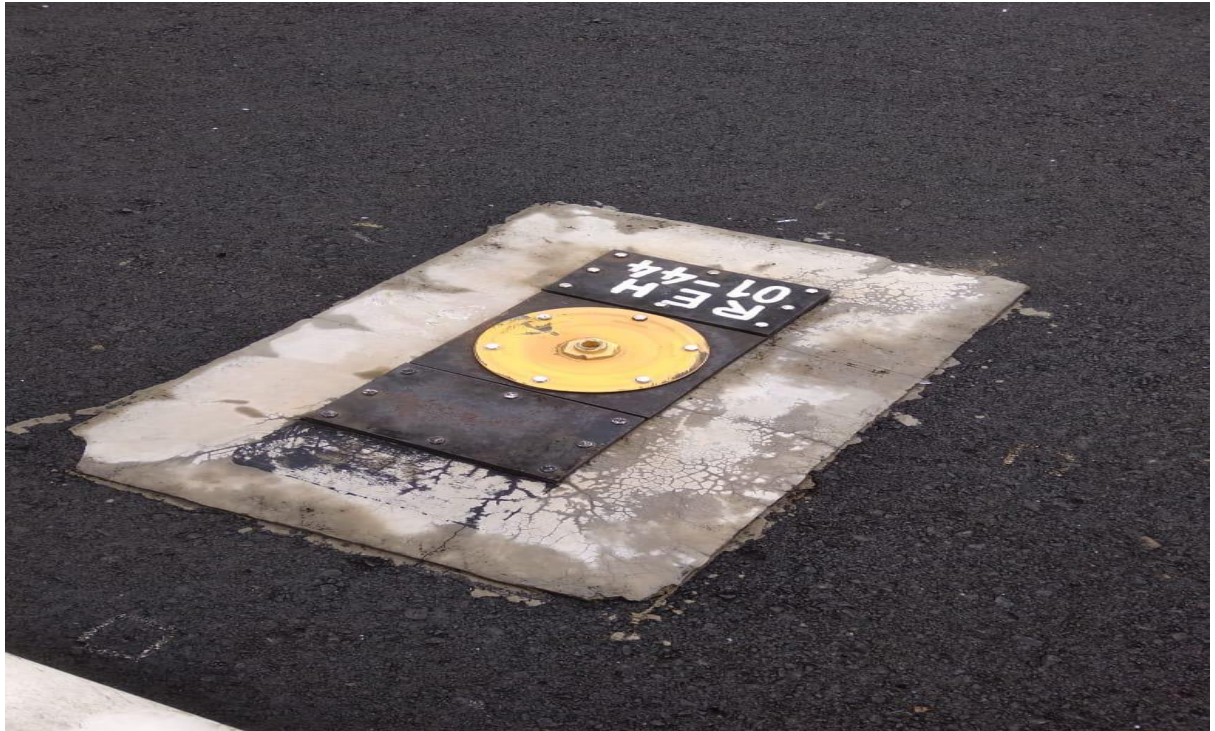
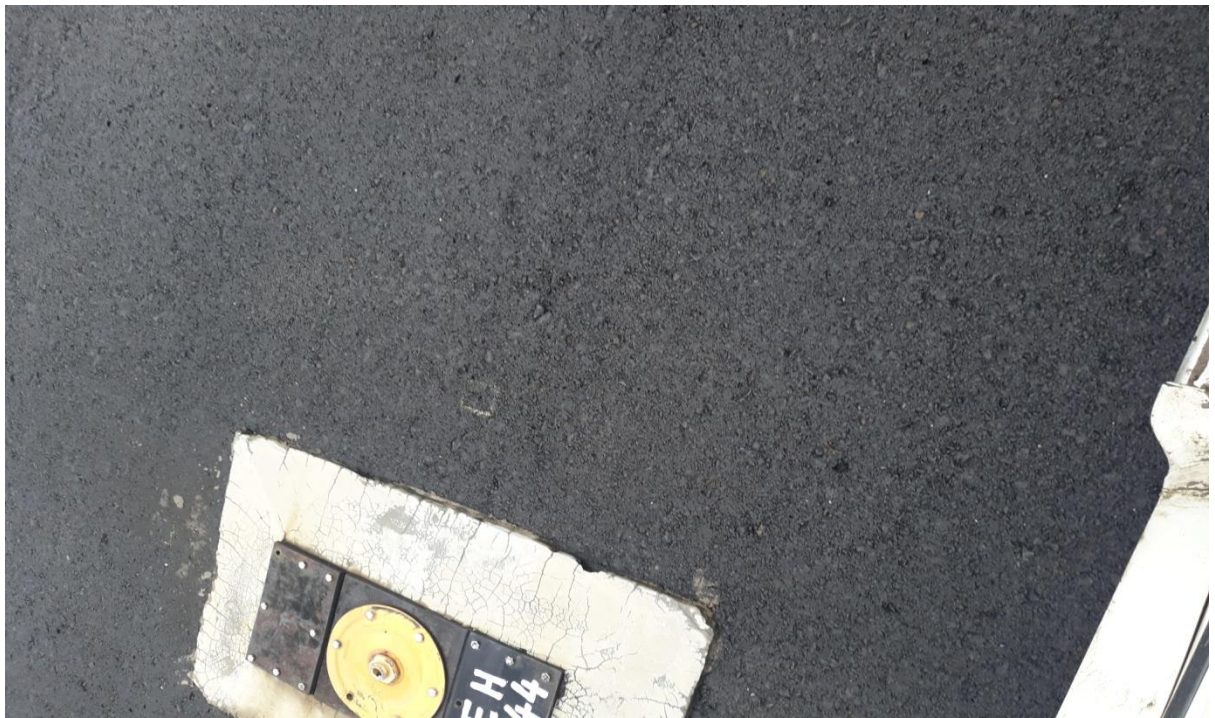
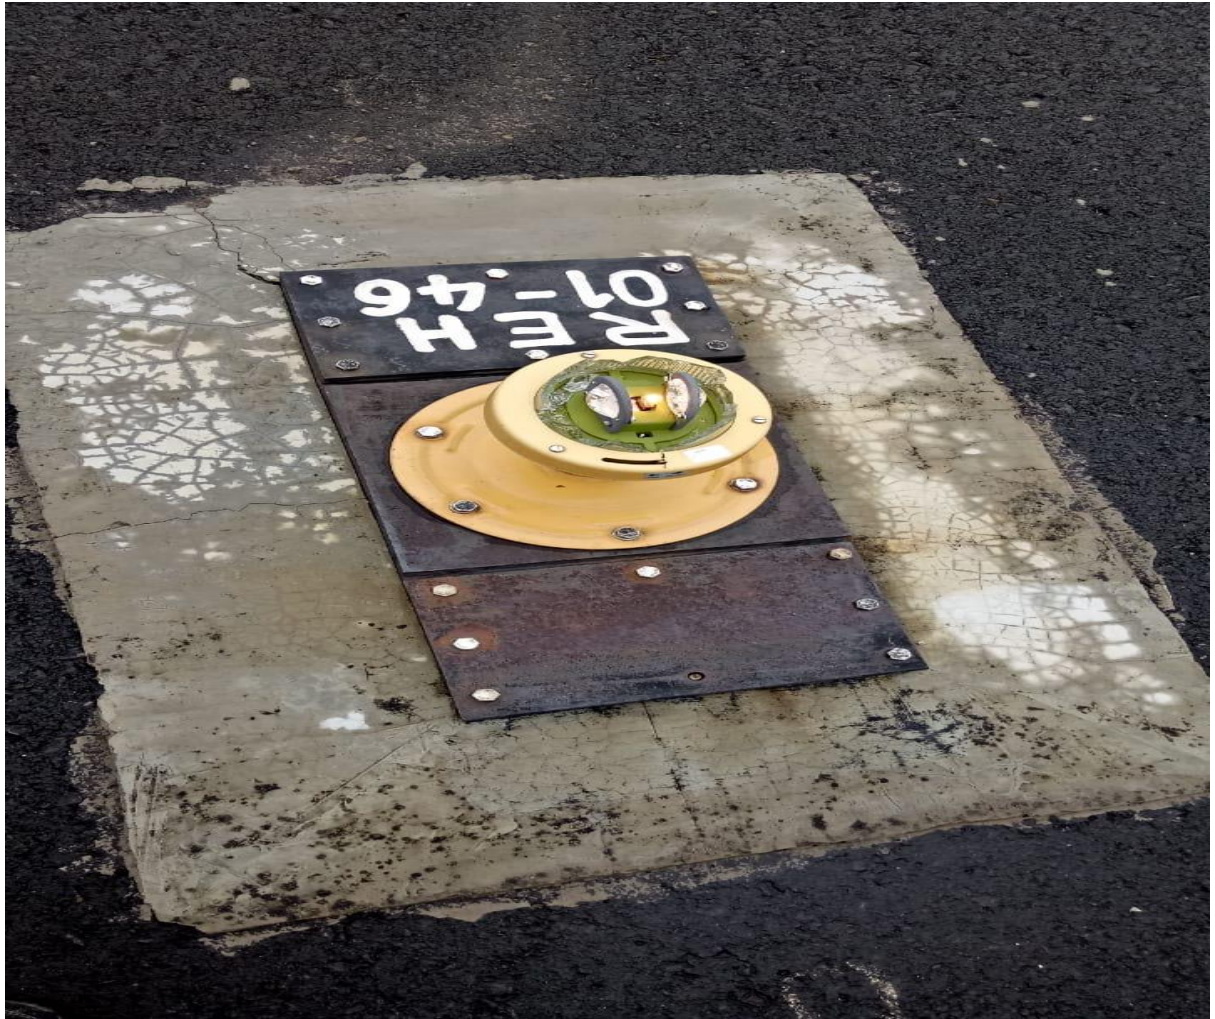
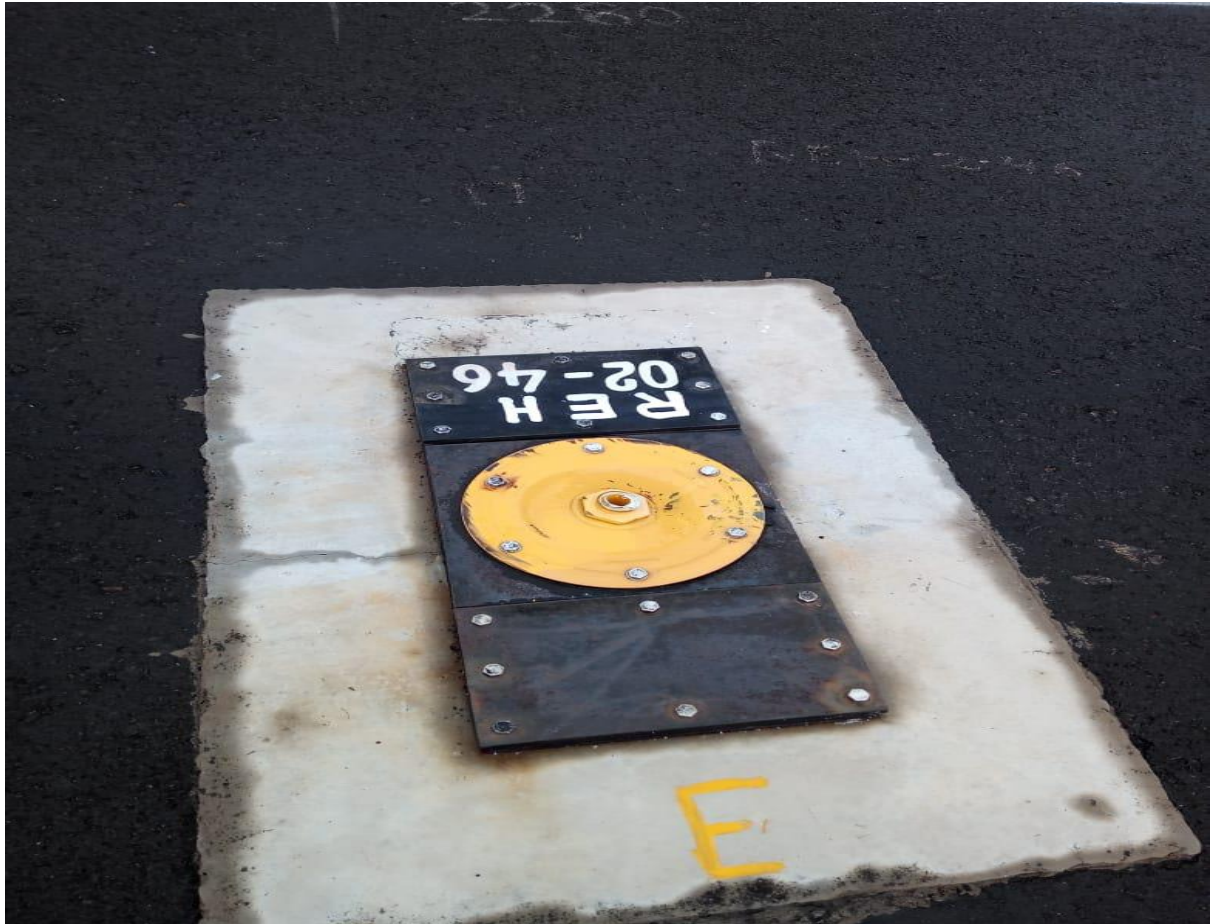
(Photographs of damaged runway edge lights)

1.4 Other damage: 05 runway edge lights on the right edge of runway 19L between taxiway 'K' and 'A' were damaged. Information of the damaged lights is given below:

Damage Sequence	Fitting no.	Distance from runway 19 L threshold
First runway edge light damaged	Fitting No. REH-02-42	806.03 metres
Second runway edge light damaged	Fitting No. REH-01-44	836.03 metres
Third runway edge light damaged	Fitting No. REH-02-44	866.03 metres
Fourth runway edge light damaged	Fitting No. REH-01-46	896.03 metres
Fifth runway edge light damaged	Fitting No. REH -02-46	926.03 metres

3.1.10. Five (05) runway edge lights were damaged by no.3 and no.4 main wheel (RH main wheel) during landing roll of the aircraft along right shoulder of the runway 19L between taxiway 'K' and taxiway 'A'.
