FINAL INVESTIGATION REPORT

Incident to M/s Indigo Airlines, Airbus A320 Neo aircraft, registration VT-IZR

on 23-Aug-2022 at Goa, India

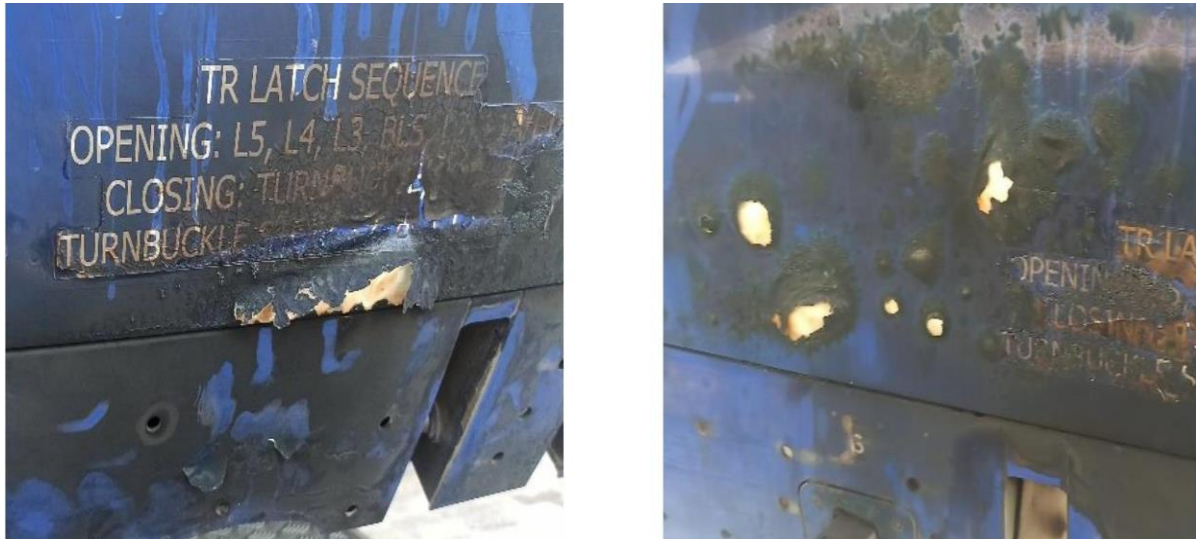
- i. Paint peeled on bottom portion of Engine No. 2 TR Cowl sleeve.
- ii. Damage to insulations of several harnesses inboard side of Engine# 2

(Fig. 1.1: Paint peel on the Lower Section of Engine No.2 Thrust Reverser Cowling)

1. Signs of overheat and black residue of smoke were observed at the bottom of the T/R cowls on Engine No.2, with peeled paint, indicating evidence of an actual fire.

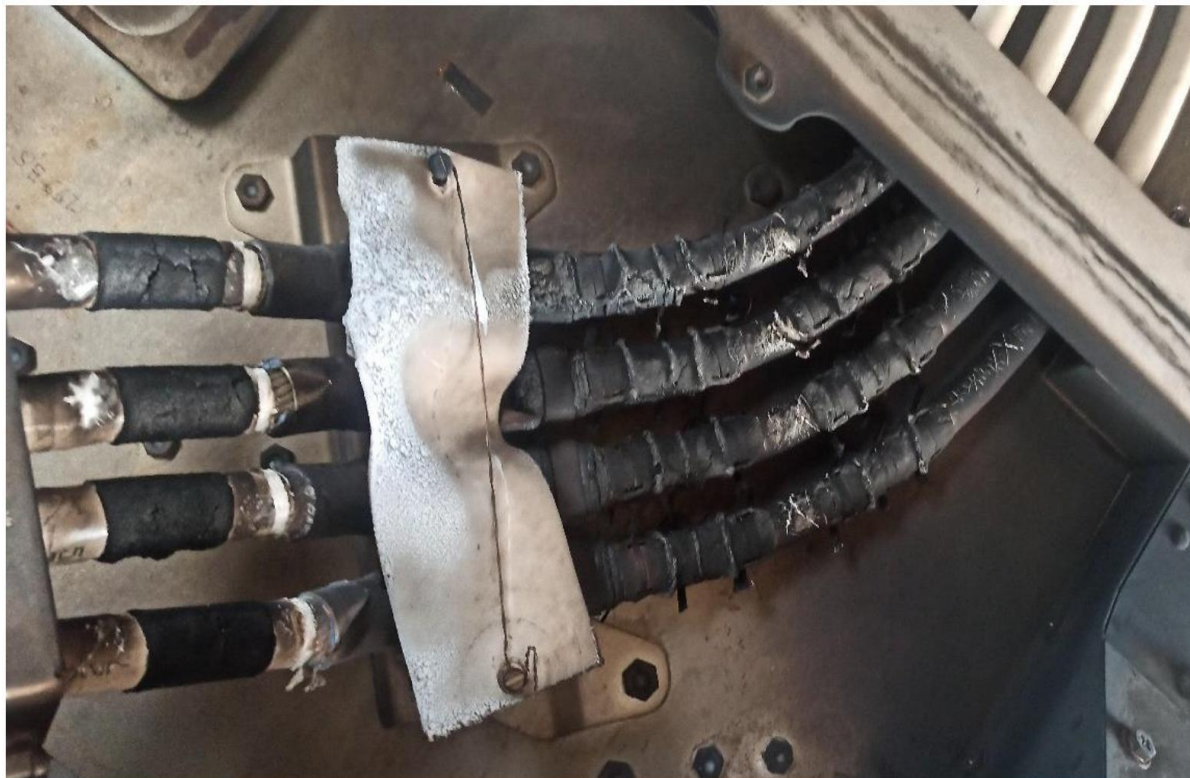
iii. Integrated Drive Generator (IDG) Feeder cable damaged with burn marks.

(Fig.1.2: IDG Feeder cables damaged with burn marks)

4. The IDG Feeder cable was damaged with burn marks.
5. No signs of fluid leakage were observed.
6. The hydraulic and engine oil quantities were within the normal range.

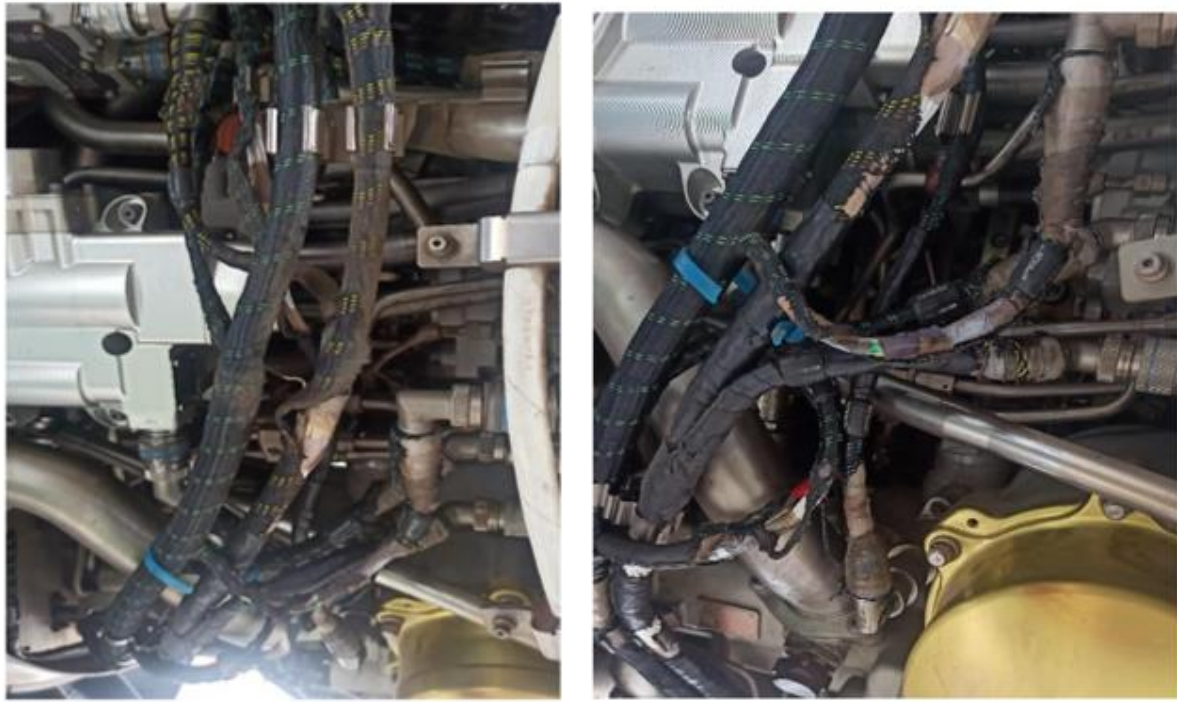
(Fig. 1.3: Several cables and harness damaged)

2. Signs of overheat were also noted on the heat shield on the inboard side of Engine No.2.
3. Burns and overheat damage were observed on the insulations of several harnesses on the inboard side of Engine No.2.

1. Visual inspection of the engine after the fire, in accordance with AMM task 72 00-00-210-817-A, which included checks of the N1 rotor, hot air leaks, and fire caused by fluid leak (engine static condition). No abnormalities were observed.
2. Damaged harnesses were replaced.

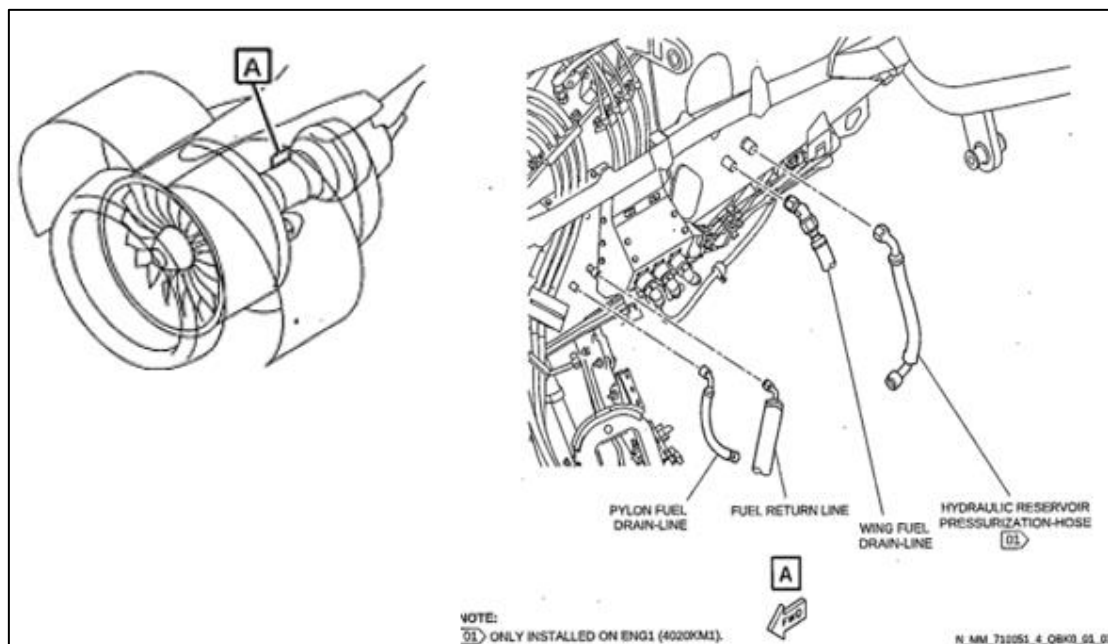
(Fig. 1.7:Fuel hoses – Fuel return line)

A torque check on the return to tank connection at the pylon revealed a reading of 36.25 lbf-ft, falling slightly below the specified AMM range of 36.65 to 39.97 lbf.ft. This deviation is categorized as an under-torque condition. However, it's imperative to acknowledge that the potential for fuel leakage from these connections cannot be entirely dismissed. Notably, the fuel in question is 'heated fuel' originates from the Ecology collector tank, which accumulates residual fuel following last engine shutdown, and recovered/ reused during next engine start. Leak of heated fuel onto the hot surface can elevate the temperature of the fuel to the point where it approaches or exceeds its flash point and can ignite fire, if there is an ignition source. In this case, even though fuel leak might have taken place, however, the investigation couldn't conclusively determine the precise ignition source that led to

1. Torque check of the return to tank connection at the pylon, which was found to be 36.25 lbf-ft. The connection was disconnected and inspected for any damage to the fitting/b-nut threads, which were found to be satisfactory. The return to tank hose on the pylon adapter was installed and torqued to a value of 38 lbf-ft (AMM ref task 73-11-48-400-803-A).

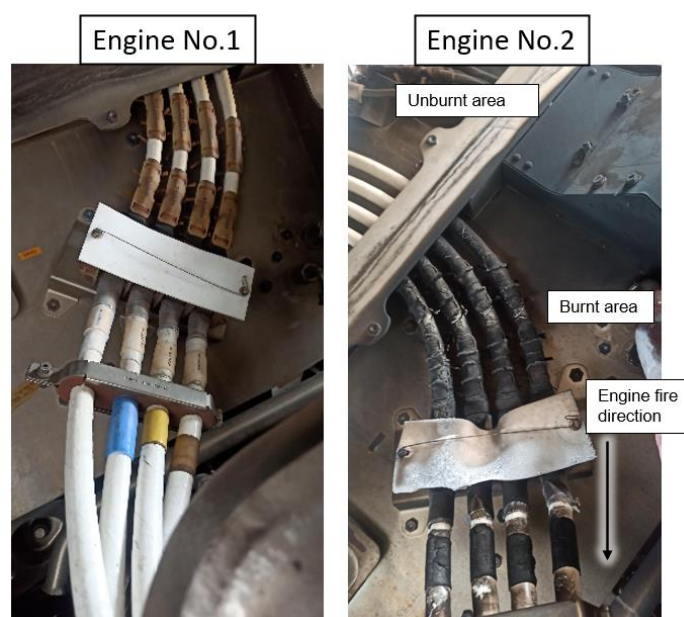
The fire caused paint peeling on the bottom portion of the Engine No.2 TR Cowl sleeve, damage to the insulations of harnesses inboard side of Engine No.2, and burn marks on the IDG Feeder cable. Large concentration of burn marks and black soot were found on the inner part of the cowl covering IDG harness area, especially areas below the Pylon Interface terminal. The area above the Pylon Interface terminal remained unburnt.

(Fig. 1.10: Power cables from IDG to pylon; Left- affected engine, Right – unaffected engine)

Physical inspection of affected area after the incident revealed signs of actual fire at the bottom of Thrust Reverser cowl area. All the harness, especially IDG feeder cables were damaged with burn marks. The burnt marks and damages were largely concentrated near the Pylon interface terminal.

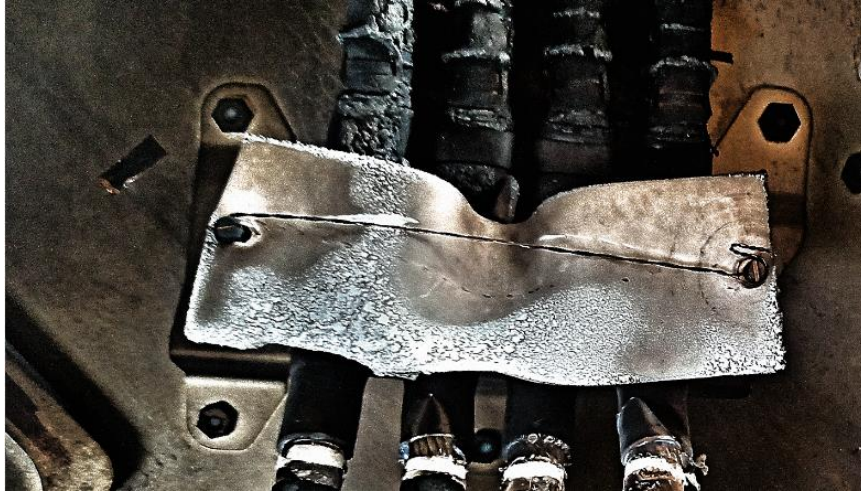
(Fig. 1.11: Enhanced image of terminal cover of Pylon Interface Terminal)

Evidence of localized heating and material degradation was observed on the terminal cover of the Pylon Interface Terminal, in the form of blistering.

The cockpit crew reported hearing a loud bang emanating from starboard side (right). This event coincided with CVR recordings, suggesting a potential electrical arcing event within the engine. This possibility is further strengthened by the presence of clear demarcation of burnt and unaffected areas, wherein the area above the Pylon interface terminal did not have evidence of fire. The blistering observed on the terminal cover of the Pylon Interface Terminal further supports this analysis, as it's a common consequence of localized heating due to electrical arcing.

Notably, the feeder cables were removed and installed on the Pylon interface terminal during engine replacement, which took place two days prior to the incident, and had flown for 27 Hrs / 18 cycles since replacement. The electrical arcing could take place on the Pylon Interface terminal due to incorrect engaging of mating connectors or un-cleaned connectors during installation of IDG cables, however the same could not be confirmed during the investigation.
