**INVESTIGATION REPORT ON INCIDENT TO
M/s INTERGLOBE AVIATION LTD. ATR 72-212A
AIRCRAFT, VT-IRA AT JODHPUR ON 30.12.2022**

**GOVERNMENT OF INDIA
DIRECTORATE GENERAL OF CIVIL AVIATION**

**Investigation Report on incident to M/s InterGlobe Aviation Ltd. ATR 72 aircraft
VT-IRA at Jodhpur on 30.12.2022**

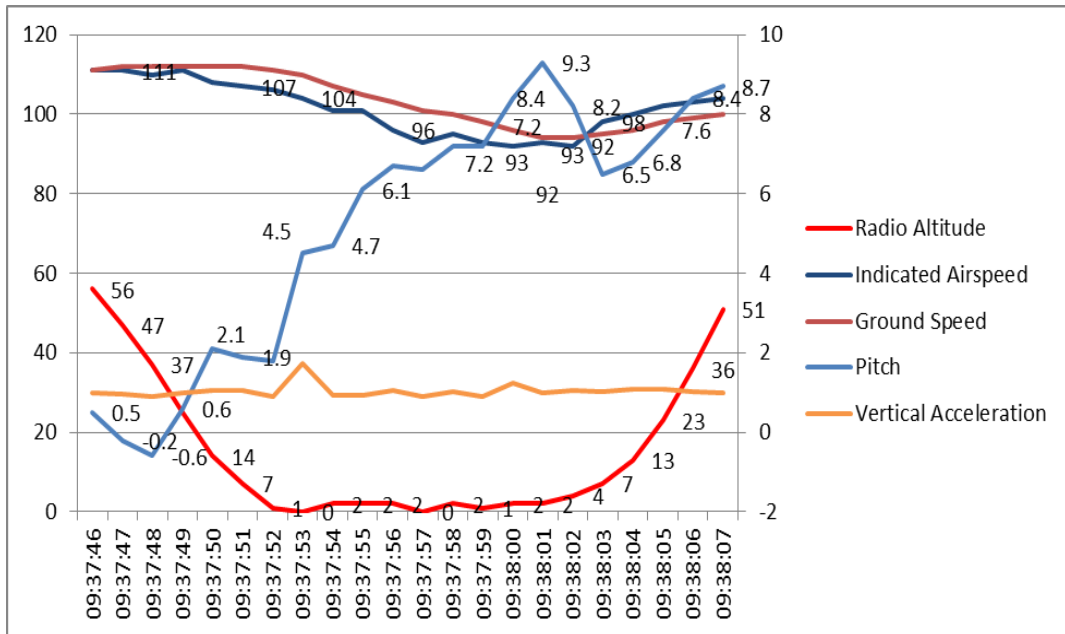
Time (UTC) Vs Altitude, Speed, Aircraft Pitch and Vertical acceleration (below 60ft Radio altitude)

6. The first touchdown (1.8 G) occurred at 09:37:52UTC with pitch of 4.5° and vertical speed of 704 ft/min. The speed (IAS) at first touchdown was 106kt (111kt ground speed) and wind recorded is 06 deg / 04 kt.

7. At first touchdown there were DUAL inputs from PIC (for a Pitch UP) and First Officer side was also for a Pitch UP but not significant.
8. The radio altitude recorded during bounce after first touchdown is 02 feet.

9. The PIC side inputs were predominant thereon and the pitch UP commands from PIC side were eased but were still predominantly towards Pitch UP at the second touchdown. Just prior to second touchdown the aircraft pitch had reached 6.7° UP.

10. Speed at second touchdown (09:37:57UTC) had dropped to 93kt IAS, which further reduced to 92kt IAS at 09:38:00UTC.
11. The aircraft pitch steadily increased based on PIC side input reaching 7.2° at second ground contact (1.3G) and further increased reaching 8.3° at third ground contact (1.36G) at 09:37:59UTC. The First officer inputs were also recorded but after second bounce they were pitch DOWN in nature and eventually inputs from First Officer stopped.

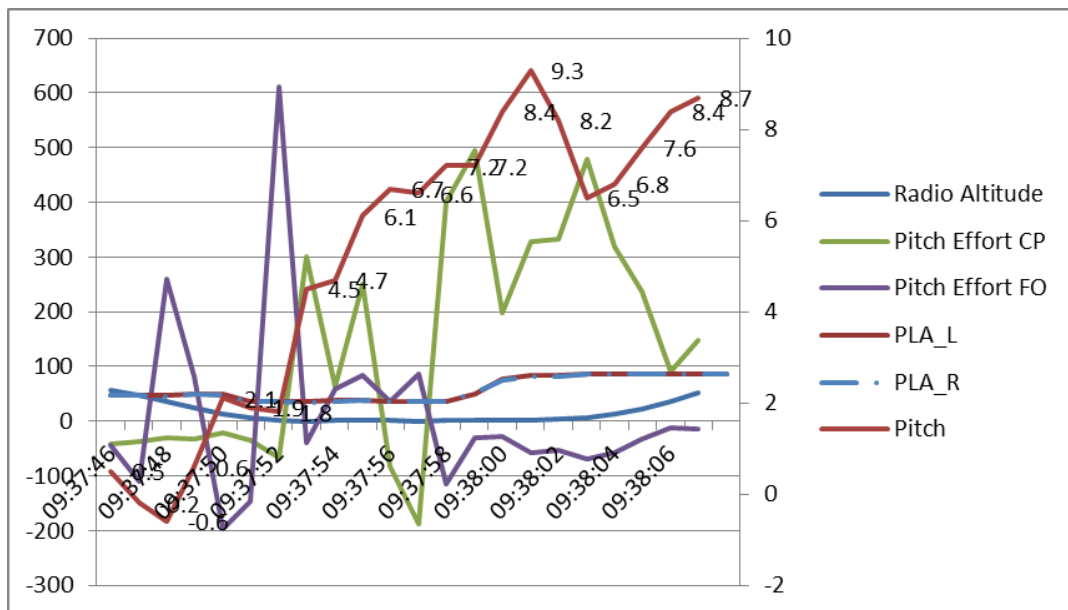
Time (UTC) Vs Altitude, PIC and First Officer Pitch inputs, Aircraft Pitch and Power Lever (below 60ft Radio altitude)

5. Below 14ft radio altitude the PL's #1 and #2 were reduced to 36° (Flight IDLE) and pitch DOWN inputs followed by significant pitch UP inputs are recorded from First Officer side. Just prior to touchdown there are recorded inputs for slight pitch DOWN from PIC side and simultaneously pitch UP inputs from First Officer side which was eased and changed to a slight pitch DOWN.

12. Following the second ground contact, after 09:37:59 UTC the PL's were advanced forward reaching the maximum of 86° and 87° (#1 and #2 PL respectively) in about 05 seconds (09:38:03UTC). Corresponding to which IAS increased past 100kts (at 09:38:04UTC) and

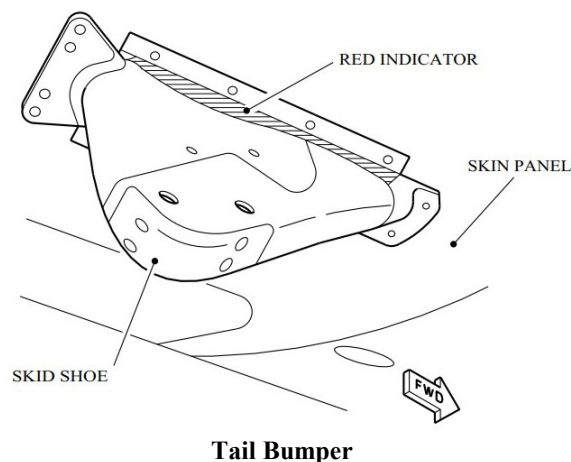
1.18.2 FCOM Reference: Tail Bumper

No damage to aircraft. Rub mark was observed on tail skid shoe not extending up to wear indicator. No wear mark observed on indicator angles. Tail skid shoe paint touch-up carried out as per ATR standard practices.

At each walk-around, inspect skid shoe.

In case of scratches, if red indicator:

- Does not show mark of wear, aircraft can be dispatched
- Shows mark of wear, maintenance action is required.

Unscheduled inspection of Tail Bumper after rub mark observation after touchdown carried out and aircraft released to service

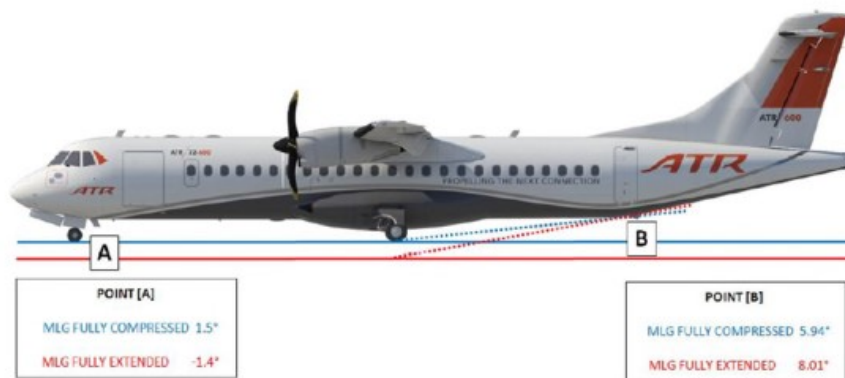
Aircraft schematics- Points of contact

The tail skid shoe/ tail bumper contacted the runway while landing at Jodhpur. Damage was limited to paint rub on the tail skid shoe/ tail bumper. No further damage/ disintegration of any part were reported.

ATR has replied that, 'Referring to Abnormal procedure REDUCED FLAPS LANDING, Pitch attitude should not exceed 6° during flare. Above this value, a tail strike can occur due to compression of shock absorber. This value is also applicable for Flaps 30° landing since a tail strike is a geometrical relationship that depends only on aircraft attitude and height of main landing gears (not on flaps configuration). It is written in the REDUCED FLAPS LANDING procedure since it is more likely to have a higher pitch attitude during flare while performing a flaps 0° landing than flaps 30°.'

Two bounces, 3 touchdowns, IAS decay during the ground phase, reaching 93kt, loss of lift with nose up input
