Final Investigation Report on Serious Incident of Runway Excursion to M/s Ambition Flying Club Cessna 172 R aircraft VT-AFR at Aligarh on 11.07.2021

1. Aircraft Type : Cessna 172 R
Nationality : Indian
Registration : VT-AFR
2. Owner/ Operator : M/s Ambition Flying Club Pvt. Ltd
3. Pilot-in-Command : CPL Holder (Instructor)
Extent of injuries : Nil
4. Co-Pilot : SPL Holder (Student Pilot)
Extent of injuries : Nil
5. Place of Incident : Aligarh Aerodrome
6. Geographical Location of Site : Latitude: 27°51'41''N
Longitude: 78°08'42'' E
7. Date & Time of Incident : 11.07.2021
1025 Hrs IST (Approx.)
8. Last point of Departure : Aligarh
9. Point of intended landing : Aligarh
10. Type of operation : Training flight
11. Person on Board : Two
12. Extent of injuries : Nil
13. Phase of operation : Landing
14. Type of incident : Runway Excursion

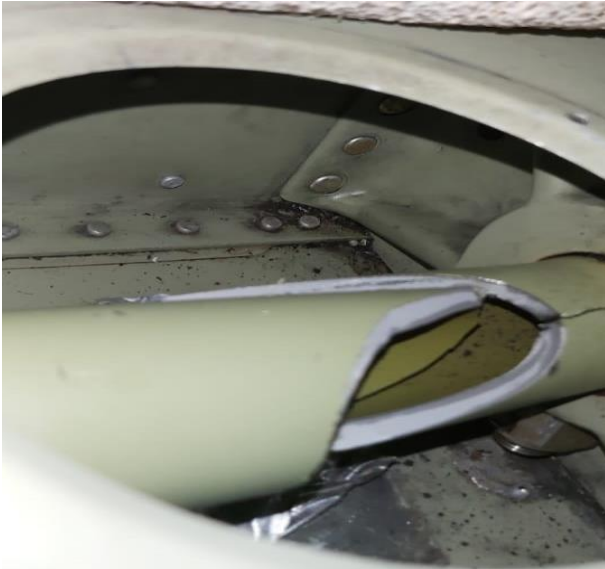
Fig:1

1. RH main landing gear spring assembly was found broken between inbound bulkhead and outbound bulkhead (Figure: 1)
2. RH horizontal Stabilizer along with elevator was found bent at middle portion (Figure: 2)
3. Scratches were observed on bottom skin of RH elevator (Figure: 3)
4. Mooring eyebolt was found broken and detached from the aircraft (Figure: 4)

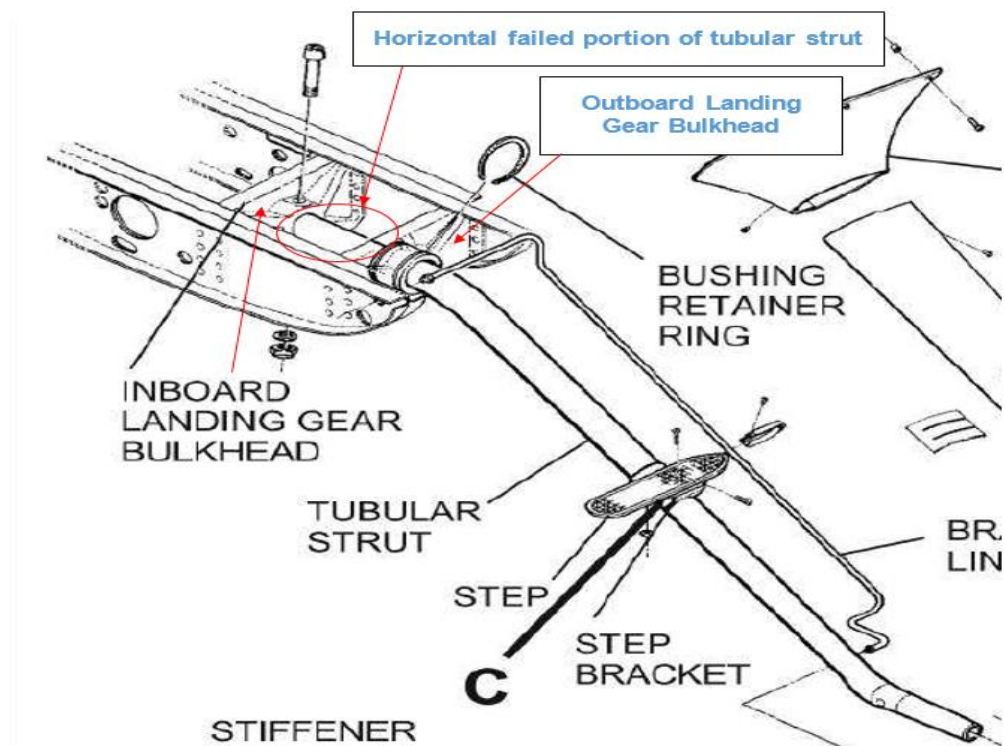
Fig-5

- i. The horizontal portion of the tubular strut which is bolted and supported at the inboard and outboard landing gear bulkheads respectively is found fractured and disintegrated between its inboard bolt hole end and outboard bushing interface end as shown in Fig 5 & 6.

Failed horizontal portion of the tubular strut as seen in illustrated parts catalogue

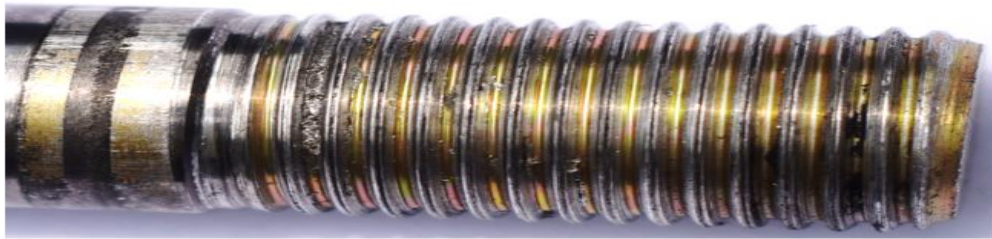
Fig-7

- ii. The bolt, nut and bushing are found to be in satisfactory condition except some damages on the threaded portion of the bolt as shown in Fig. 7

Thread damage on the bolt fastening at inboard landing gear bulkhead

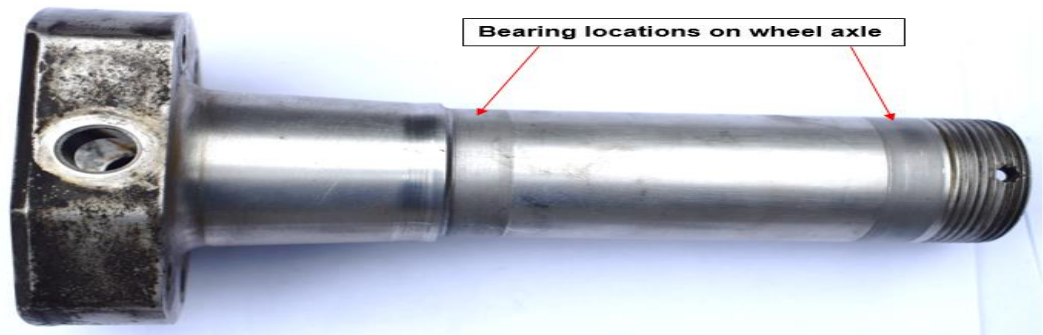
Fig-8

- iii. The outer diameter of the wheel axle at the wheel bearing locations dimensionally found to be undersized and worn out from prescribed limits.

Bearing locations on the wheel axle

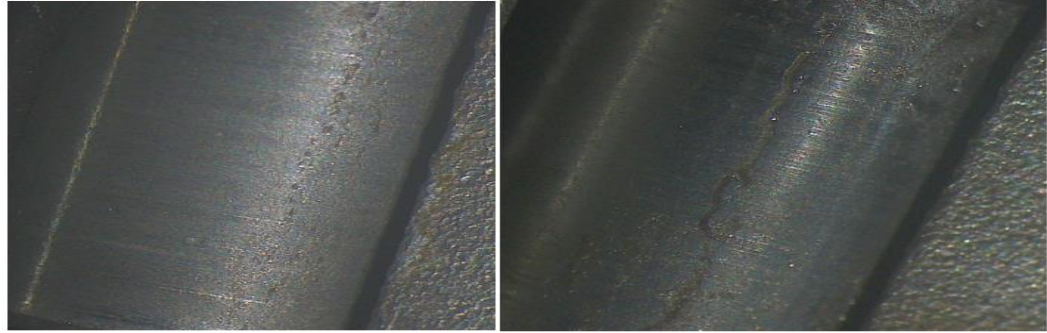
Fig-9

- iv. The rollers within tapered bearing units are found to have corrosion pitting and brinelling marks.

Corrosion pitting and brinelling marks on the rollers of bearing

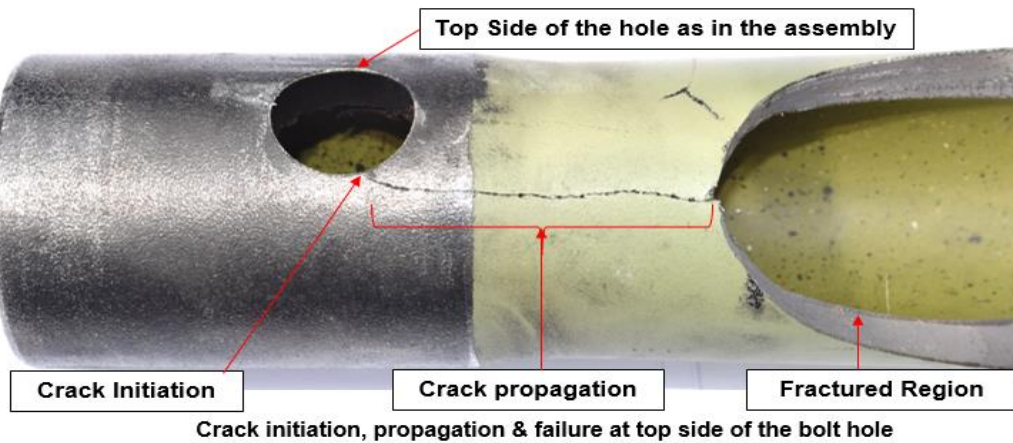
Fig-10(a)

vi. It is evident from the macroscopic examination of the failed tubular strut that the crack initiation point was at the top bolt hole region and crack has propagated under fatigue loads. The availability of beach marks & their direction at lower magnification (16X) and faint striation mark at higher magnification (624X) confirms that the crack initiation point was at the top bolt hole region and crack has propagated under fatigue loads.

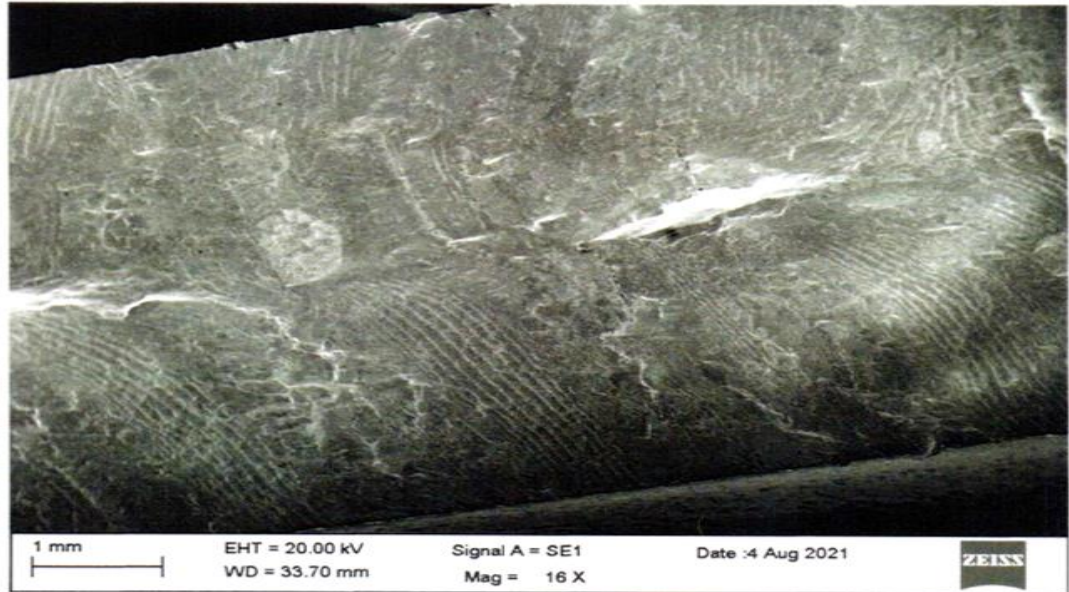
Fig-10(b)

Cyclic loading pattern seen on the crack propagation region in SEM

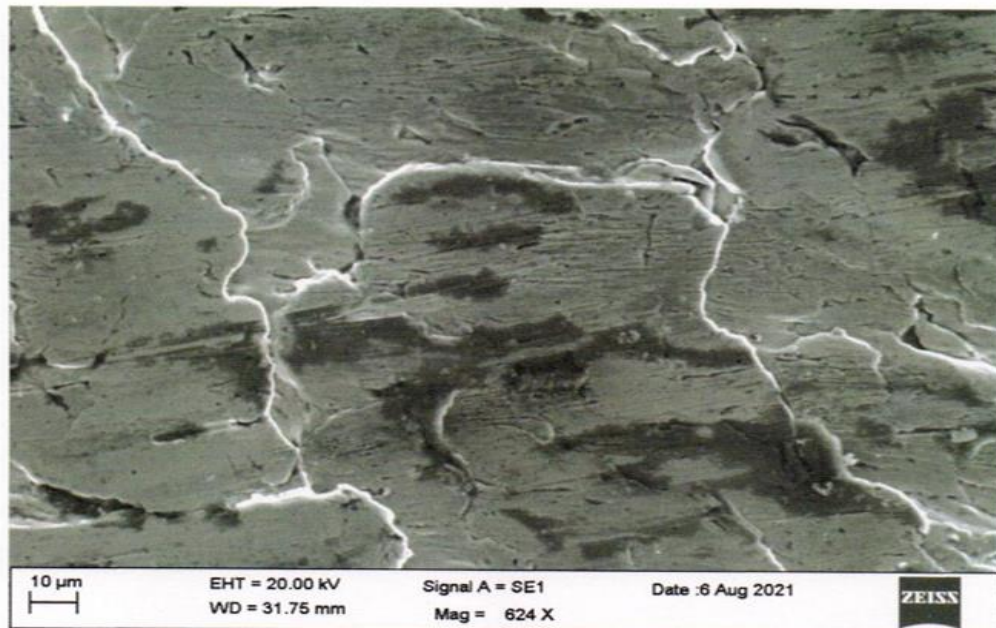
Fig-10(c)

Striation marks seen on the crack propagation region in SEM

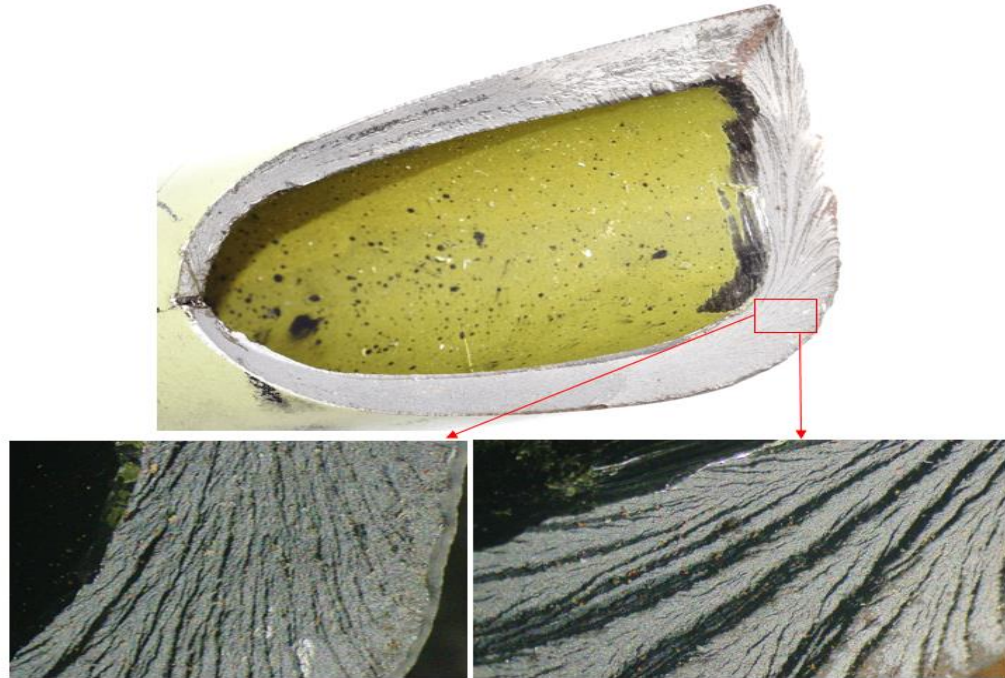
Fig-11(a)

The fatigue cracking would have propagated over certain length, causing structural discontinuity in the strut and eventually disintegrating the tubular strut under rapid overload which is evident from the slant, fibrous and dimple features observed on fracture surfaces of failed strut's fragmented portions.

Slant, fibrous feature and chevron marks seen on the fracture surface

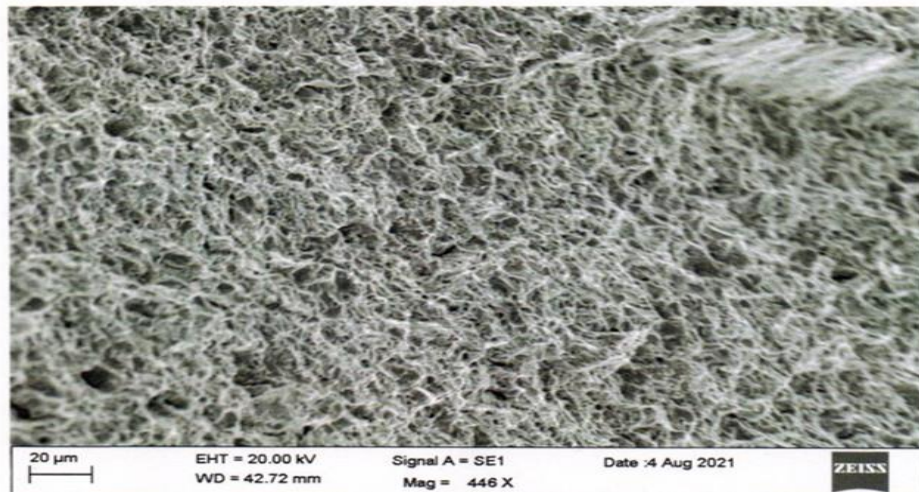
Fig-11(b)

Dimple signature seen on the disintegrated fracture portion of the strut under SEM

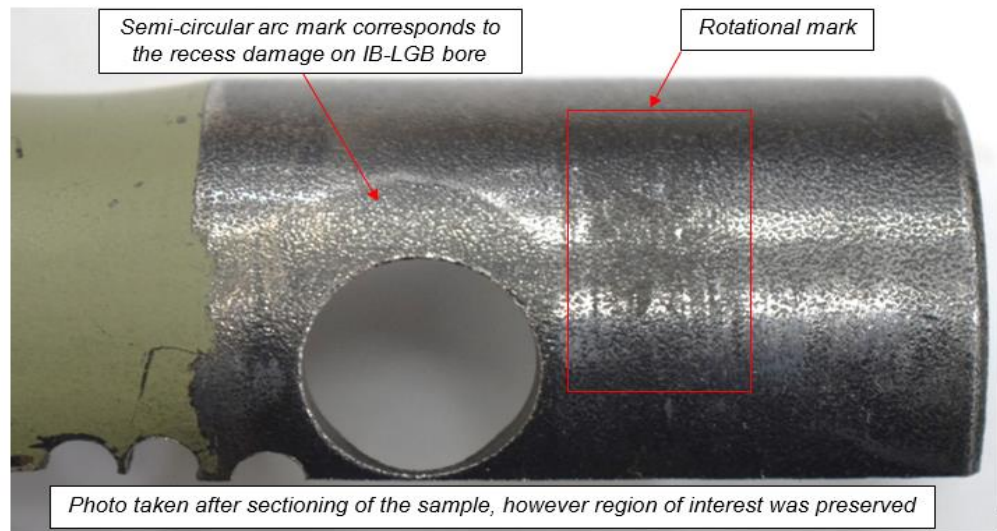
Fig-12

- vii. The availability of semicircular arc impression observed around the bottom bolt hole region of the tubular strut indicates that when the tubular strut was installed into the bore of the IB-LGB with the bolt & nut, probably the recess damage region on the IB-LGB had not come in contact with the tubular strut and only the surfaces outside the recess region had come in contact with

strut which confirms that the recess damage was probably pre-existing in the IB-LGB bore.

Circular arc and rotation mark at the tubular strut bottom bolt hole region

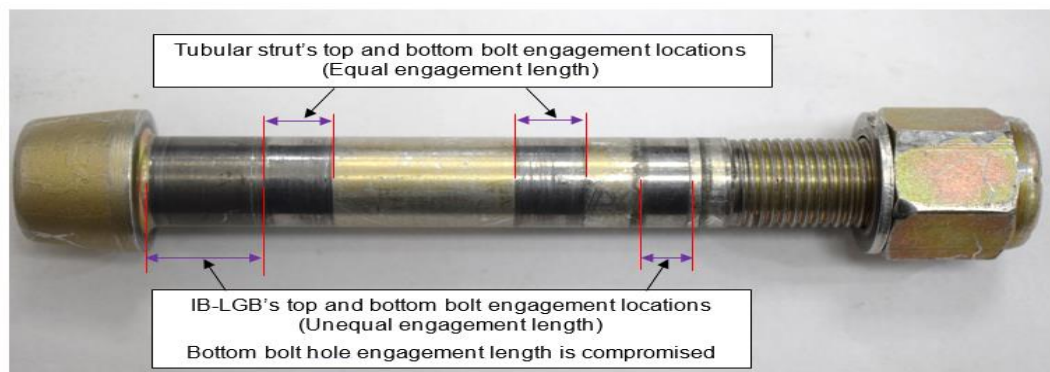
Fig-13

- viii. Also, the reduction in IB-LBG's bottom bolt hole grip impression on bolt shank and oversizing of the IB-LBG's bore diameter and its bolt holes diameter from dimension checks indicates that bottom bolt hole damage, bore and bolt holes oversizing were pre-existing.

Unequal bolt engagement length from top and bottom bolt holes of IB-LGB

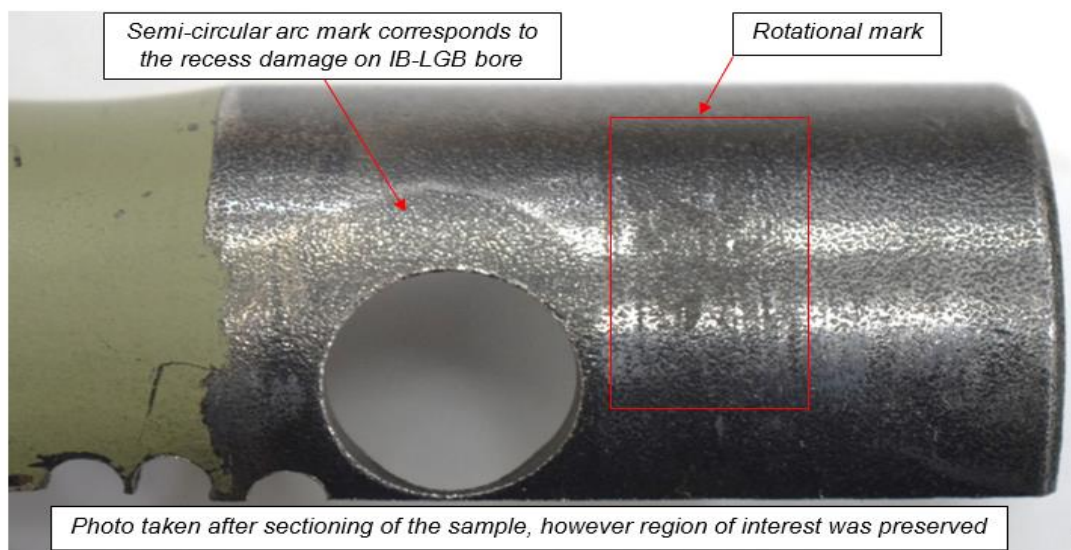
Fig-14

- ix. Further, the rotational marks on the bottom surface of the tubular strut indicates that due to the pre-existing recess damage and oversizing of the bore and bolt holes in the IB-LGB, probably the tubular strut would have undergone swinging motion within the bore region. The loads imposed at the

joint due to the probable swinging motion of strut in addition to the normal landing loads would have caused the strut to fail in over fatigue loads.

Circular arc and rotation mark at the tubular strut bottom bolt hole region

- One time removal and inspection of LH-MLG tubular strut of aircraft VT-AFR for any crack/corrosion.
- One time dimension check of IB-LGB bore of left MLG for any oversizing to prevent any reoccurrence.
