DIRECTORATE GENERAL OF CIVIL AVIATION

**FINAL INVESTIGATION REPORT OF RUNWAY EXCURSION
INCIDENT TO M/S JET AIRWAYS PVT LTD, AIRBUS-330 AIR
CRAFT VT-JWV ON 29.08.2017 AT CHATRAPATHI SHIVAJI
INTERNATIONAL AIRPORT, MUMBAI**

FINAL INVESTIGATION REPORT ON LATERAL RWY EXCURSION TO M/s. JET AIRWAYS PVT. LIMITED, AIRBUS-330 AICRAFT VT-JWV AT CHATRAPATI SHIVAJI INTERNATIONAL AIRPORT, MUMBAI ON 29.08.2017

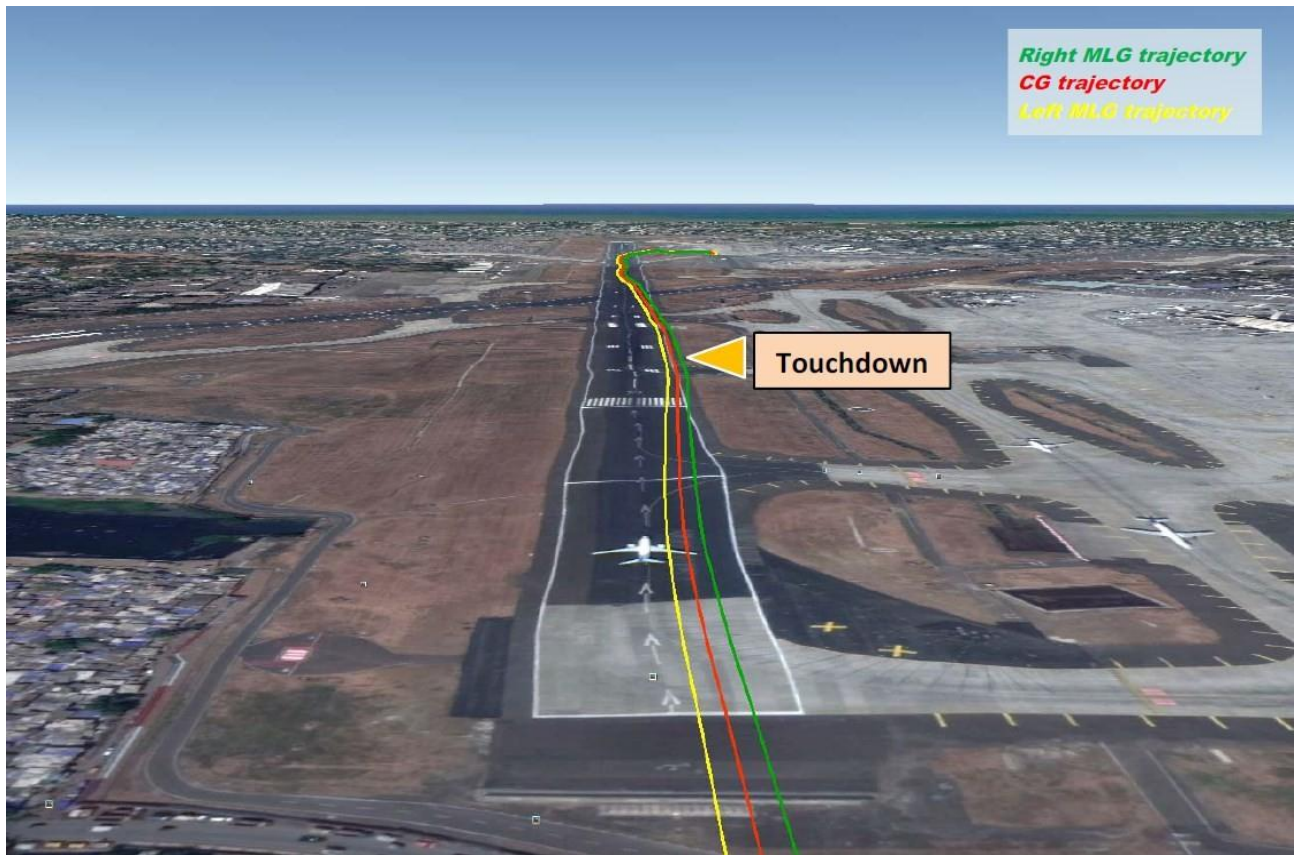
Aircraft Trajectory

During the initial touchdown, the right main landing gear touches first with a crab angle outside the Right RWY edge marking in the shoulder area despite of the attempts by PIC from ~70 ft RA by application of left rudder input in an attempt to return the aircraft onto the RWY centerline.

The aircraft touched down with a heading of 256 degrees on the wet RWY skidded further to the right. The reverse thrust was initially set to idle (03 seconds after touchdown) and differential braking (predominantly full left brake application) was used along with appropriate directional controls (full left rudder) to turn to left and come out of unpaved/uneven surface and align with the RWY centerline.

Despite of the efforts, the right main landing gear left the paved shoulder area of the RWY and entered the grass portion on the right side of the RWY. This further caused the aircraft to continue skidding. The PIC continuously applied full left rudder and left braking to bring the aircraft back to the RWY centerline.

The right main wheel after travelling for approx. 250 m in the unpaved/uneven surface continued to roll forward while the right main wheels came in contact with a paved surface of taxiway N5 and steered to the RWY centerline.

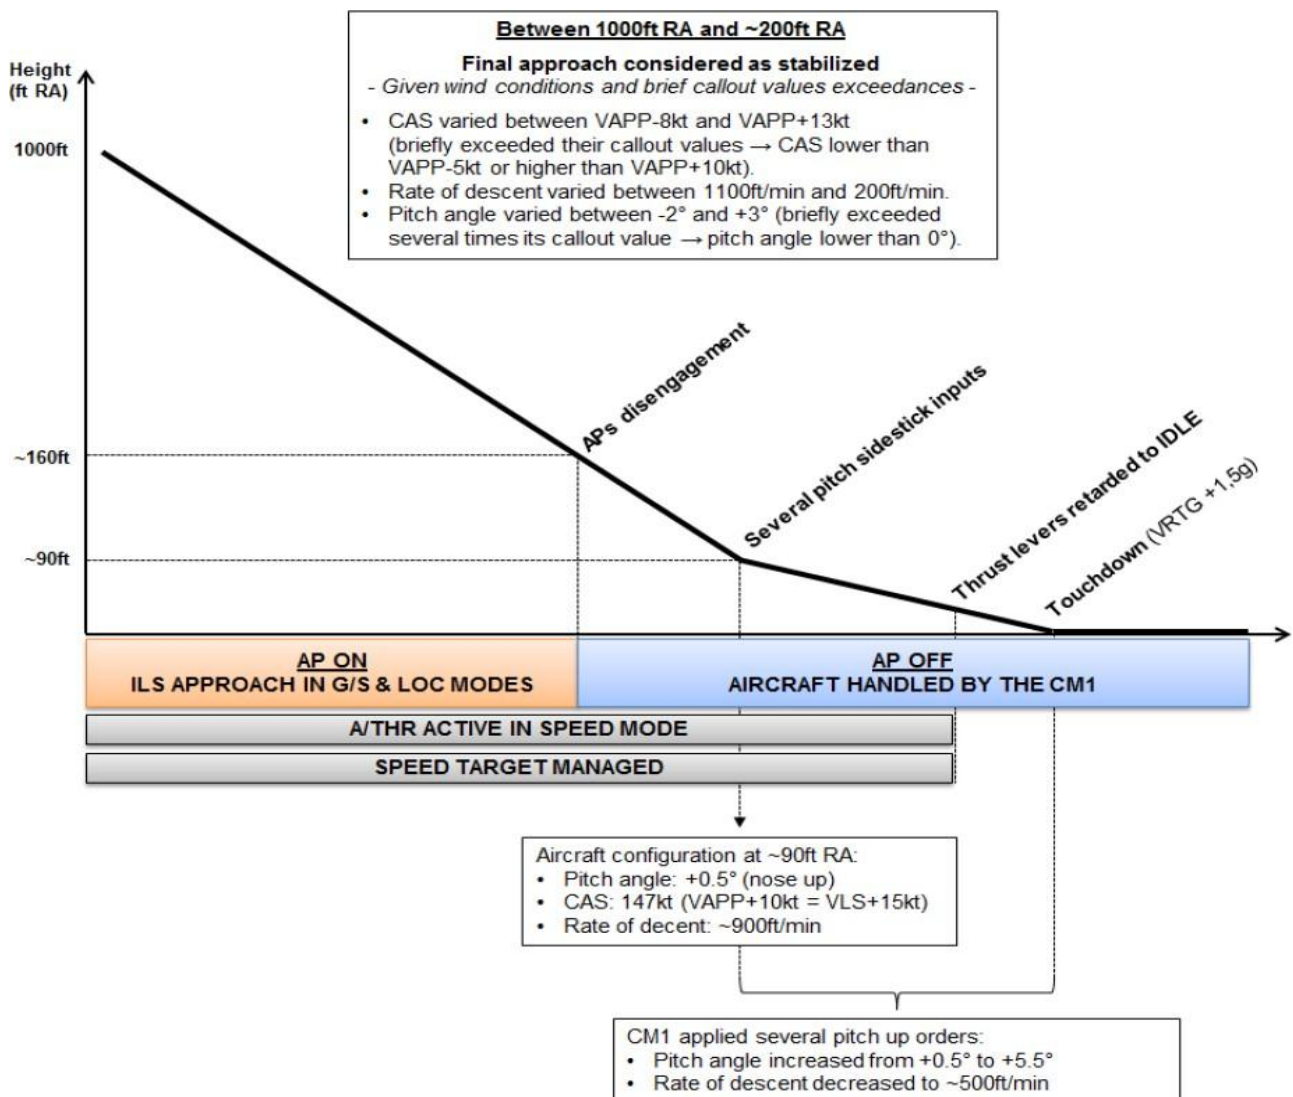
Final Approach from 1000 ft to touchdown

According to the roll angle recorded at touchdown (+1.5°), the right main landing gear touched down first followed by the left main landing gear.

The touchdown occurred out of the RWY on the right side.

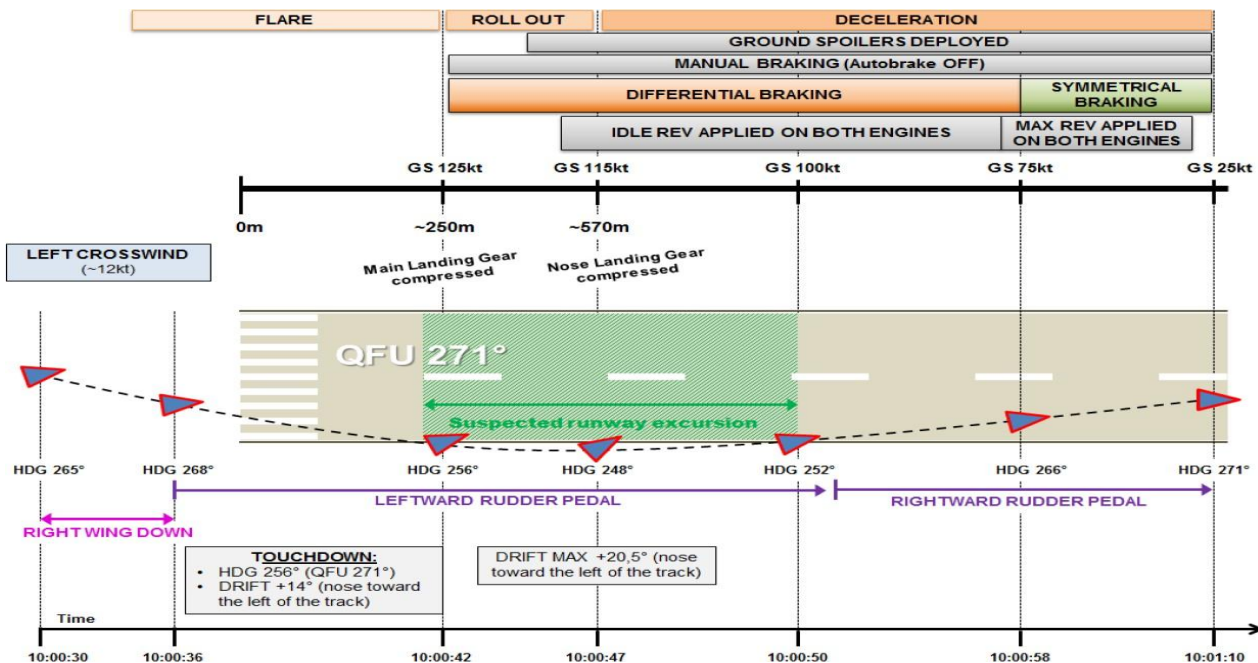
Rollout and Deceleration

- Aircraft was on the right of the RWY.
- Left side stick order was recorded up to ~4/5 of full deflection just after touchdown then no significant roll side stick order was recorded:
 - Roll angle decreased and remained around 0° (wings level).
- Leftward rudder pedal orders were applied (up to full deflection) then rightward rudder pedal orders were applied (up to full deflection).
 - Heading decreased to 248° then increased up to 272° (QFU 271°).
- After the lateral RWY excursion, the aircraft returned on the RWY centerline.

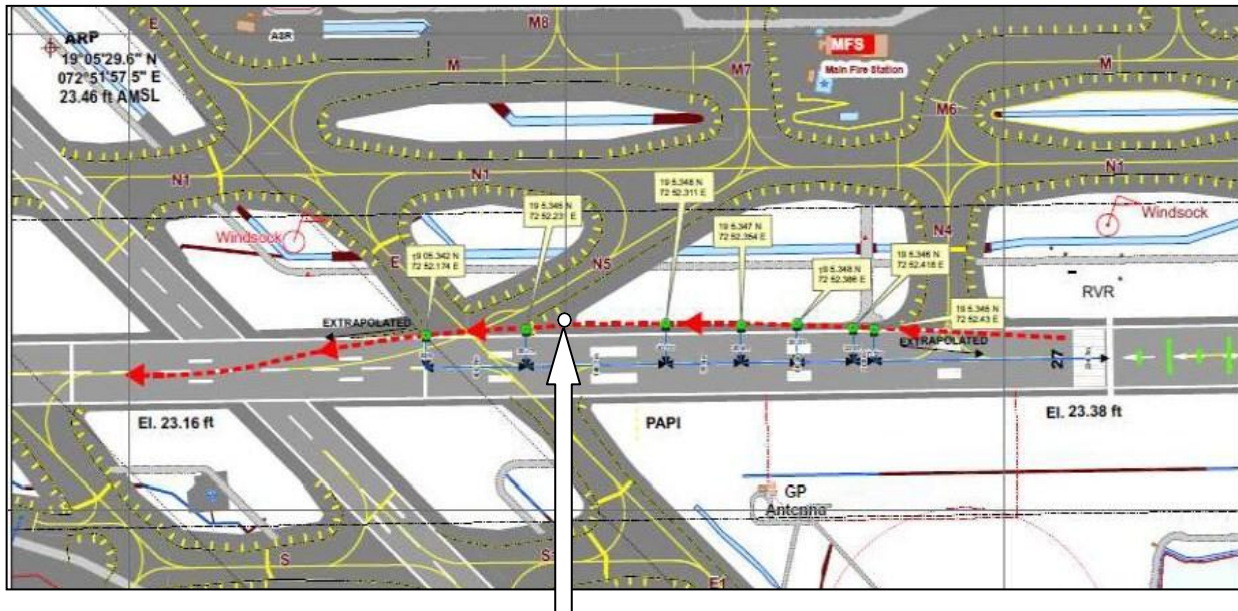
Point where aircraft exited unpaved/uneven surface and enters paved surface

During site visit, it was observed from marks, that the aircraft touchdown was in the touchdown zone approximately 1585 m from the threshold to right of the RWY center line such that the right main landing gear touched down outside the RWY edge marking, in the paved shoulder area.

Due to the surface of the RWY being wet, the aircraft skidded due to Viscous Hydroplaning & continued to move further laterally.

The Right main landing gear left the paved shoulder area of the RWY and enters the grass portion on the right side of the RWY. This further caused the aircraft to continue skidding. In the process, no RWY edge lights got damaged as the Right main wheels missed the lights.

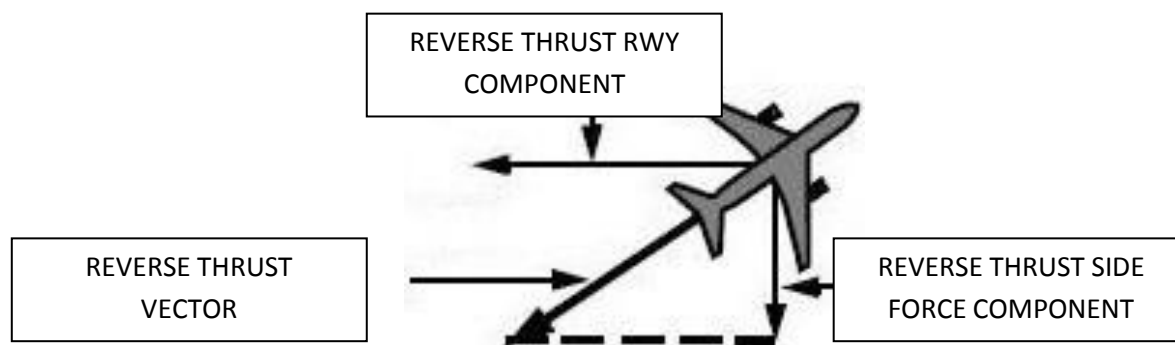
b) REVERSE THRUST SIDE FORCE COMPONENT (SKIDDING SIDEWAYS)

The tendency of Aircraft skidding sideways on a wet RWY is increased by reverse thrust side force component when the aircraft lands in crosswinds.

The reversers have a destabilizing effect on the airflow around the rudder and thus decrease the efficiency of the rudder. Furthermore they create a side force, in case of a remaining crab angle, which increases the lateral skidding tendency of the aircraft. This adverse effect is quite noticeable in case of wet RWYs in crosswind. To reduce the sideways skidding tendency, the reverse thrust should be set to idle. At low speeds the directional control of aircraft becomes problematic, more specifically on wet RWYs. In such case differential braking is to be used by releasing the pedal on the opposite side to expected turn direction. Once the aircraft is brought back to directional control, the reverse thrust may be set to Max.

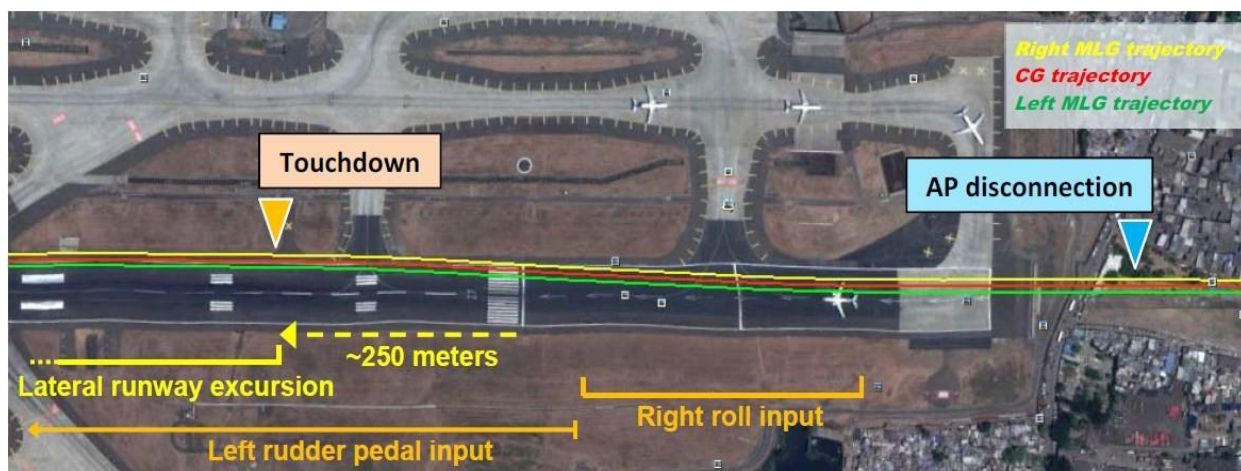
Trajectory/Touchdown

As per DFDR readout, the aircraft touched down with a roll angle of +1.5°, the right main landing gear touched down first followed by the left main landing gear. The touchdown occurred with a crab angle (heading 256 degree) out of the right RWY edge marking in the shoulder area.
