**FINAL INVESTIGATION REPORT ON
FUEL LEAK INCIDENT TO
M/s AIR INDIA LTD BOEING 787-800 AIRCRAFT VT-ANE ON
21/08/2017 AT MUMBAI**

**GOVERNMENT OF INDIA
O/o, DIRECTOR AIR SAFETY, WESTERN REGION,
NEW INTEGRATED OPERATIONAL OFFICE COMPLEX,
SAHAR ROAD, VILE PARLE (EAST), MUMBAI-400099**

On 21st August 2017, M/s Air India Ltd Boeing 787-800 aircraft VT-ANE was involved in fuel leak incident during taxi to the runway while operating flight AI - 131 (VABB-EGLL).

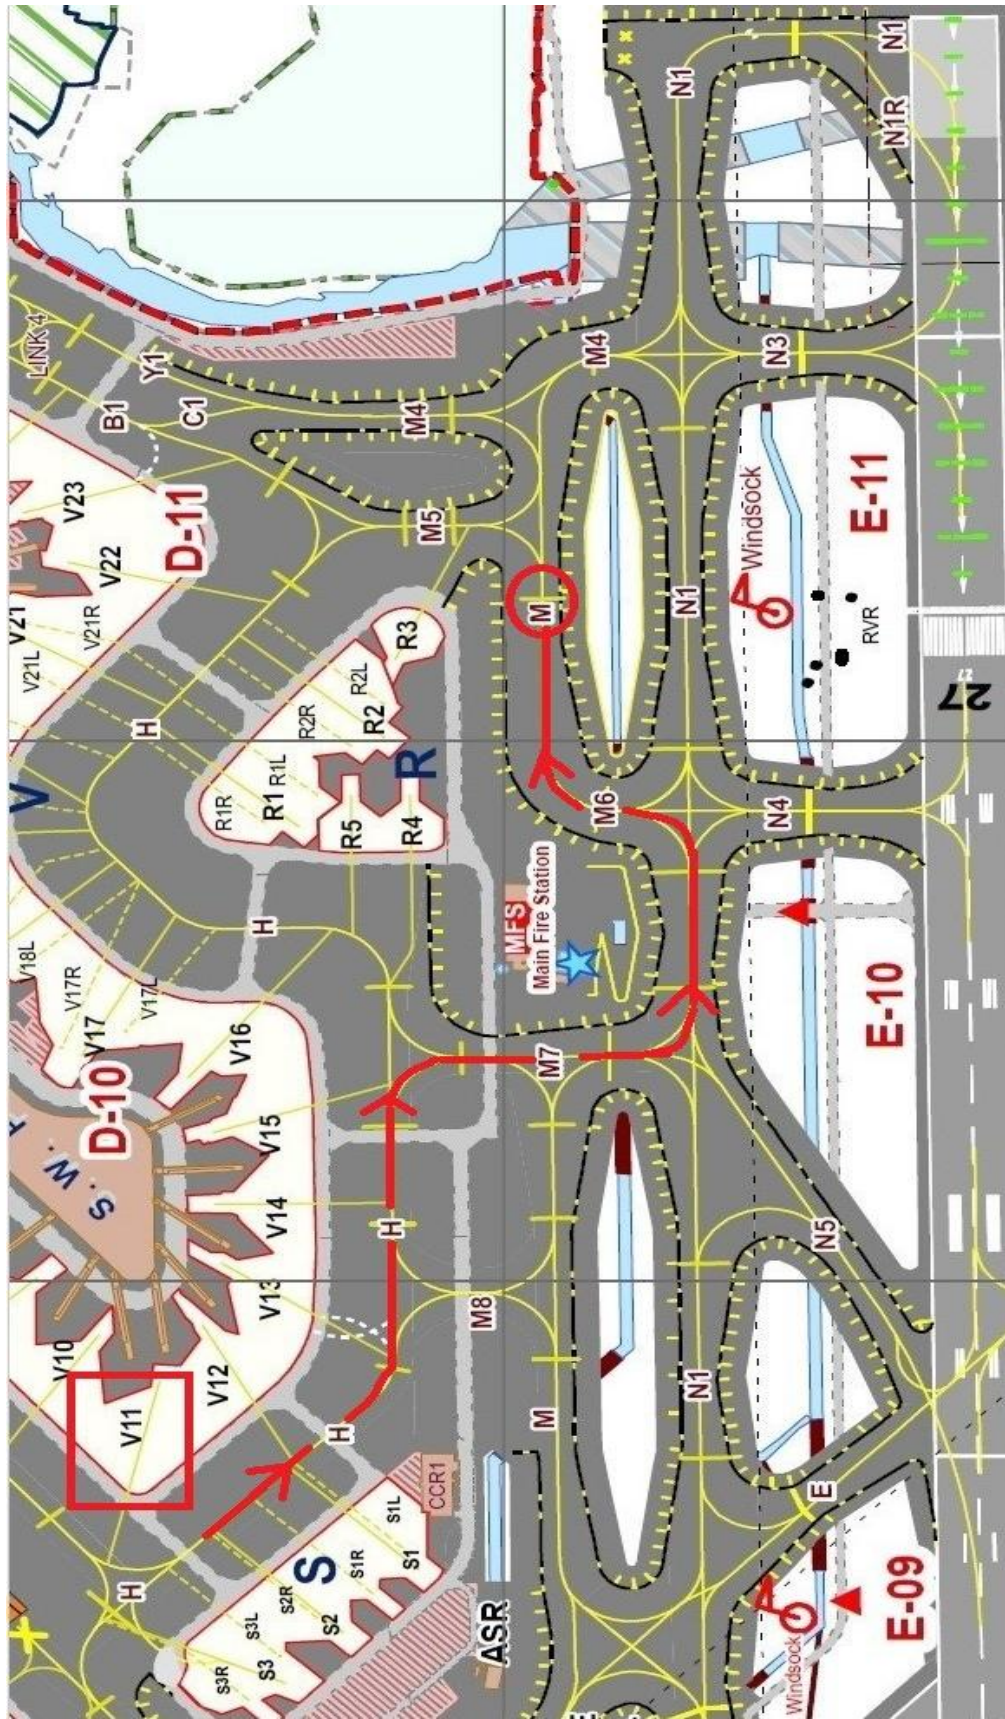
Figure# 1 Location of incident

By this time crew noticed that 1,000 Kg of fuel was already lost from aircraft and they decided to return back. AI-131 requested SMC at 01:27 hrs to take left on M6 to which SMC agreed and directed AI-131 to take left on M6 and hold short of M5 on taxiway M. Aircraft then taxied to taxiway M and held its position short of taxiway M5 at 01:29

hrs (Refer Figure# 1). Number of calls were given by SMC, Fire Tender and Follow me for AI-131 to shut down the engine.

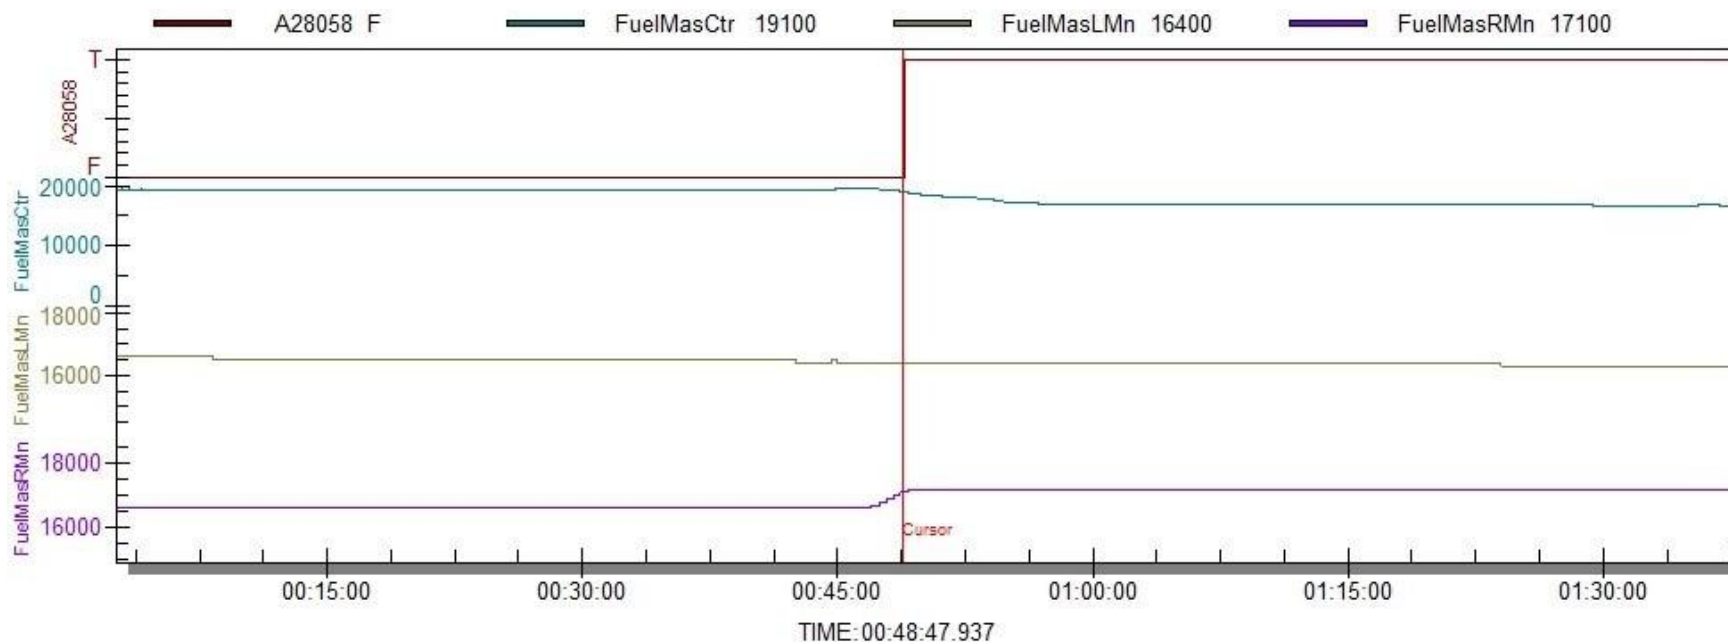
Figure # 2 Graphical representation of FDR data

The decrease in center tank fuel quantity and increase in RH main tank quantity substantiates that the fuel is being transferred from center tank to RH main tank. At the time of Fuel Imbalance message, the fuel quantities of LH main, centre and RH main tanks were 16,400 Kg, 19,000 Kg and 17,100 Kg respectively.

Graph shown above corresponds to the condition just before Fuel imbalance message. Time shown in the graph is the elapsed time of FDR recording.

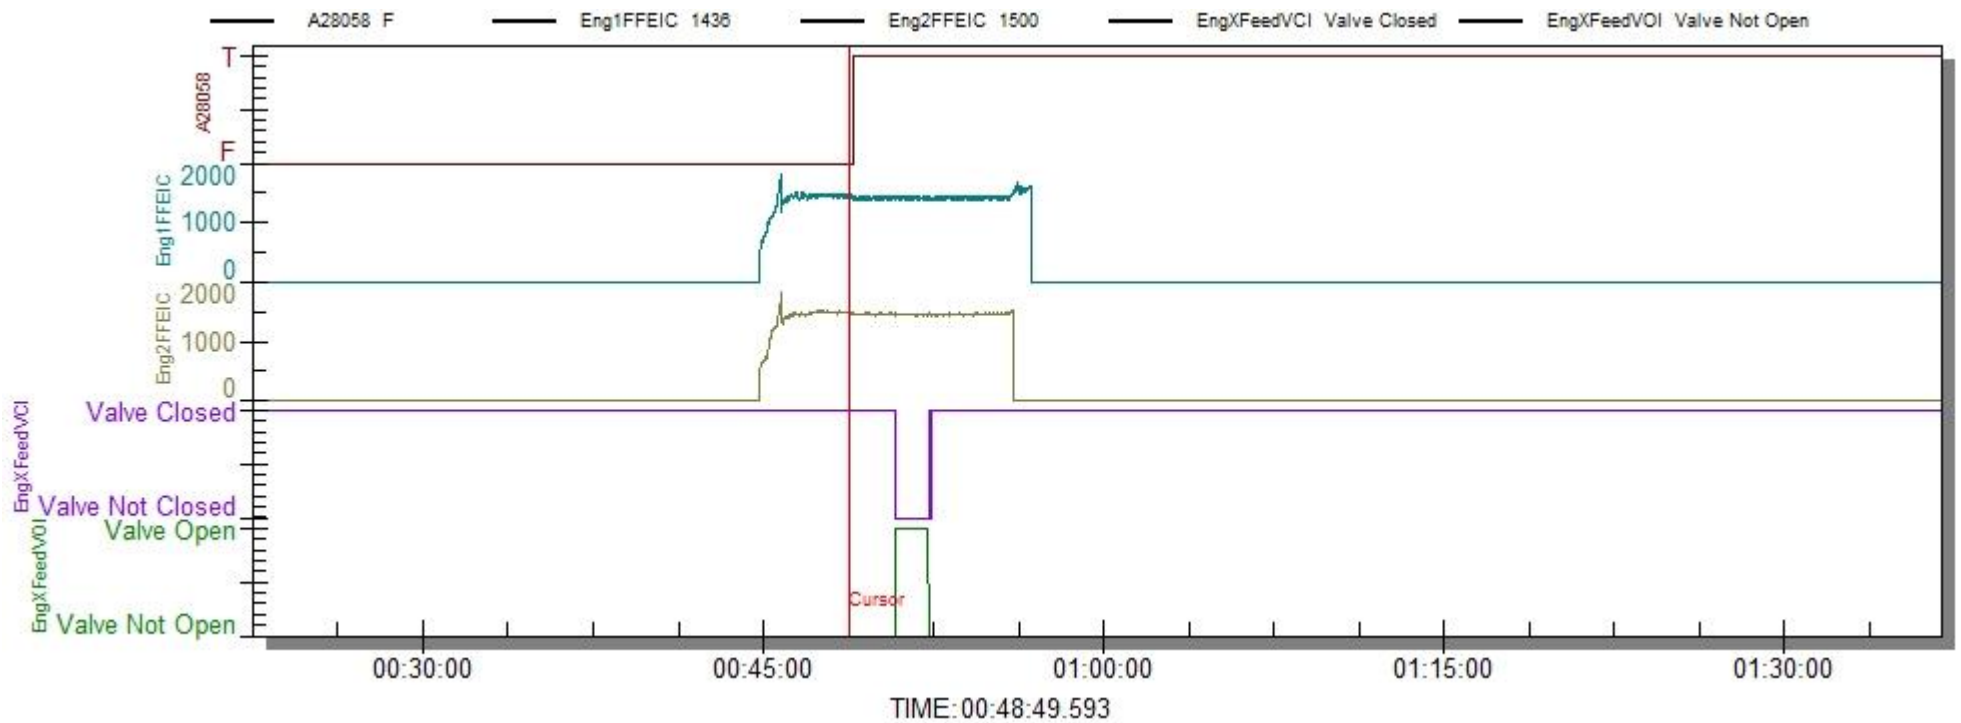
Figure # 3 Graphical representation of FDR data

After the fuel imbalance message crew put the cross feed valve to OPEN position as per FCOM procedure.

Graph shown above corresponds to the condition just before Fuel imbalance message. Time shown in the graph is the elapsed time of FDR recording.

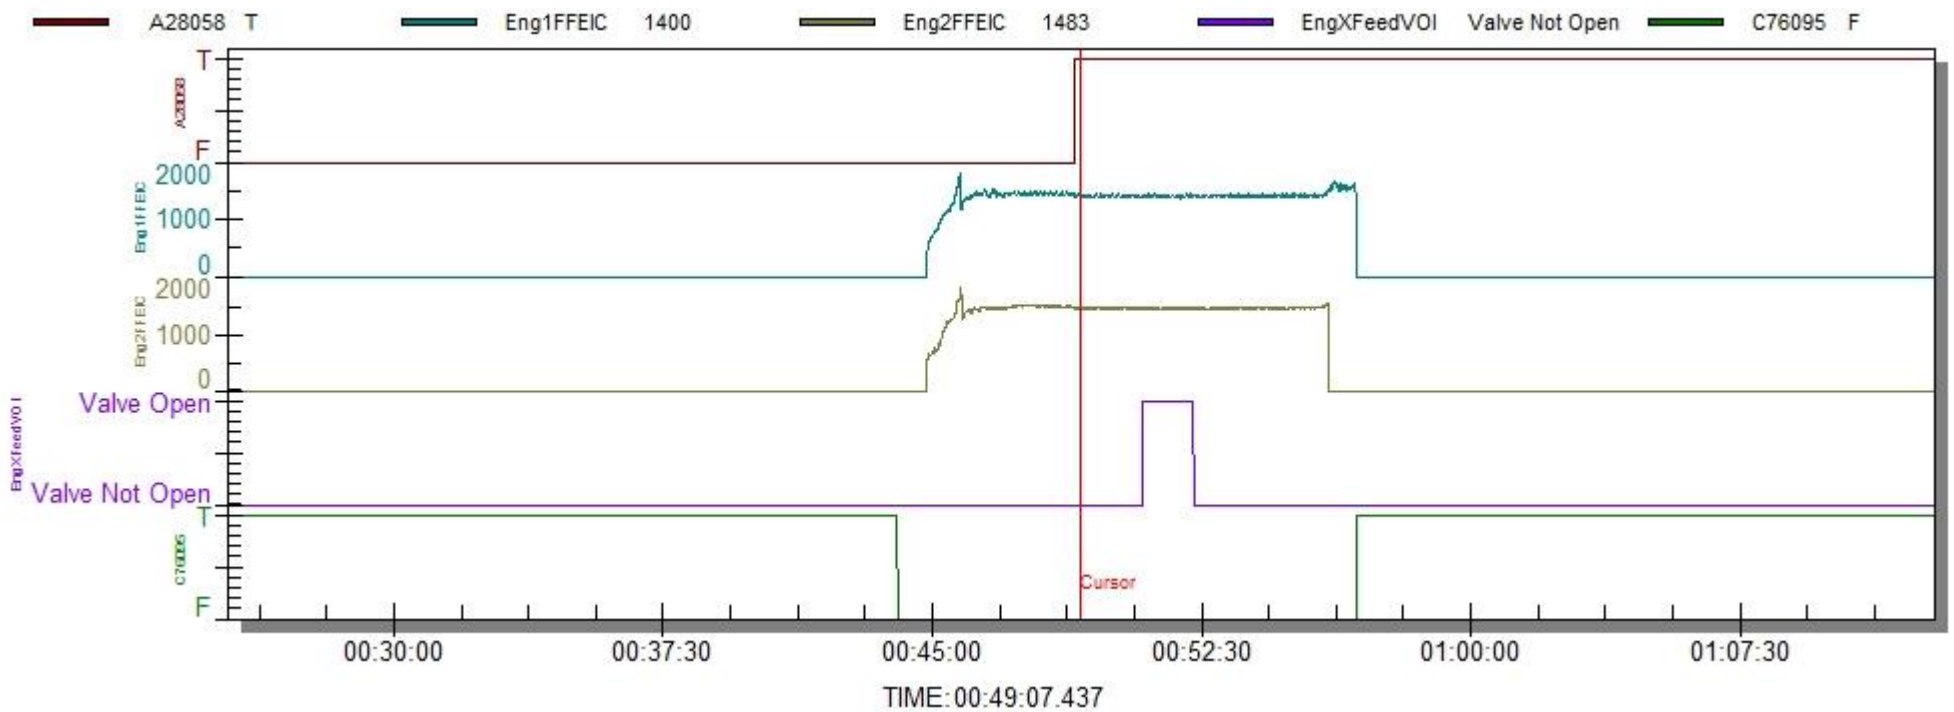
Figure # 4 Graphical representation of FDR data

Graph shown above corresponds to the condition just after Fuel imbalance message. Time shown in the graph is the elapsed time of FDR recording.
