**Government of India**  
**Directorate General of Civil Aviation**

**Investigation Report on Gear-Up landing incident to  
M/s Patiala Aviation Club aircraft VT-PBD at Patiala on  
12.02.2020**

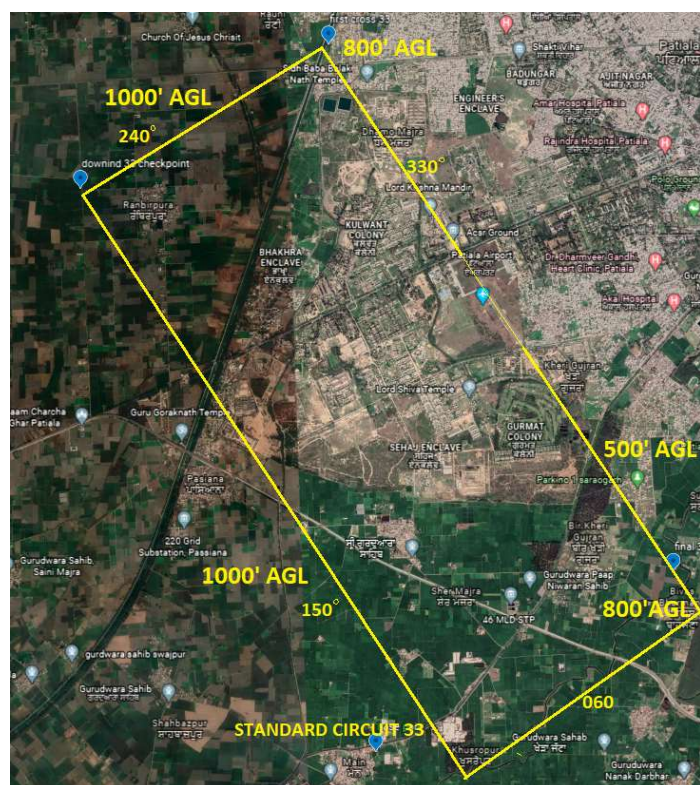
Standard Circuit Pattern

Patiala Aviation Club informed that, they also make use of two circuit patterns. A 'SHORT CIRCUIT' pattern, wherein a left turn is taken after 500ft AGL post take-off and a 'STANDARD CIRCUIT' wherein a left turn is initiated after 800ft AGL post take-off. The 'STANDARD CIRCUIT' and 'SHORT CIRCUIT' pattern, as submitted by Patiala Aviation Club is illustrated in page 20. Whereas, the definitions and conditions at which these are followed/used i.e., 'Standard Circuit Pattern' and 'Short Circuit' is not detailed in the approved Training Procedures Manual.

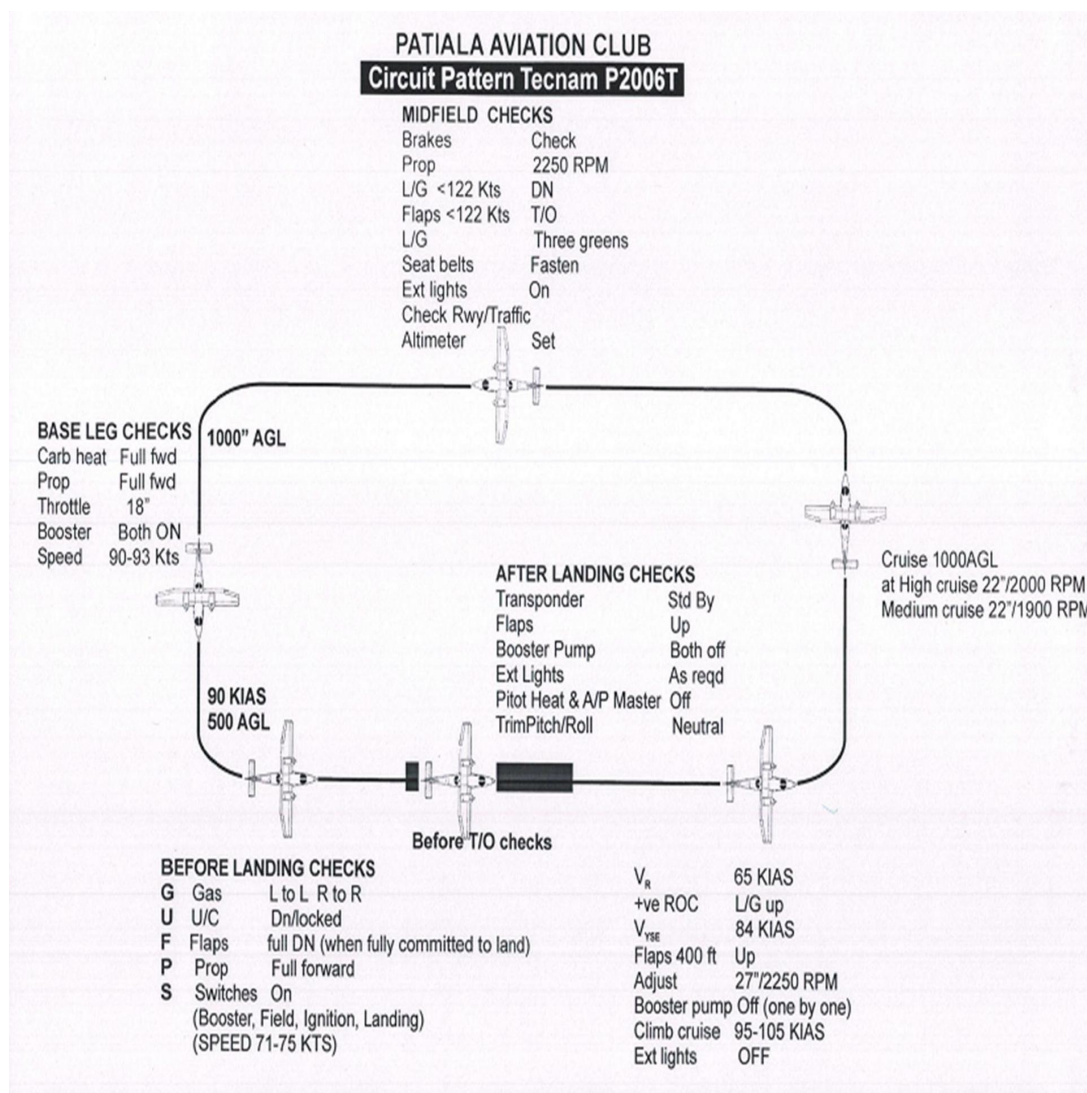
**Figure-II : Circuit Pattern**

The circuit pattern with checklist prepared and used by Patiala Aviation Club for TECNAM P2006T aircraft is as illustrated below:
