**INVESTIGATION REPORT**

**INCIDENT TO A109SP HELICOPTER VT-YMA OF M/S**  
**LULU INTERNATIONAL Pvt. Ltd. AT COCHIN ON 11<sup>th</sup>**  
**APRIL-2021**

**OFFICE OF THE DIRECTOR OF AIR SAFETY**  
**(SOUTHERN REGION), CHENNAI**

**Final Investigation Report on Incident to A109SP helicopter VT-YMA  
of M/s Lulu International at Cochin on 11<sup>th</sup> April-2021**

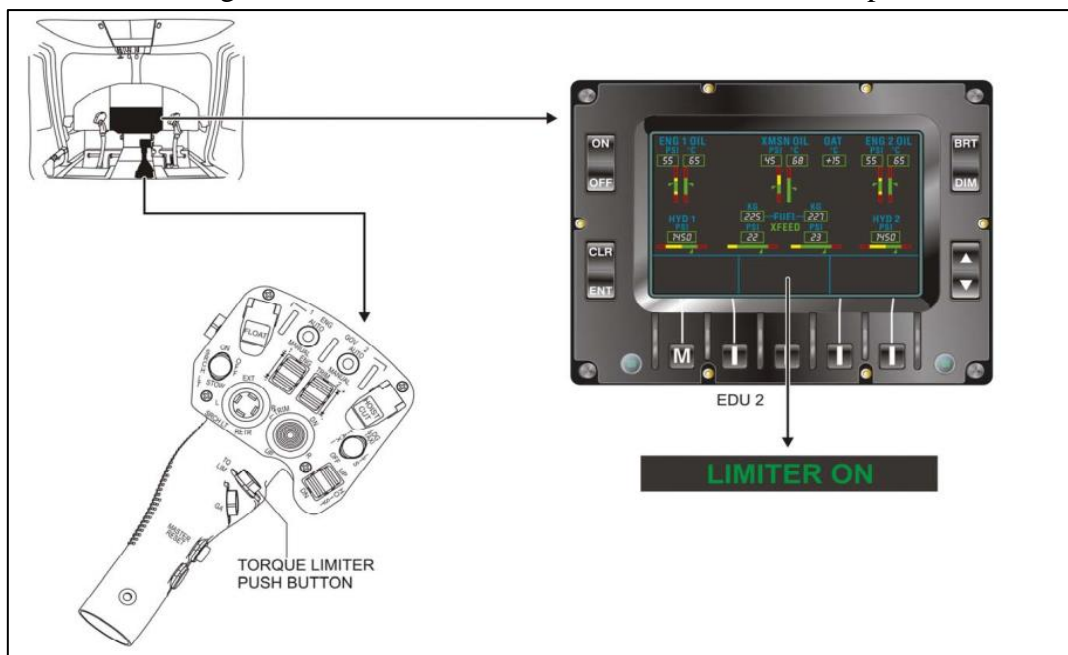
(Fig. 4: Torque Limiter push button on Collective; EDU showing ‘Limiter ON’)

When the ECU detects this selection, sends a signal to the Data Acquisition Unit (DAU) that generate a “LIMITER ON” advisory message on the Electronic Display Unit (EDU 2). These limits can be reset upon pilot’s command, to disable the function a second push on the button is necessary.

As per engine manufacturer, when this limit is reached (total torque reaching 220%), the fuel flow to the engine is decreased, which will in turn reduce rotor speed.

The Rotorcraft Flight Manual (RFM) for AW109SP provides a ‘caution message’ in the ‘Before Take-Off’ checks regarding usage of Engine torque limiter function and its implications. As per the RFM, this function is required to be kept active during Automatic Flight Control System (AFCS) Upper Modes and Flight Director Modes. Apart from this, there is no other guidelines or requirements provided by the Helicopter or engine manufacturer regarding usage of Engine torque limiter.

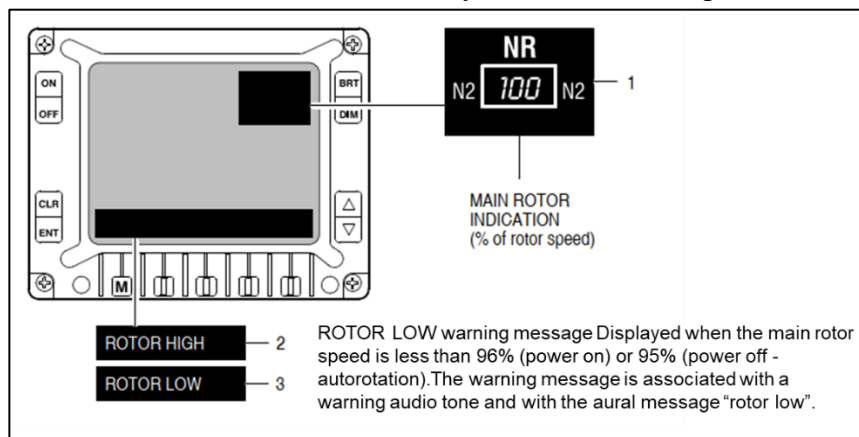
(Fig. 6: EDU highlighting indications of ROTOR LOW & HIGH caution)

‘ROTOR LOW’ warning message is displayed when the main rotor speed is less than 96% (power on) or 95% (power off -autorotation). The warning message is associated with a warning audio tone and with the aural message “rotor low”. The warning audio tone and the aural message reset when the NR is less than 80%.

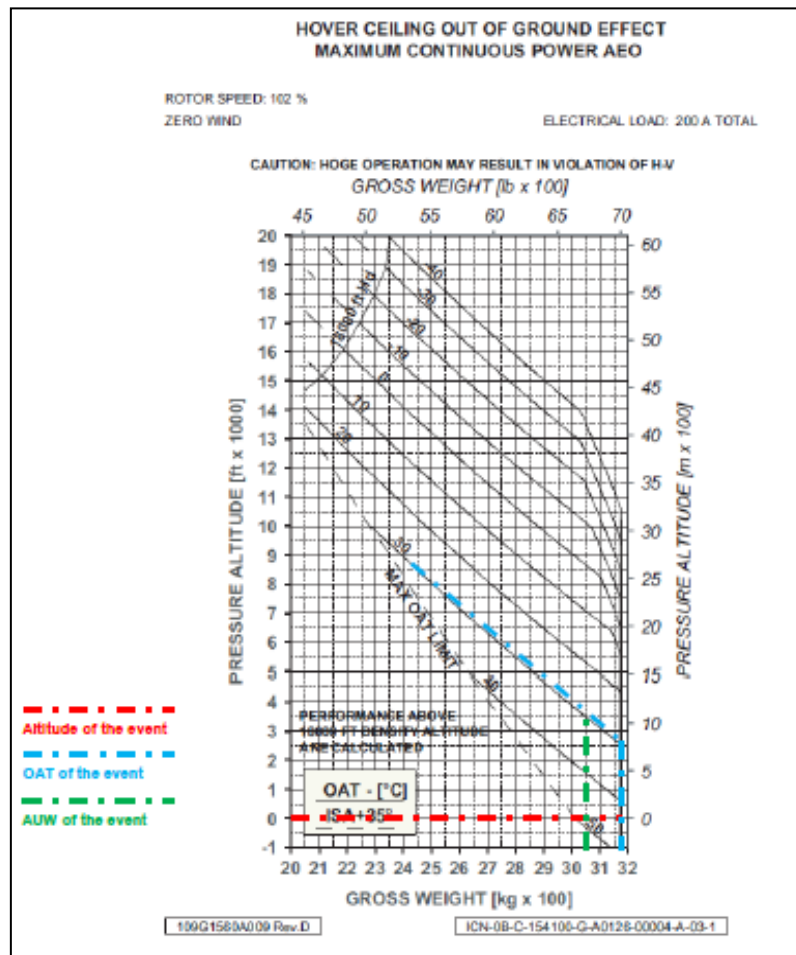
(Fig. 7: Performance chart: Extract of AW109SP RFM Section 4)

According to the published RFM Performance charts, the helicopter can achieve HOGE at MTOW in the conditions of the incident day (30°C OAT and 0ftAMSL), even when limiting power to AEO MCP (i.e. 100% on each side).

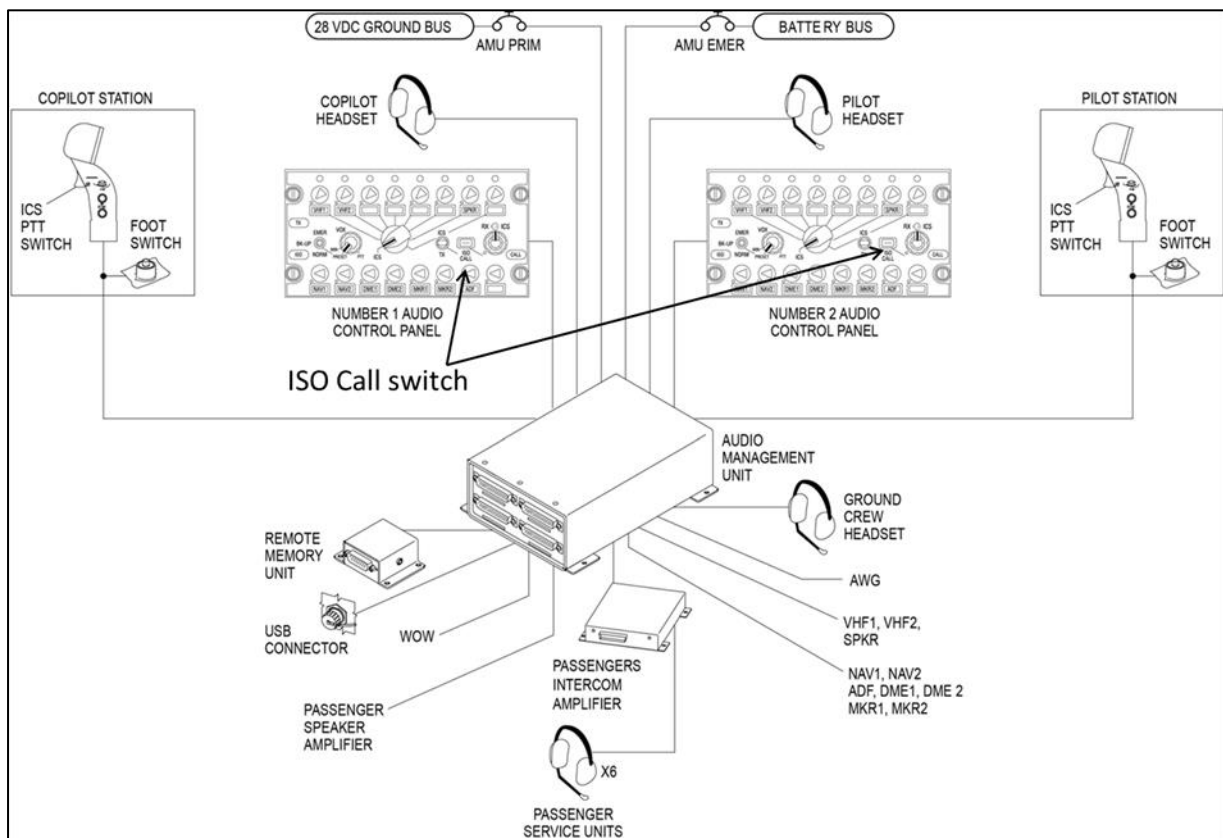
(Fig.8: Digital Audio Control System)

In this incident, as per CVR recordings and clarification from both the pilots, it was observed that audio inputs of all the channels (Pilot, ATC & Passenger conversations) were fed to pilot's headphones. The crew did not isolate themselves from the passengers during the flight. This has been the practice in the organization.

7. PIC was Pilot Flying and Co-Pilot was Pilot Monitoring. The helicopter was flown manually by the PIC.
8. The entire conversations of crew and ATC were overlapped with inter-cabin conversations (passenger conversation) as the crew did not isolate themselves from the cabin communications, thereby not adhering to Sterile cockpit.

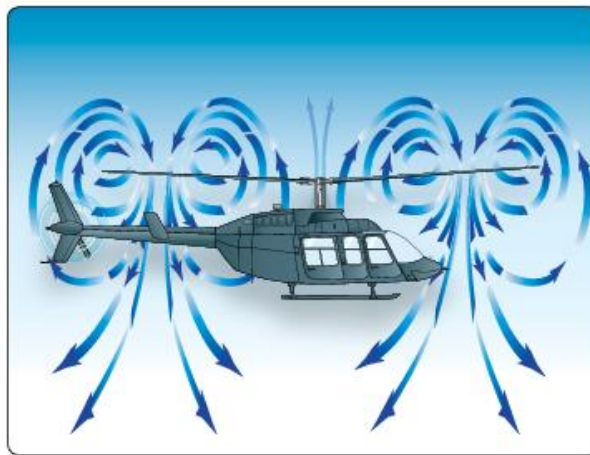
(Fig. 12: Vortex Ring State)

As a result of these changed flow conditions, the lift produced by the rotor is massively reduced and the rate of descent of the helicopter is increased accordingly. By pulling on collective the effect is amplified.

A vortex ring state may be entered during any maneuver that places the main rotor in a condition of descending in a column of disturbed air and low forward airspeed. Airspeeds that are below translational lift airspeeds are within this region of susceptibility to vortex ring state aerodynamics
