**INVESTIGATION REPORT ON INCIDENT TO  
M/S TATA SIA AIRLINES LTD. (VISTARA) AIRBUS  
A320-232 AIRCRAFT VT-TTF WHILE OPERATING  
FLIGHT UK -733 (SECTOR: CHENNAI - KOLKATA)  
ON 25.02.2019**

**DIRETORATE GENERAL OF CIVIL AVIATION  
GOVERNMENT OF INDIA  
NEW DELHI**

**INVESTIGATION REPORT ON INCIDENT TO M/S TATA SIA AIRLINES LTD.  
(VISTARA) AIRBUS A320-232 AIRCRAFT VT-TTF WHILE OPERATING FLIGHT  
UK -733 (CHENNAI - KOLKATA) ON 25.02.2019**

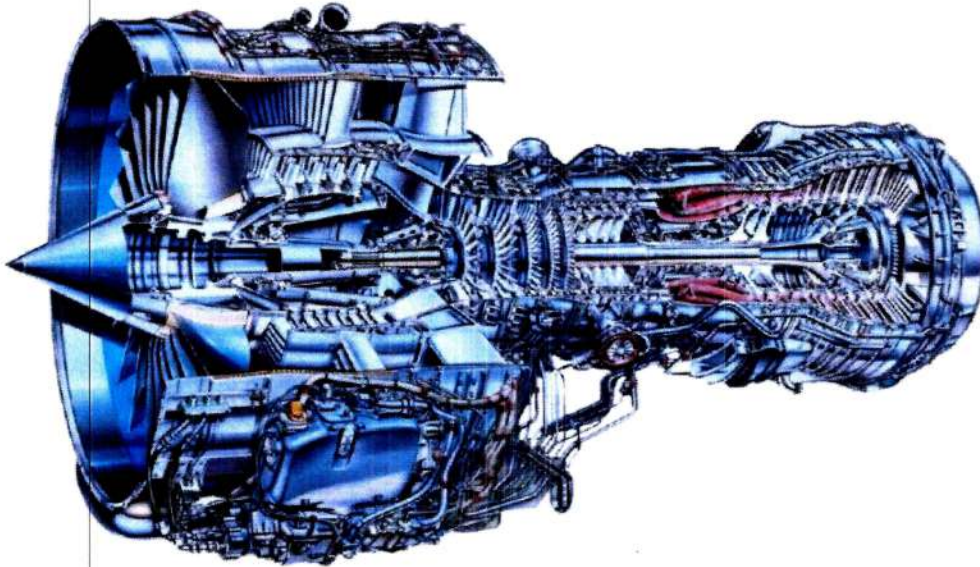
**IAE Engine V2527-A5**

The involved engine V2527-A5 (S/N V17533) was sent to IAE by the operator for investigation. Further the engine was sent by IAE to Turbine Services & Solutions in Abu Dhabi, United Arab Emirates for disassembly. The findings and conclusion of IAE investigation report are detailed below:
