**FINAL INVESTIGATION REPORT OF
IN-FLIGHT ENGINE SHUTDOWN INCIDENT TO
M/s SPICEJET LTD. BOEING B737-8, AIRCRAFT VT-MXA ON
03.05.2022 AT CHENNAI.**

**O/o DIRECTOR AIR SAFETY, SOUTHERN REGION,
INTERNATIONAL CARGO COMPLEX, MEENAMBAKKAM,
CHENNAI-600016**

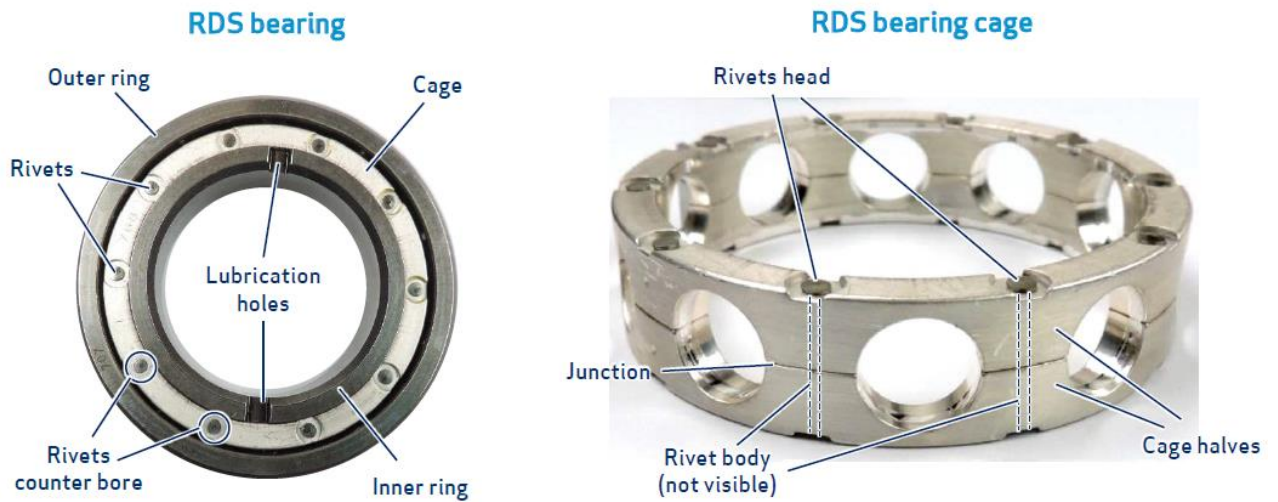
Figure 9: RDS bearing and cage (Source: M/s CFM)

As per M/s CFM, the RDS Bearing failures are caused due to

- Insufficient oil film between cage pilot diameter and inner ring.
- Cage wear is due to
 - Inadequate bearing geometry that prevents proper oil film establishment.
 - Insufficient oil flow reaching cage journal bearing.
- The Rivets fatigue
 - Cage halves assembly not at design intent could contribute to rivets abnormal stress and early failure.

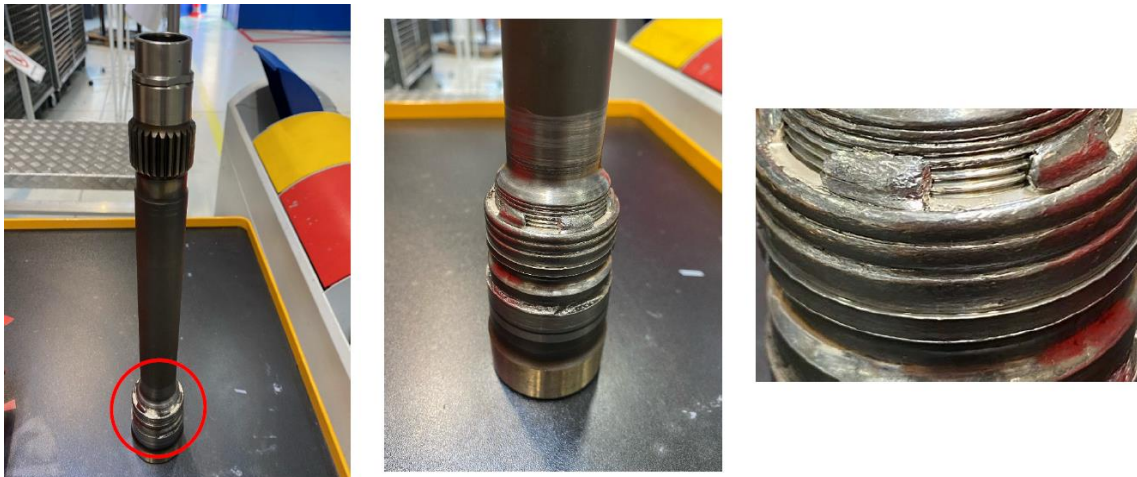
Figure 12: Inner Radial Drive Shaft (Main Assembly)

The failed engine was returned to M/s CFM for disassembly and investigation. During disassembly, the major findings after investigations performed on the Radial Drive Shaft are:

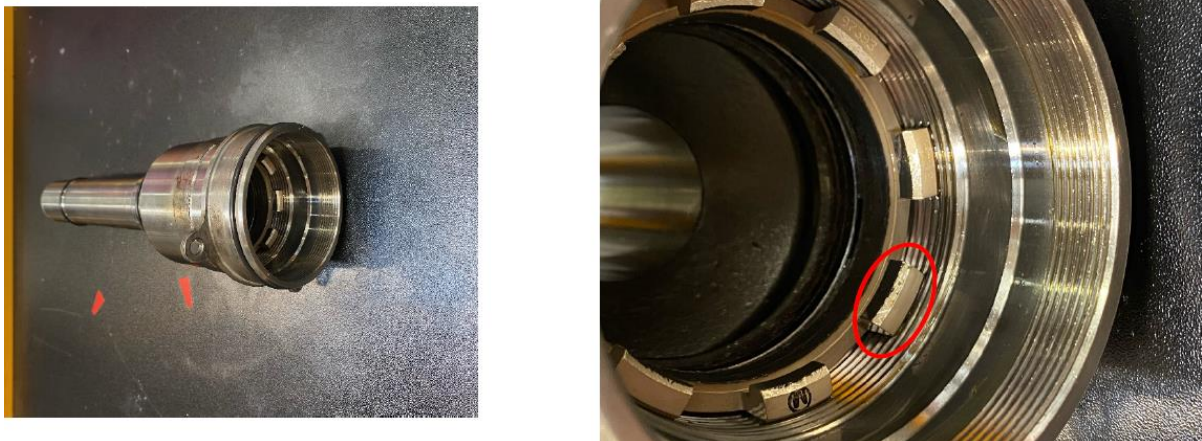
Figure 13: Inner RDS

- Strong wear and spalling on outer ring raceway with a strain hardening on the surface of the raceway and shoulders over the circumference. The strain hardening covered 1/3 of the total thickness of the ring and shows a second quenching then an over tempering on hardness profiles. Raceway with wear (burrs observed on raceway edges) and spalling all over the circumference.
