SYNOPSIS:

On 7th May 2017, M/s. Jet Airways Boeing 737-700WL aircraft VT-JGY Operating service 9W-730, sector Delhi to Patna, while taxiing on Taxiway 'Z' to 'Z3' holding point for Runway 29, hit with the another aircraft of M/s. Jet Airways Boeing 737-700WL aircraft VT-JGX Operating Service 9W-603, sector Delhi to Srinagar which was on taxiway 'Z4' short of holding point Runway 29 at around 0930UTC.

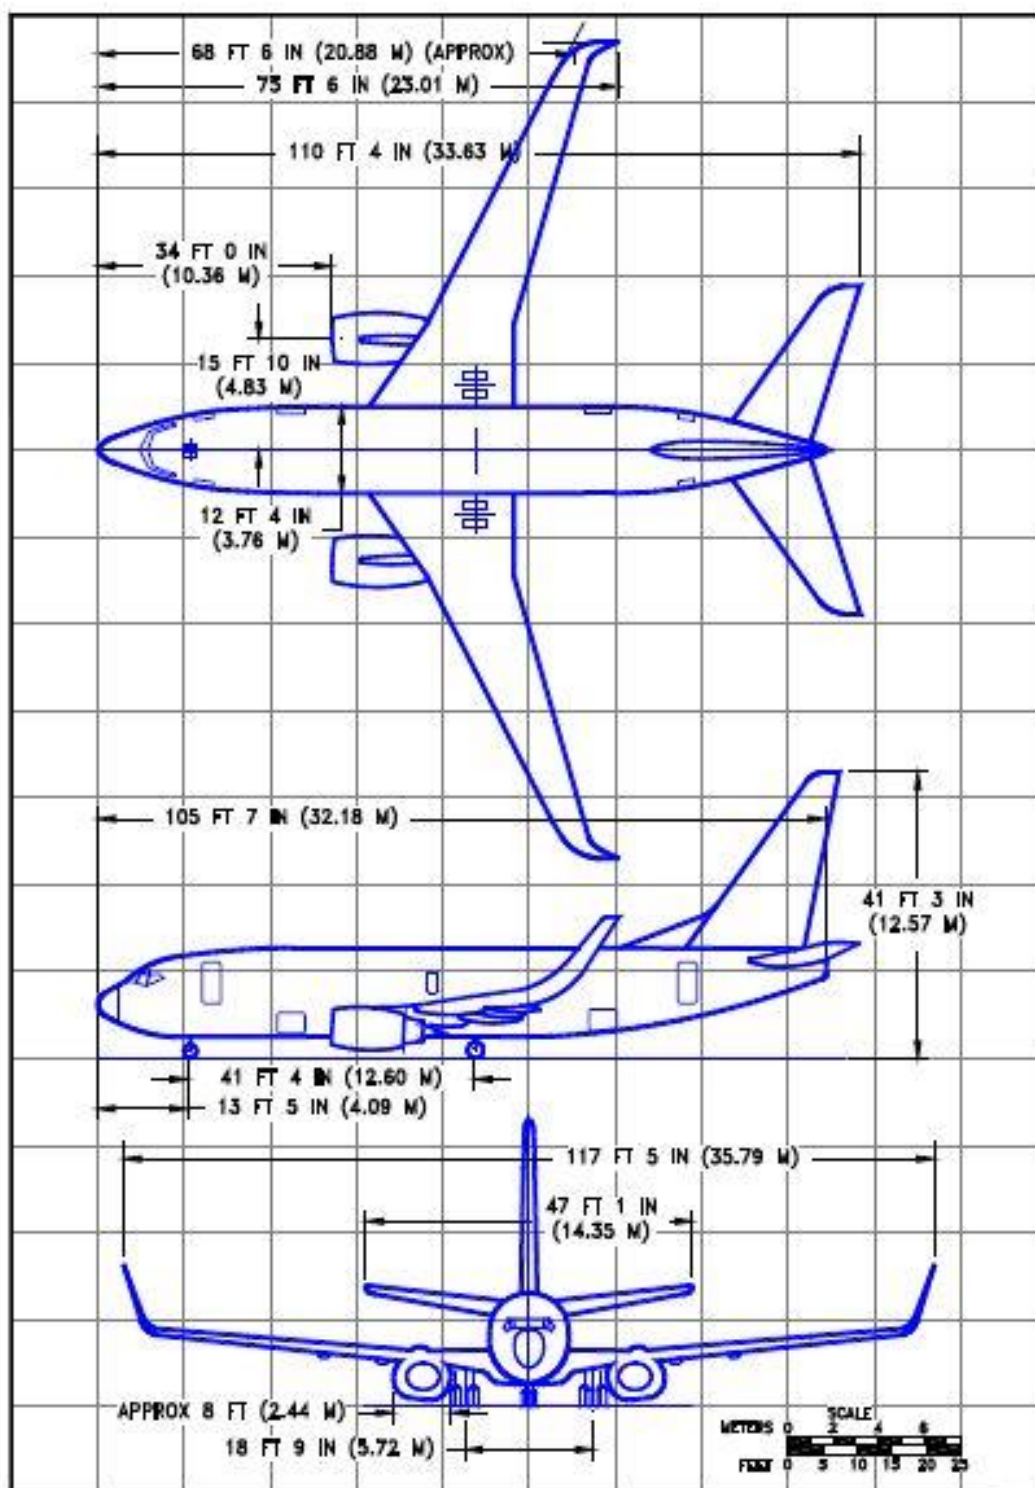
B737-700 aircraft with winglet has got dimension of length of 33.63meters and Breadth of 35.79meters. Elevator total dimension 14.35meters.

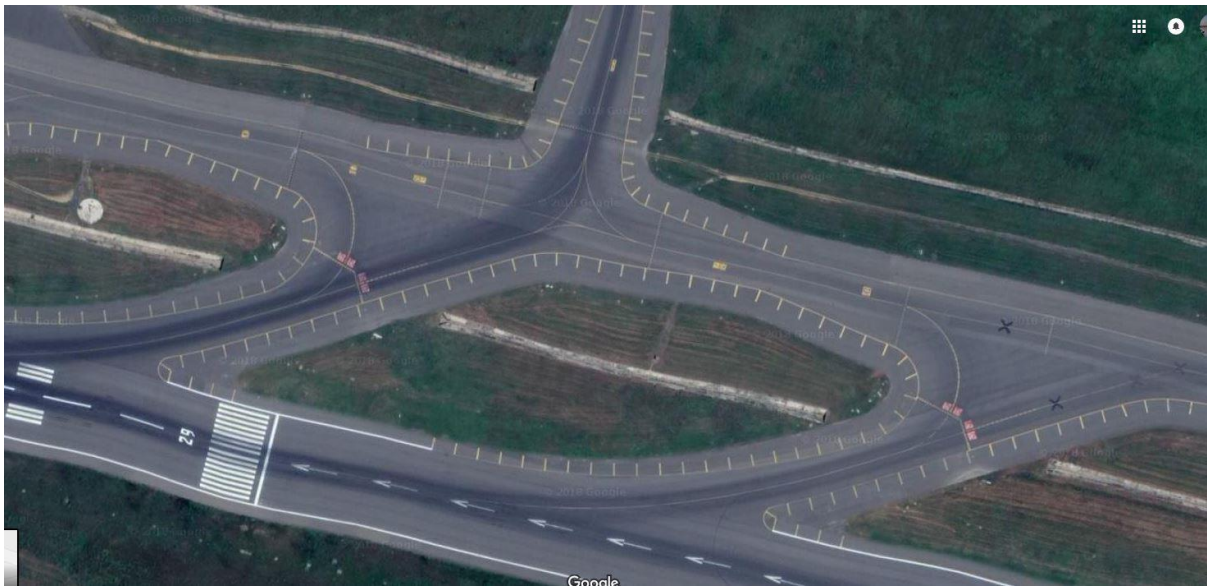
Fig.8:- Taxiways Z-z4 and Z3 with markings

Distance existing between Z taxiway centre line and Z4 holding point was found as 62.5 meters.

From the actual measurements, the distance between, taxiway 'Z4' holding point and taxiway 'Z' centreline found as 62.5meter. As calculated under 1.17 paragraph, had there been VT-JGX was exactly on the holding point, there would have been enough (approx. 10.9 meter) clearance existed.

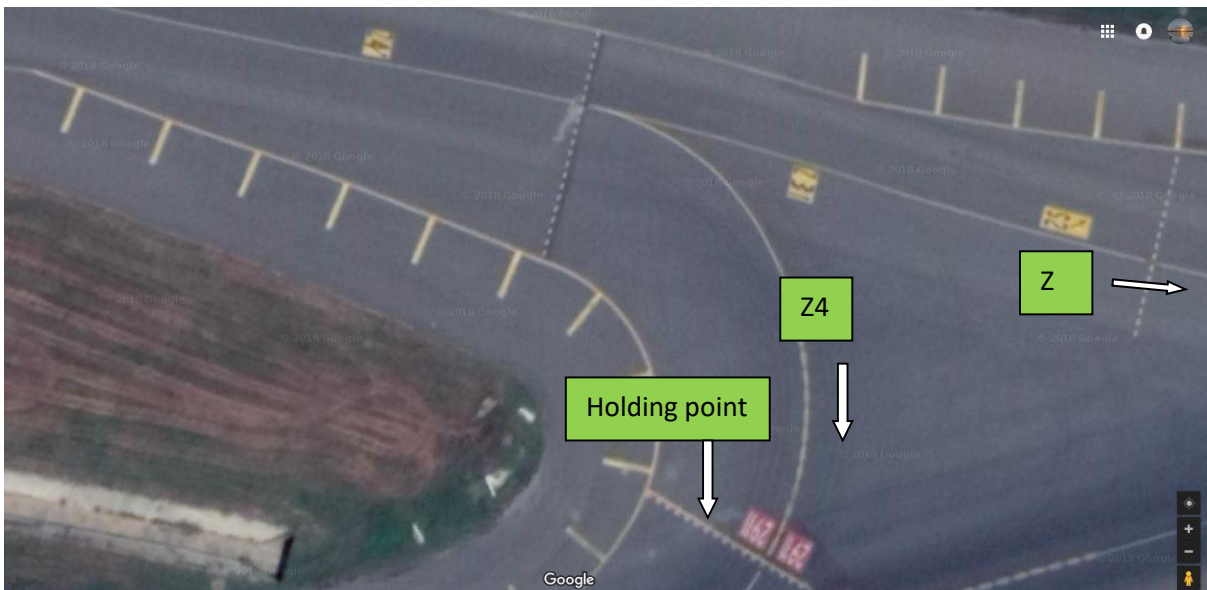
Fig.9: Taxiways Z4 and Holding point markings

Aircraft clearance between both the aircraft of similar type were checked and observed that had it been the first aircraft, ie, VT-JGX, exactly on the holding point, the second taxied aircraft, ie., VT-JGY, might have got wing tip clearance of 10.9m.
