FINAL INVESTIGATION REPORT

Incident to M/s Indigo Airlines, Airbus A320 Neo aircraft, registration VT-IZR

on 23-Aug-2022 at Goa, India

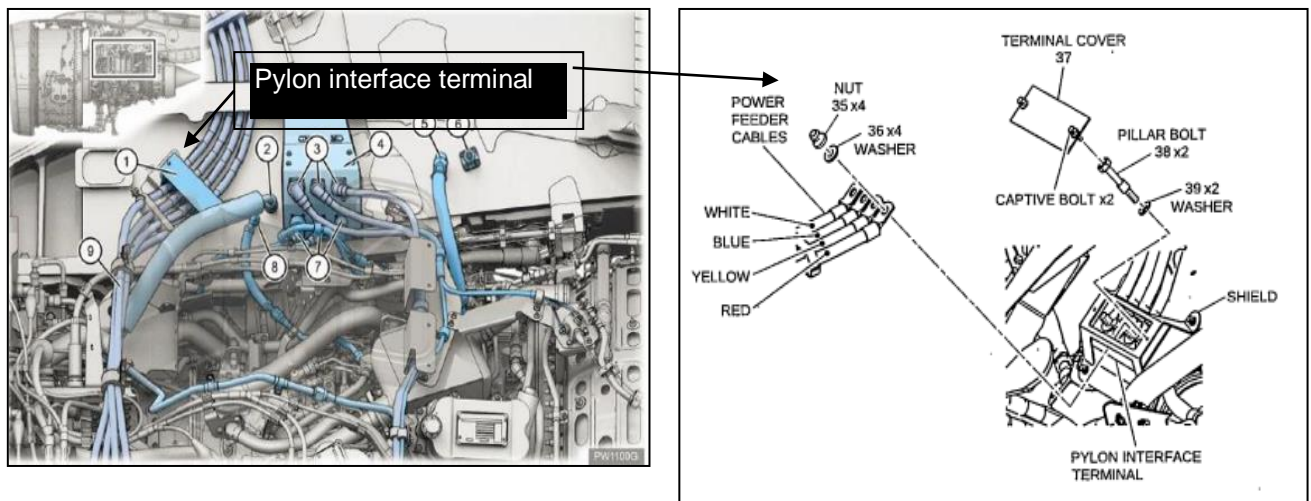
(Fig. 1.6: Pylon Interface Terminal and the IDG cables)

Evidence of localized heating and material degradation was observed on the terminal cover of the Pylon Interface Terminal, in the form of blistering.
