**ACCIDENT REPORT ON NRSA SUPER  
KING AIR 300 VT-EQM OVER TALOJA  
HILLS NEAR BOMBAY ON 15.7.93.**

**ACCIDENT REPORT ON NRSA SUPER KING AIR 0300 AIRCRAFT VT-EQM  
OVER TALOJA HILLS NEAR BOMBAY ON 15.7.1993**

A. Aircraft : Type : Super King Air  
 Model : 300  
 Nationality : Indian  
 Registration : VT-EQM  
 Engine : PT6A-60A

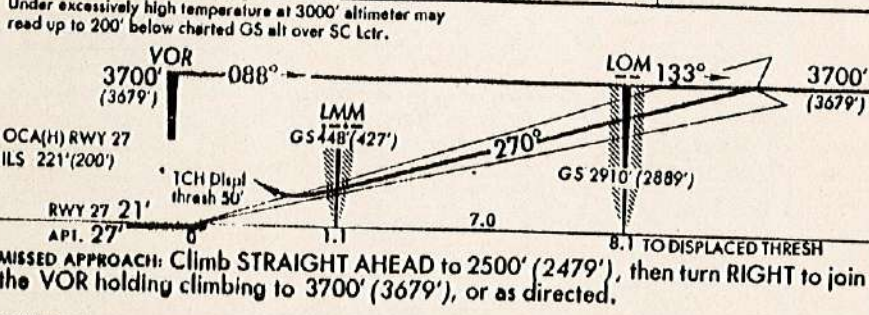
BOMBAY, INDIA  
 BOMBAY  
 ILS Rwy 27  
 LOC 110.3 SCZ  
 MSA 2500' WITHIN 12 NM.  
 MSA 3700'  
 090°  
 2500'  
 090°  
 3700'  
 MSA  
 BBB VOR  
 Apl. Elev. 27'

ATIS 126.4  
 BOMBAY Approach (R) 127.9  
 BOMBAY Tower 118.1  
 Ground 121.9  
 All Set H'rs  
 Rwy Elev. 1 H'rs  
 Trans level. By ATC  
 Trans alt 4000' (3979')

STRAIGHT IN LANDING RWY 27			CIRCLE TO LAND	
ILS			LOC (GS out)	
ELEV 221' (200')				
Full	IDZ or 1/2 mi	At 5 out	Max Kt	MDA(H)
1200m		SEE 11-2	100	1440' (1413') 2000m
			135	1440' (1413') 2400m
			180	1440' (1413') 4800m
			205

In the instant case, at the time of impact the aircraft was under radar vectoring by the Approach Controller. From the recordings of the ATC tape corroborated by that of the CVR tape, it is evident that the aircraft was descended in steps from FL 140 when it first contacted Bombay Radar. At 0621 UTC timing of the ATC tape transcript, the aircraft VT-EQM was told by radar to turn right heading 240 and intercept localizer from right. The aircraft was at level 55 at this stage. According to the CVR tape, after about 1 minute of above transmission, the aircraft is being asked by radar to descend to 3700 ft. on QNH 1001 and report leaving 55. After reporting leaving 55, the aircraft subsequently reported at 4000 ft after 51 seconds. This indicates that the aircraft had descended from FL 55 at the rate of approx 1800 ft. per minute when it passed through the level of 4000 ft. From the CVR and ATC tape there is no evidence that the pilot after having told to intercept the localizer had reported to ATC of intercepting the same at any time thereafter.
